**ENVIRONMENTAL ASSESSMENT  
(KRAZEN AND ASSOCIATES)**

**PHASE I ENVIRONMENTAL  
SITE ASSESSMENT UPDATE  
COLLEGE PARK YARD PARCELS 3 AND 4  
NORTH FIRST STREET AND RYLAND STREET  
SAN JOSE, CALIFORNIA**

Project No. 044-00051  
November 1, 2000

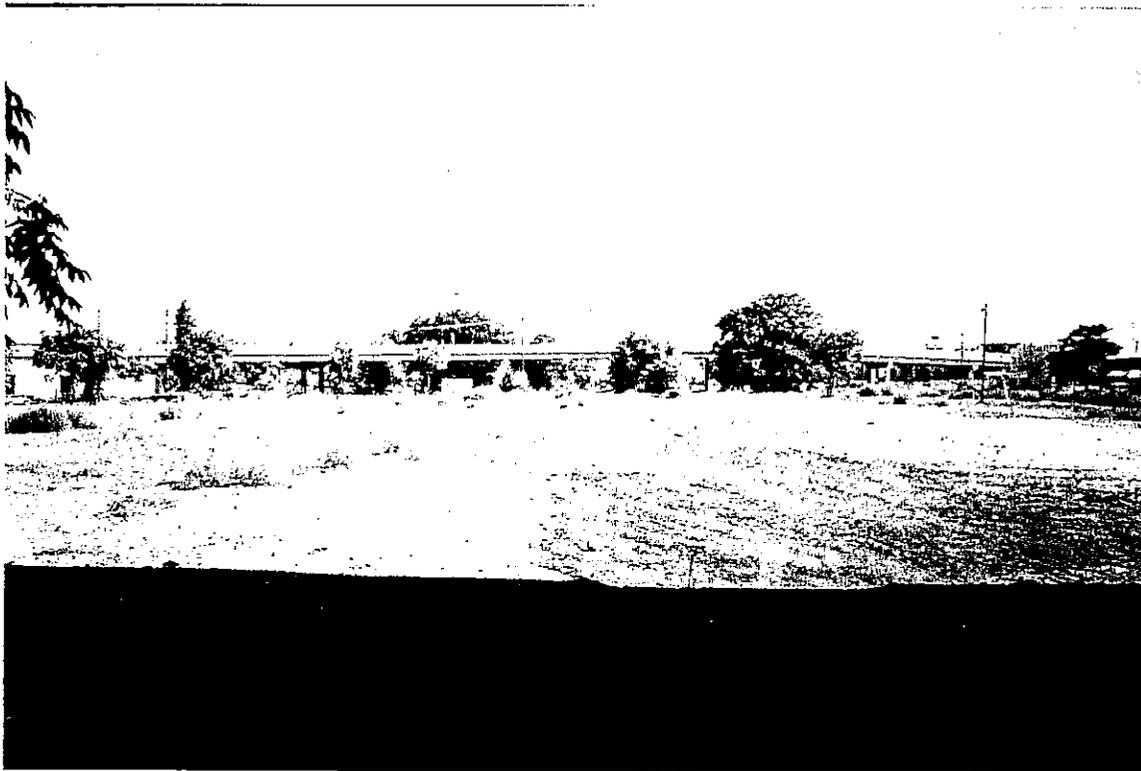
Photo 1: View to the east from near the western side of Parcel 3.

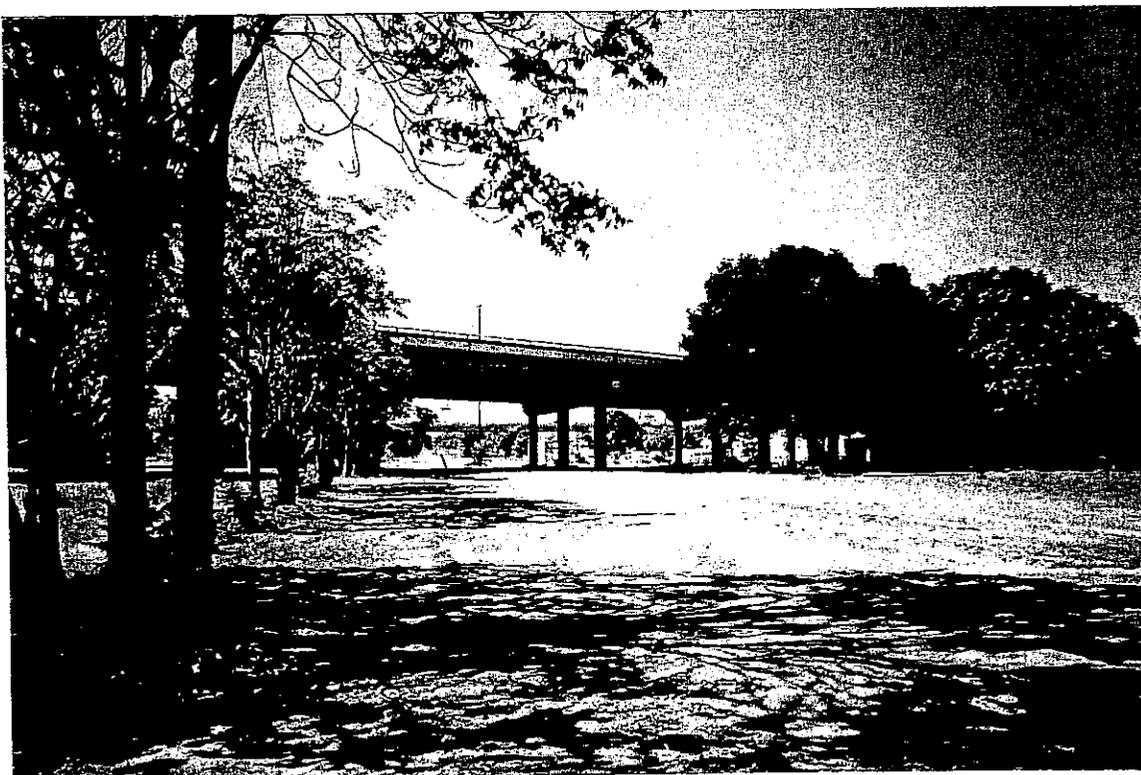
Photo 2: View to the west from Parcel 4.

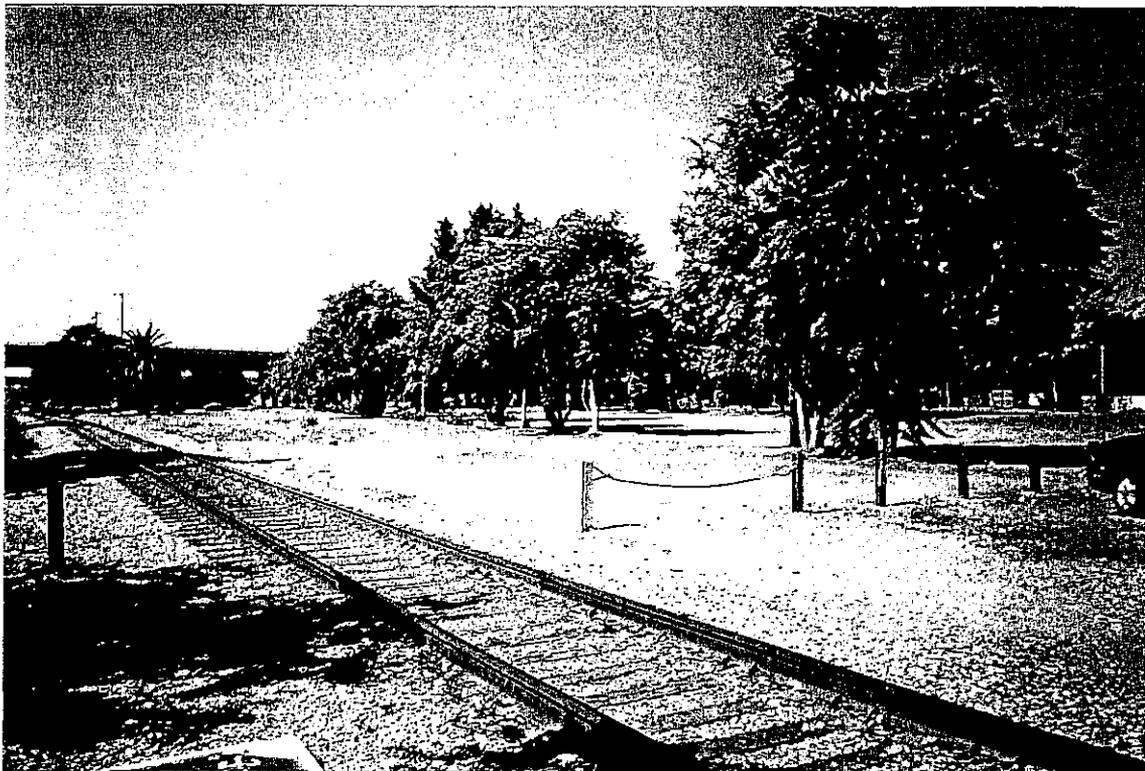
Photo 3: View to the west from parcel 4.

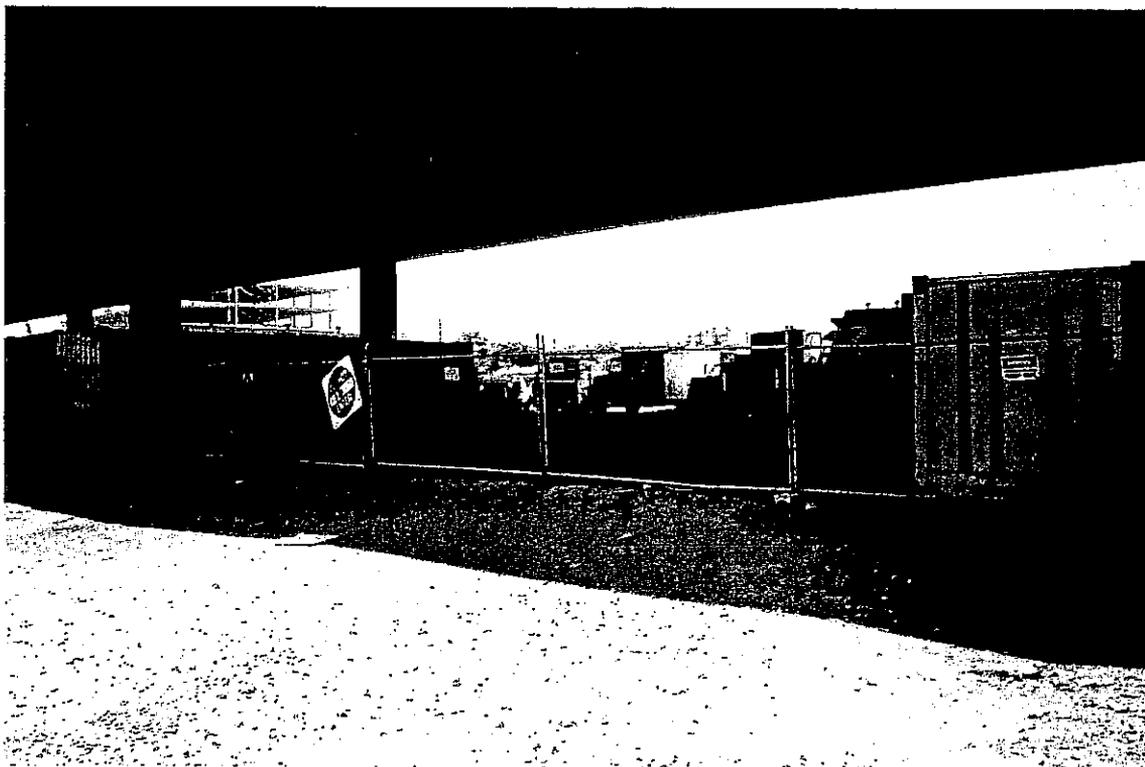
- A fenced area was observed underneath the Guadalupe Freeway Overpass. The fenced area primarily contained vehicles and large metal containers and appeared to be a storage area, possibly for a construction company or a transportation company.

Photo 4: View of the vehicle and container storage area locate beneath the Coleman Overpass.

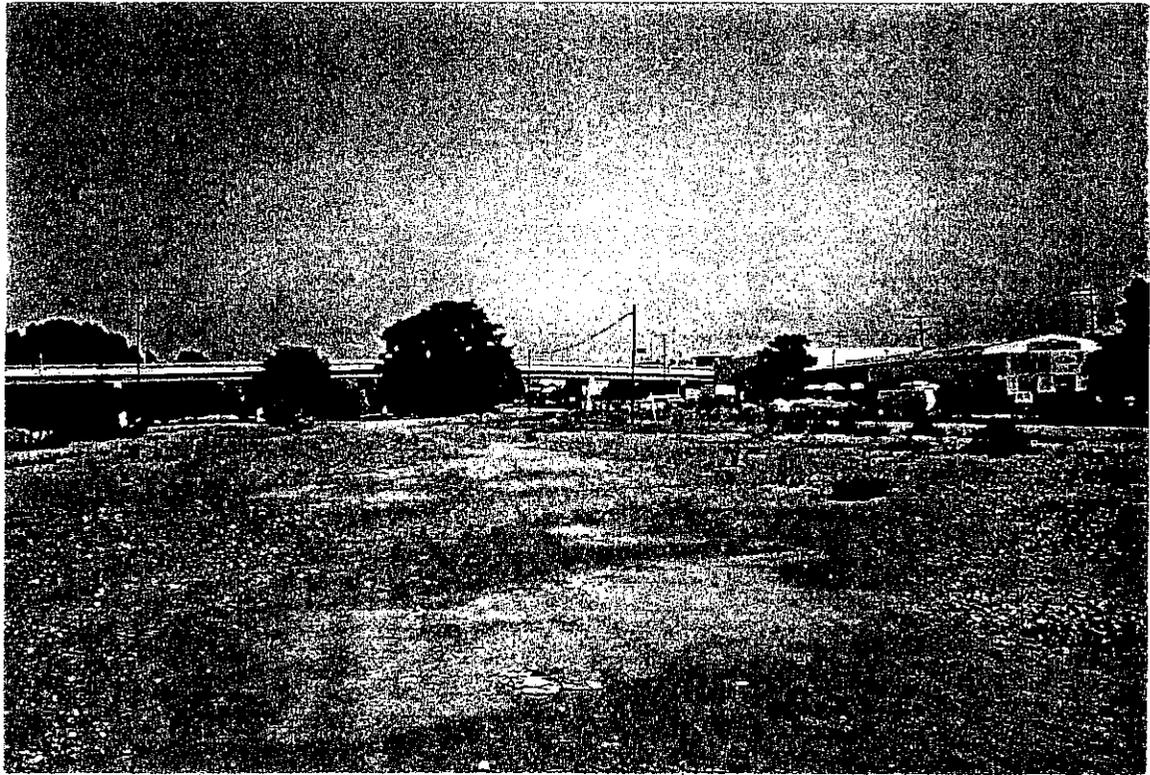
Photo 1: View to the east from near the western side of Parcel 3.

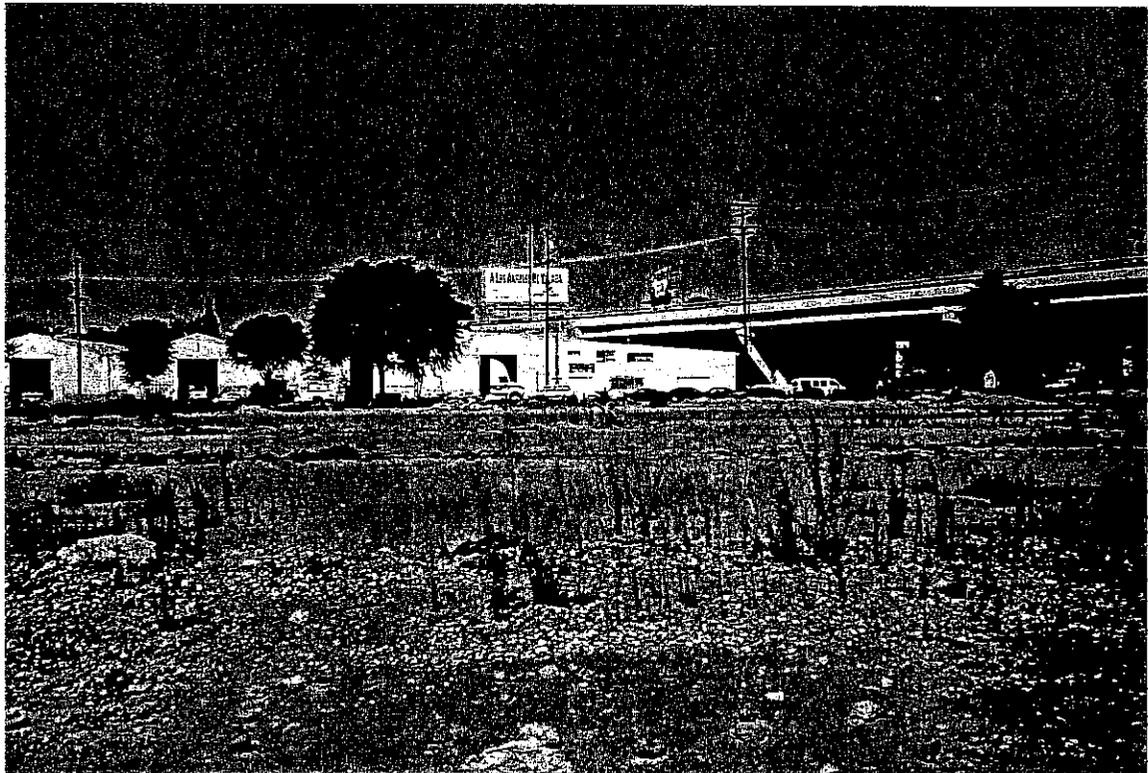
Photo 2: View to the north from near the center of Parcel 3.

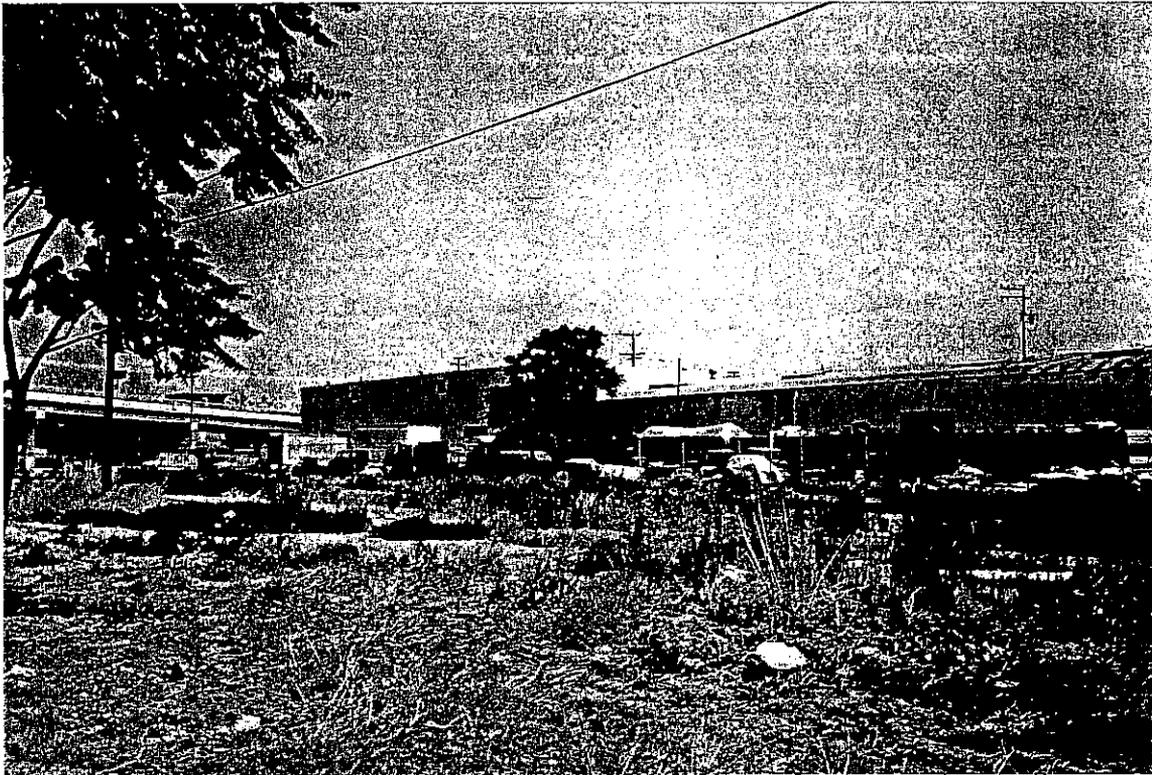
Photo 5: View to the south of Parcel 3 showing adjacent business in background.

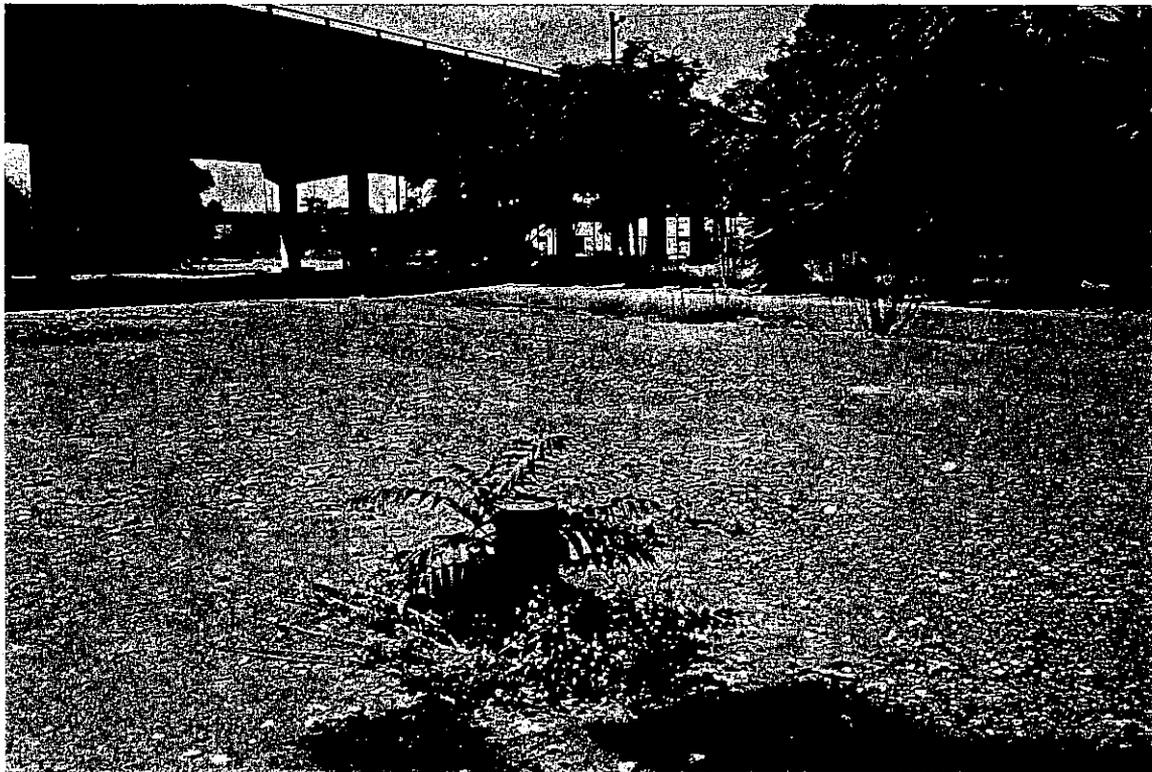
Photo 6: View of monitoring well located on Parcel 4.

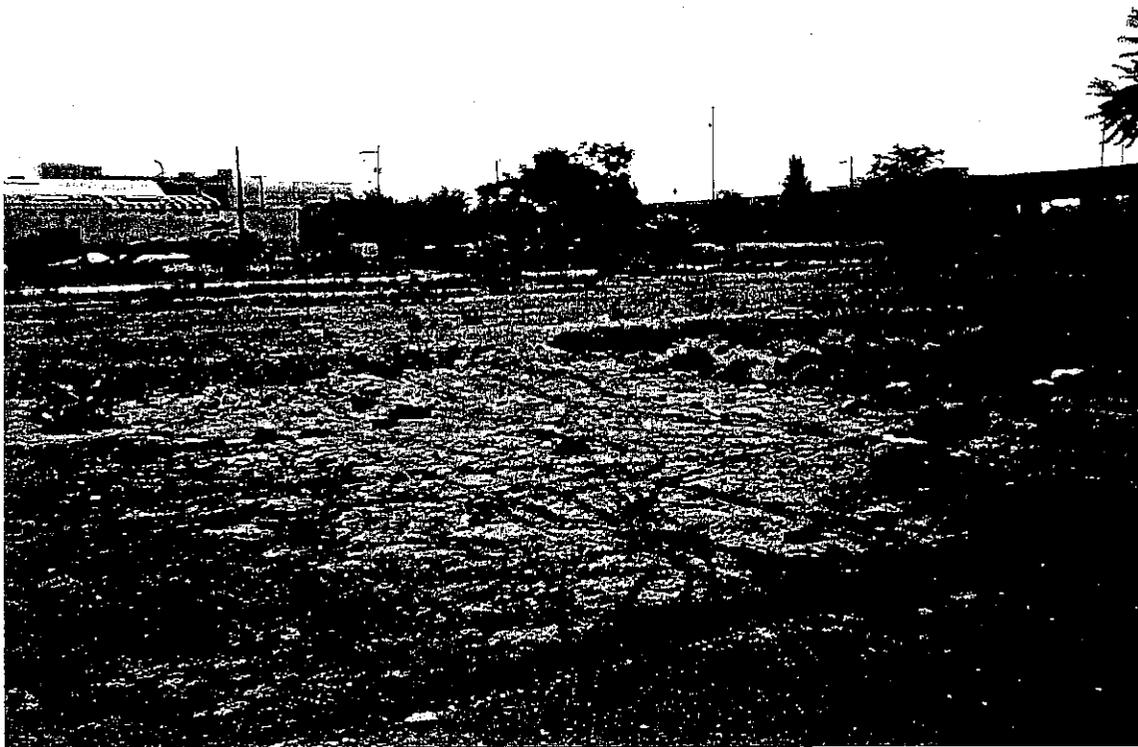
Photo 3: View of a slight depression on Parcel 3.

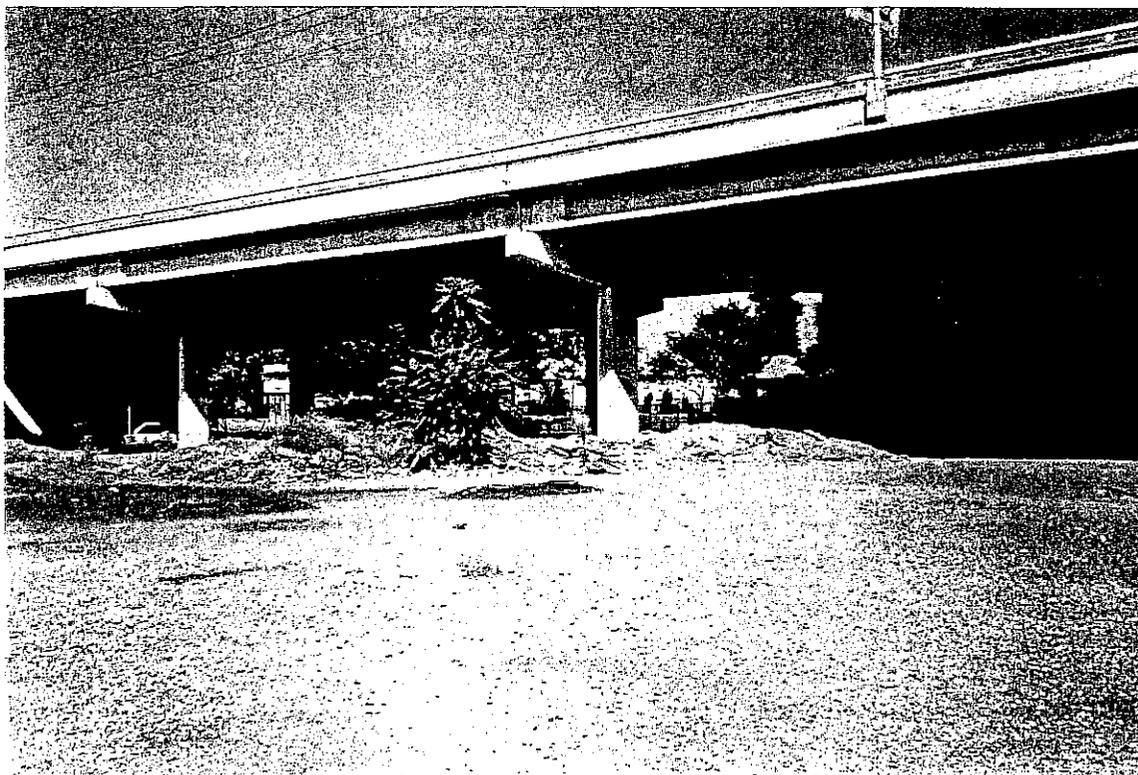
Photo 4: View to the northeast at the eastern side of Parcel 3. Note soil piles in the background.

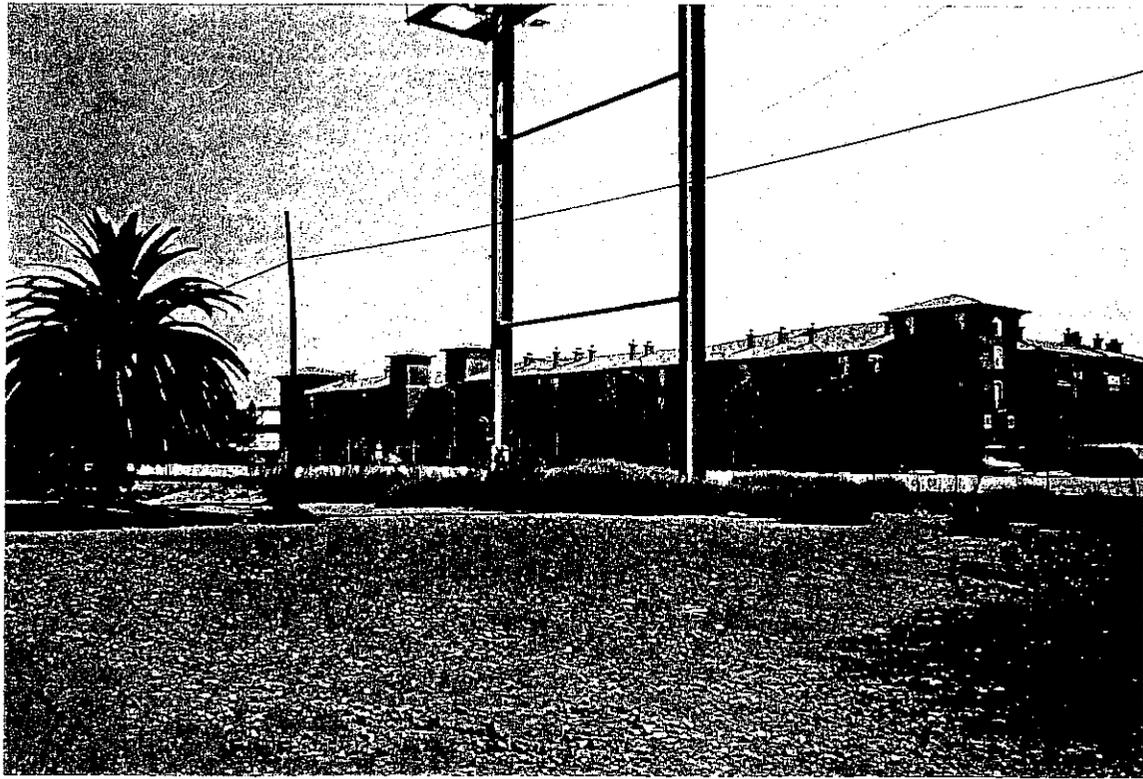
Photo 7: View to the southeast of Parcel 4 showing adjacent vacant parcel and residential.

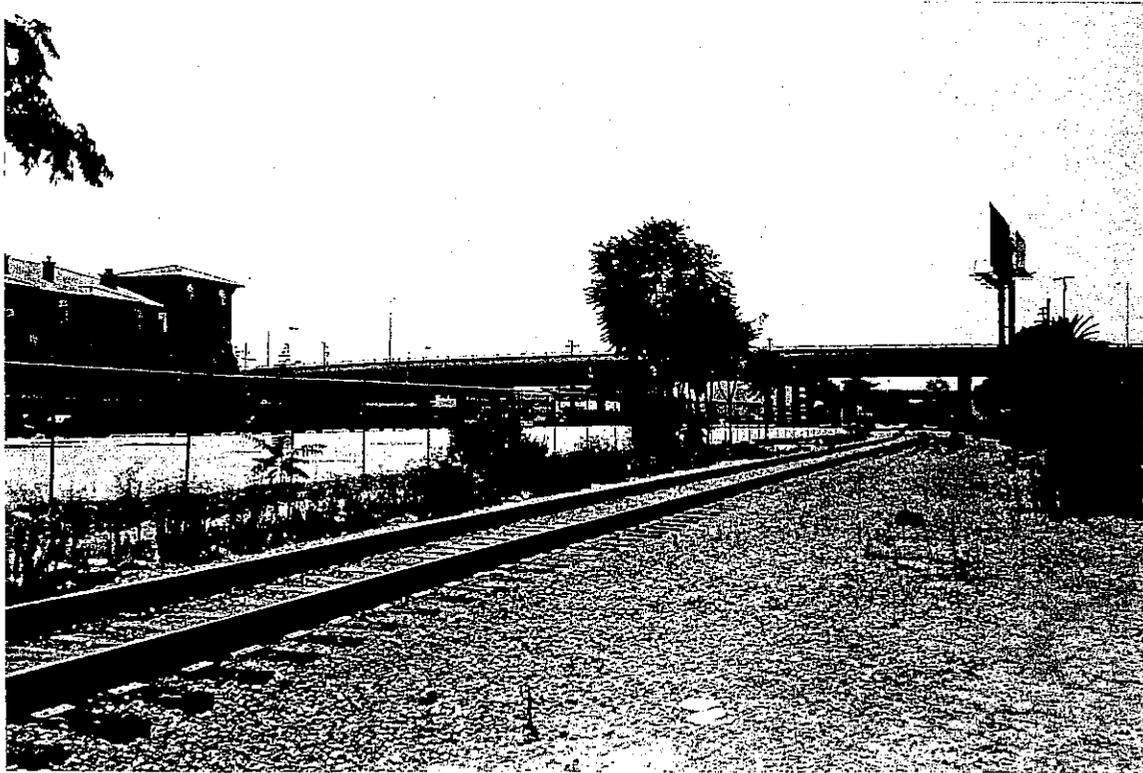
Photo 8: View of the southwest of adjacent railroad tracks.

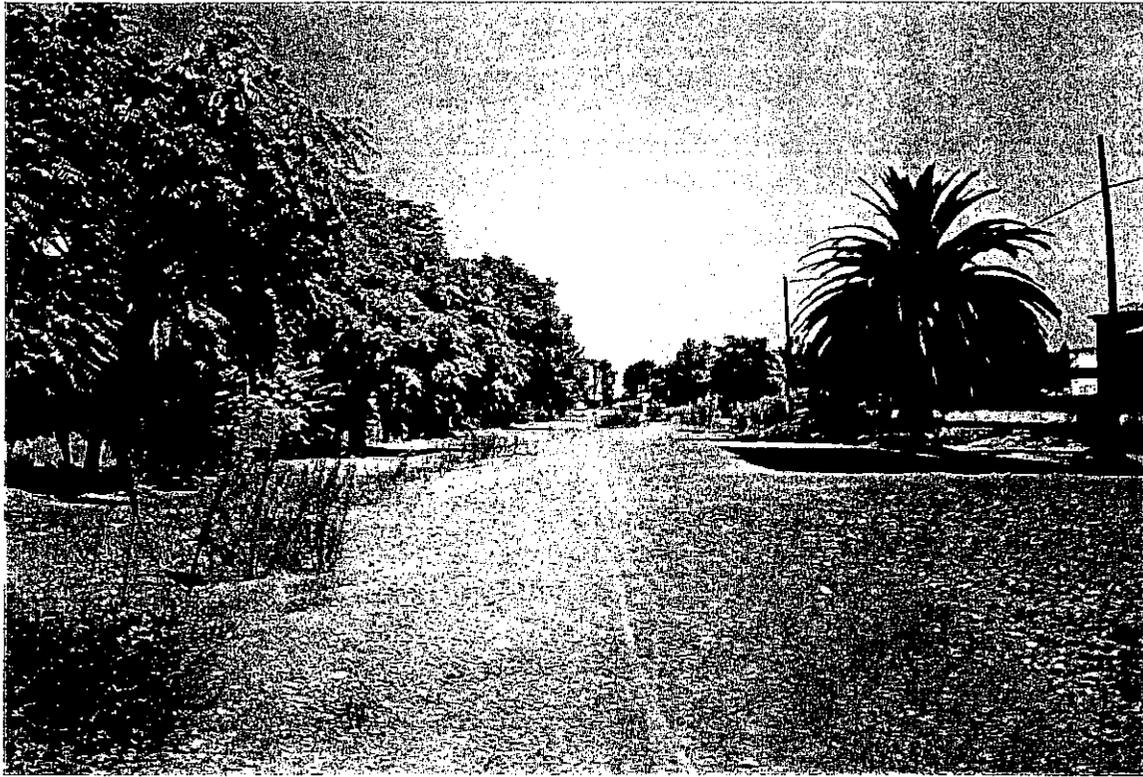
Photo 9: View to the east from near the western portion of Parcel 4.
