Subject: 2009 Year 9 Monitoring Report for the Rubino Development Site.

YEAR 9 (2009)

MITIGATION/MONITORING REPORT

RUBINO DEVELOPMENT PROJECT

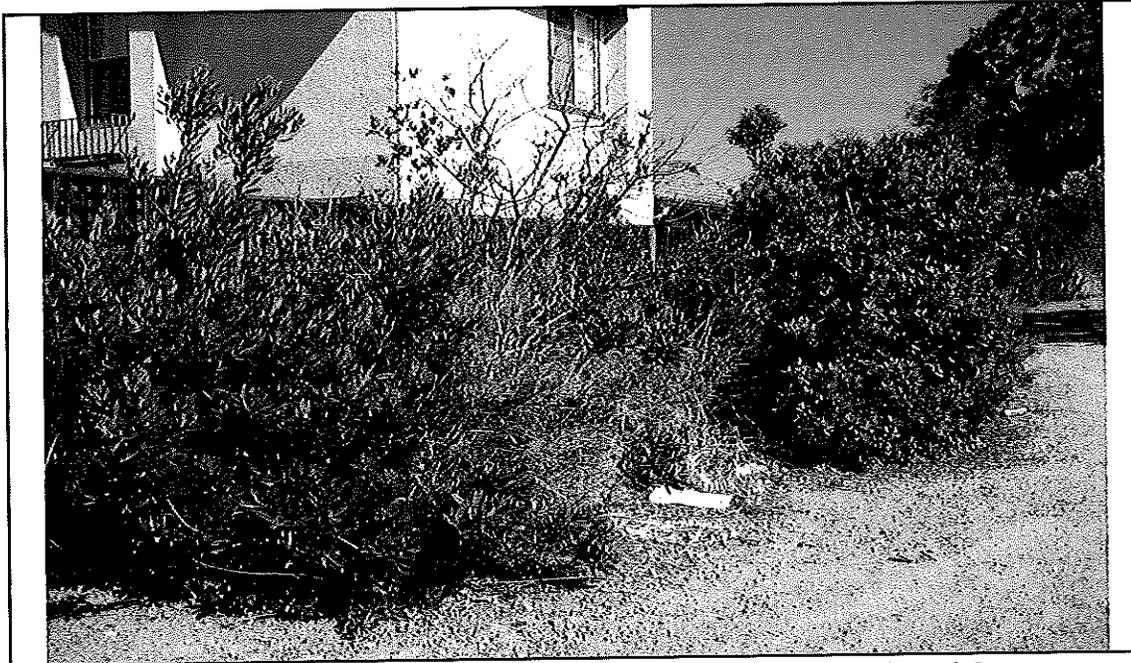
Photo 1. Southern view of Rubino Restoration site along the east side of the Guadalupe River. Toyon shrubs look full and healthy.

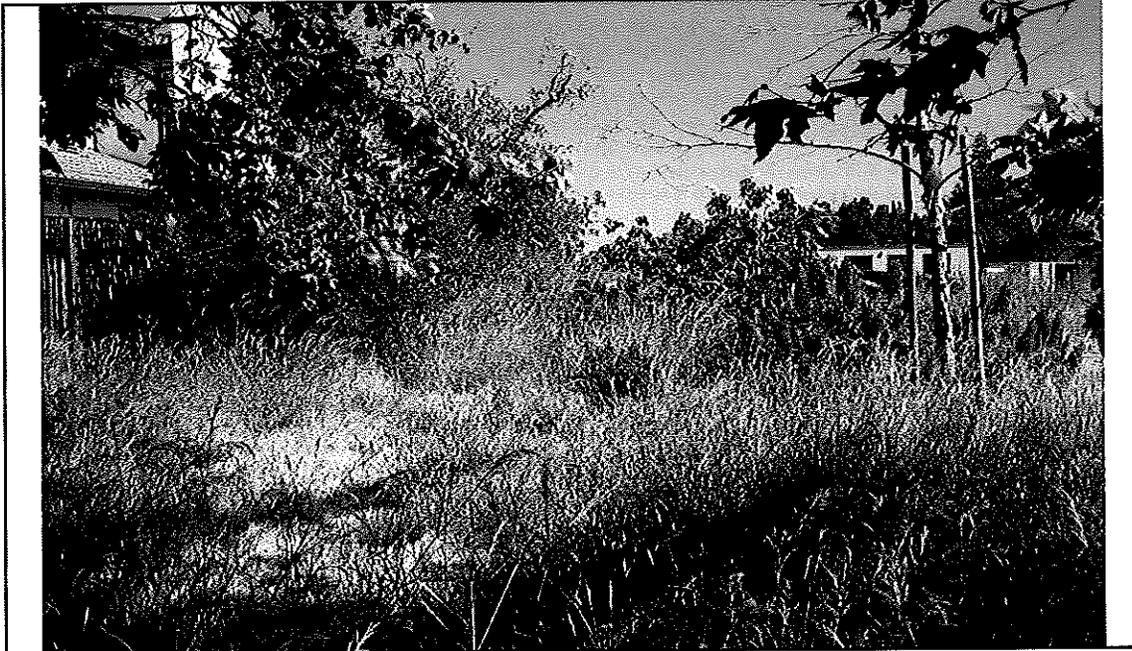
Vegetative cover by weed species is 100 percent throughout the Restoration site on the Canoas Creek side and roughly 80 percent on the Guadalupe River side (Attachment 2). Based on the height and amount of weed species on the site, it appears that maintenance crews have not been out to weed the site or check irrigation lines for some time. Herbicide overspray intended for invasive weed species was, again, observed to have negative impacts on the blackberry, snowberry, and coffeeberry shrubs lining the fence along Canoas Creek. This has been a recurring problem since monitoring started in 2001. Among the hardest hit by herbicide overspray has been the California blackberry shrubs. Since 2001, Canoas Creek has lost 152 blackberry shrubs (31.5 percent survival rate), the majority of which can be attributed to herbicide overspray.

Photo 3. Southern view of Rubino Restoration site along the east side of the Guadalupe River south from Sunbonnet Loop. Note the heavy weed growth in this area.

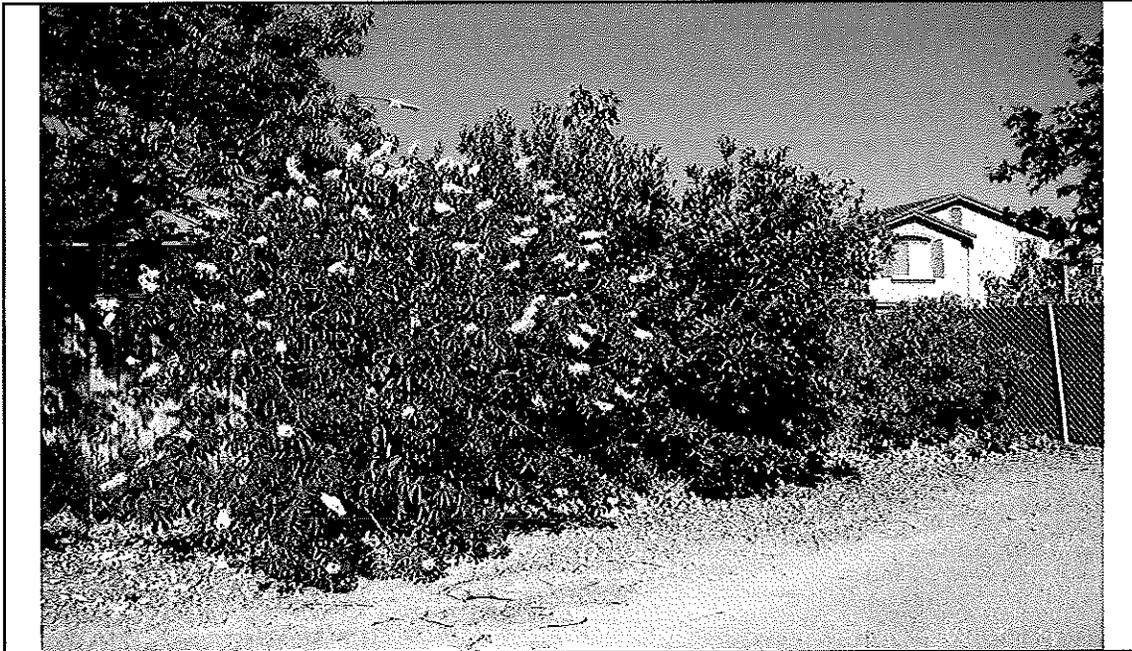
Photo 5. Southern view of restoration site east of Guadalupe River and west of McBride Loop. The buckeyes are doing well in this area.

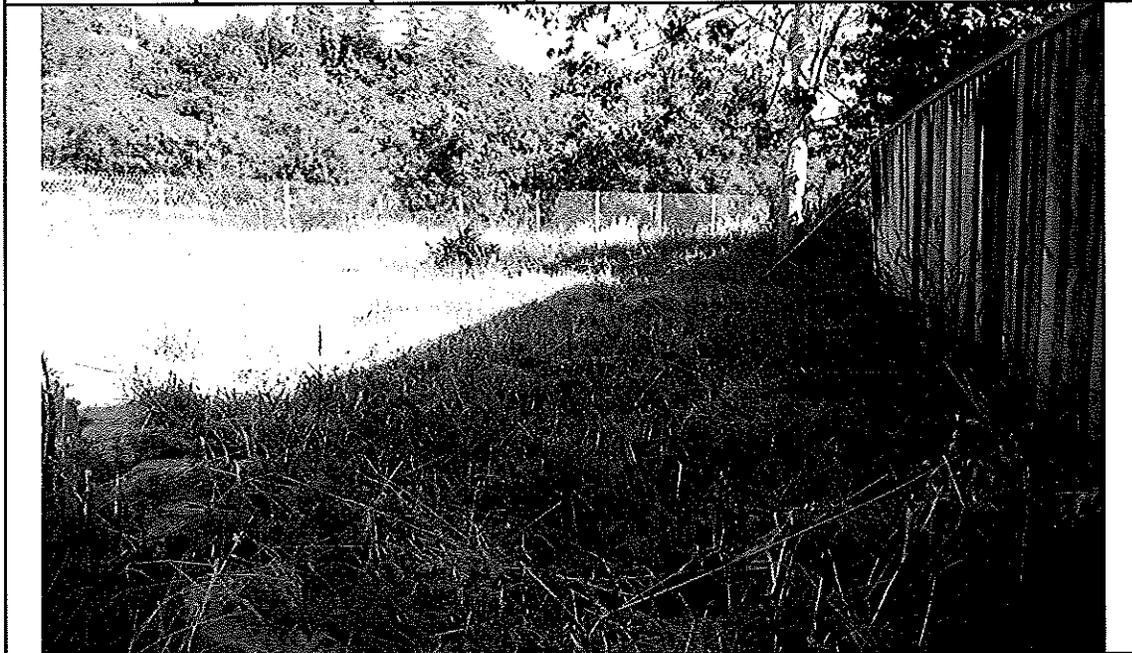
of the smaller mitigation shrubs, such as snowberry and coffeeberry. Residents are also responsible for the removal of roughly 50 California rose shrubs at the northern end of the mitigation site along Canoas Creek (Attachment 2, Photo 6). It appears that the weeds grew to such heights that a nearby resident took a weed whacker to the mitigation site and completely mowed down the northern section of the site, taking the mitigation roses out in the process.

Photo 6. Southern view of Rubino Restoration site along the west side of Canoas Creek. Roughly 50 rose bushes occurred against the fence since 2001 and have been weed whacked.

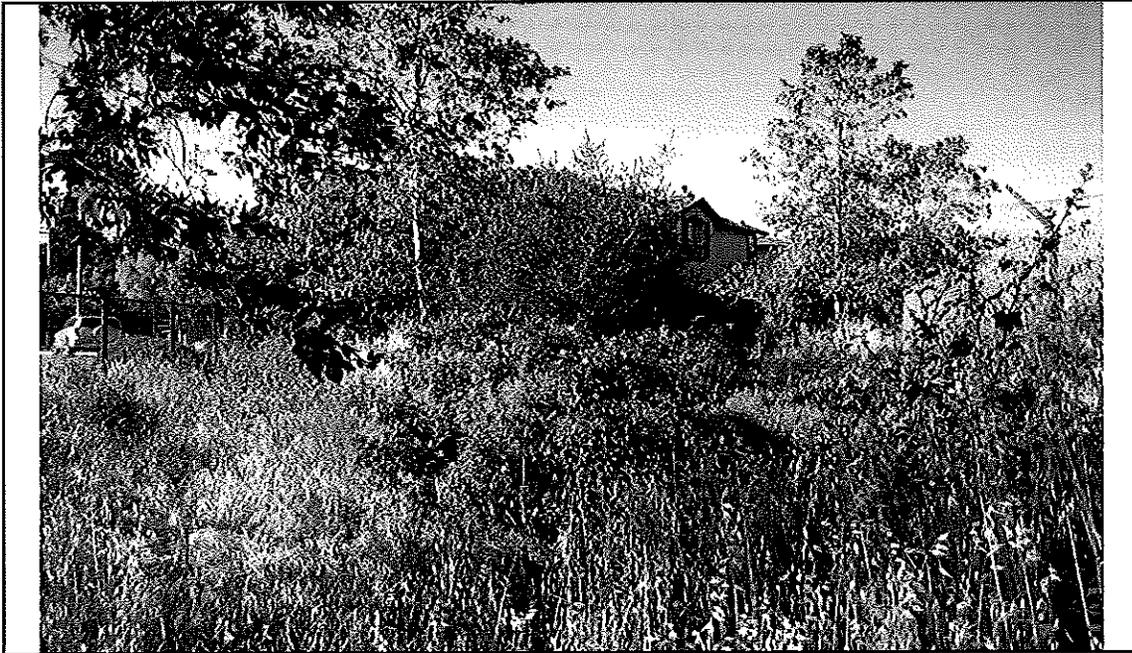
Photo 7. Northeastern view of the Rubino Restoration site along the west side of Canoas Creek north of Atkin Loop. Weed growth is heavy along Canoas Creek.

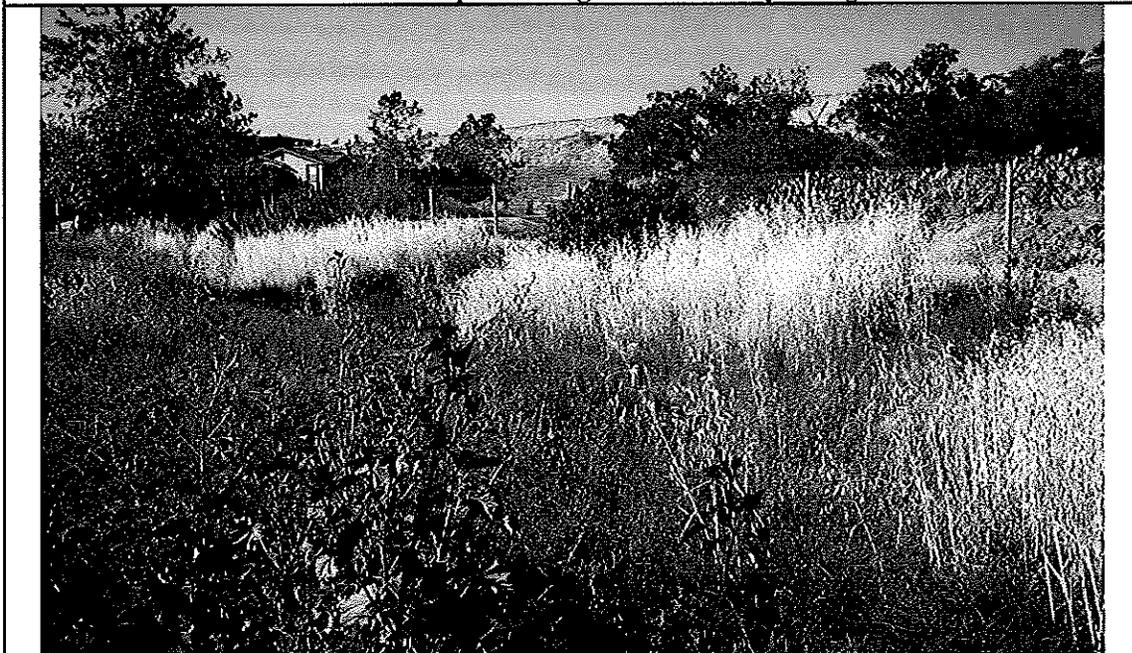
Photo 8. Northern view of restoration site west of Canoas Creek and east of Atkin Loop. Large coffeeberry shrubs observed in background. Note the heavy weed growth throughout this section of the restoration site.

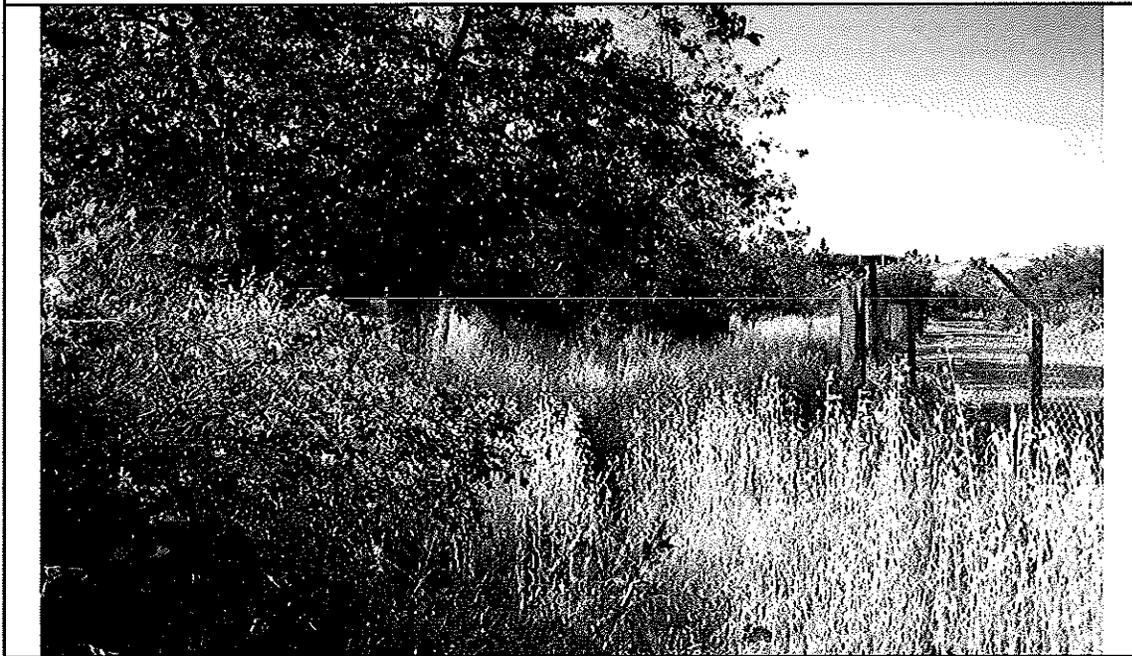
Unfortunately, the weed species throughout the site are also displaying excellent health in the form of leaf out, flowers, and expanded size and height. Weeds were observed within both the Guadalupe River and Canoas Creek planting areas, but were much more prevalent in the Canoas Creek corridor. Weed species in this area displayed 100 percent cover, reaching heights in excess of 8 feet and covering and obscuring several mitigation plant species.

Photo 10. Northern view of restoration area along west side of Canoas Creek east from Romani Court. Restoration plants are difficult to see due to the heavy weed growth throughout the site.

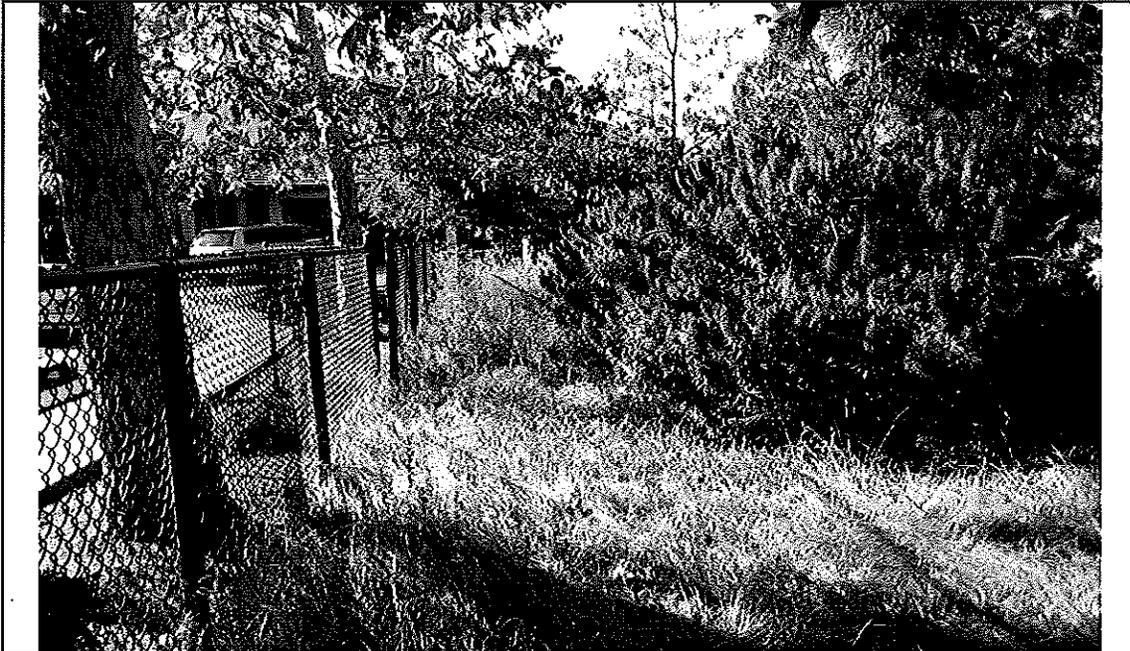
Nine Pride of Madeira shrubs exist in the Guadalupe River planting area where the planting plans only call for seven. Each of these plants was observed to be healthy and is exhibiting vigorous growth, having increased greatly in size since the Year 7 monitoring event. All plants were in full bloom during the Year 9 monitoring event and were being used by a variety of insect and passerine species.

Photo 11. Rubino Restoration Area viewed north from Brevins Loop. The Pride of Madeira has grown to tall heights.

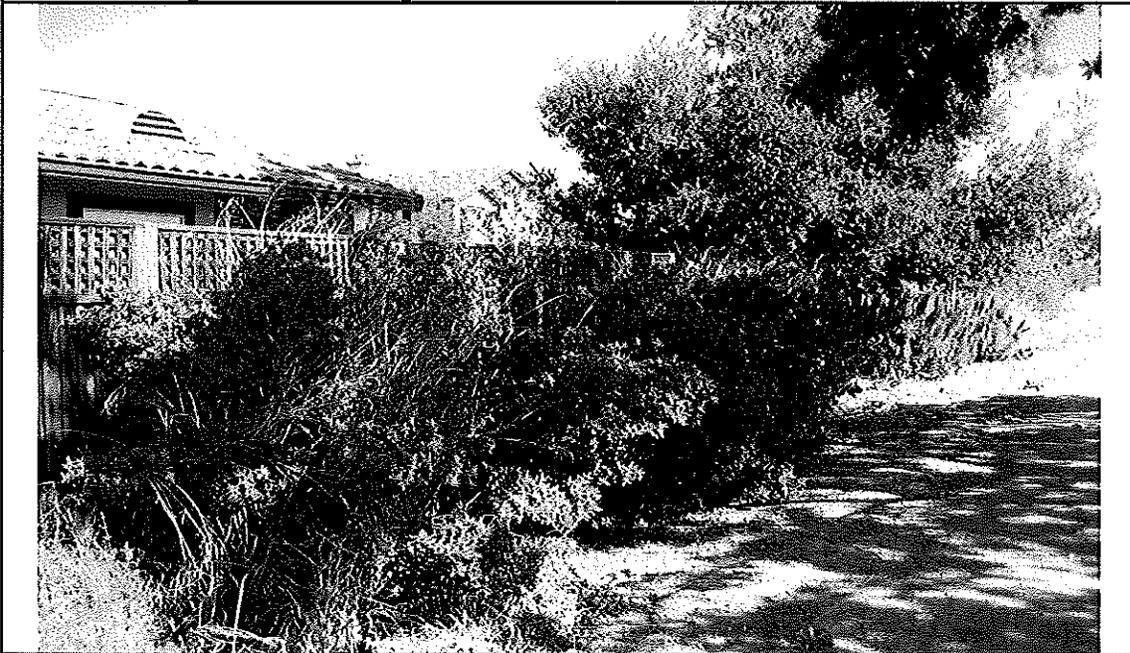
Photo 12. Large size coffeeberry specimen exhibits excellent growth habitat.

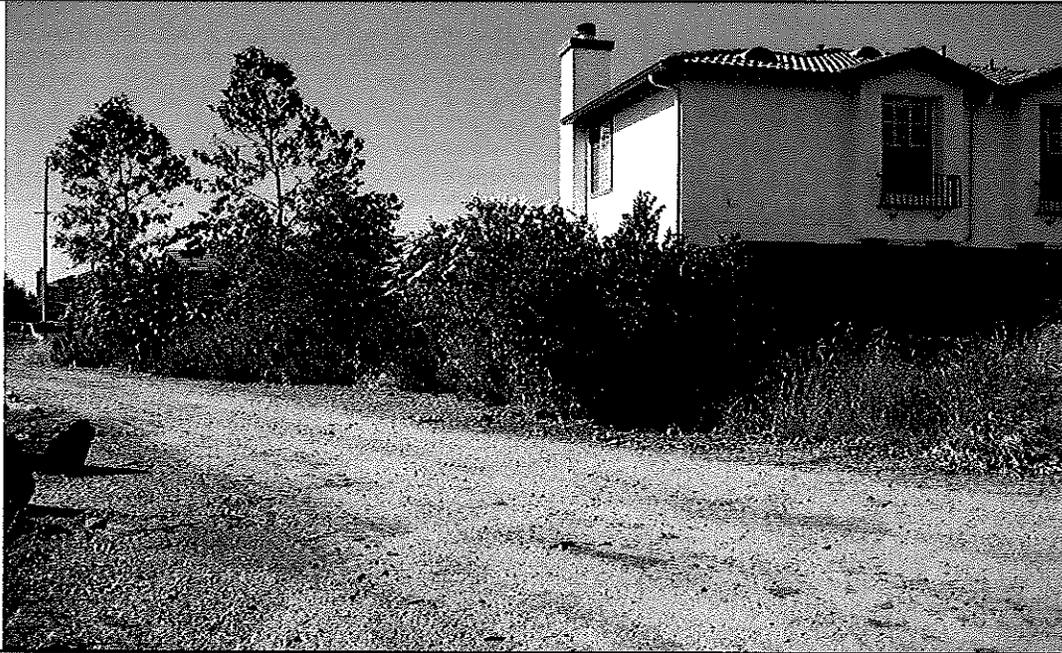
Photo 13. Very tall toyon shrubs and buckeye trees exceed height of residential fencing.

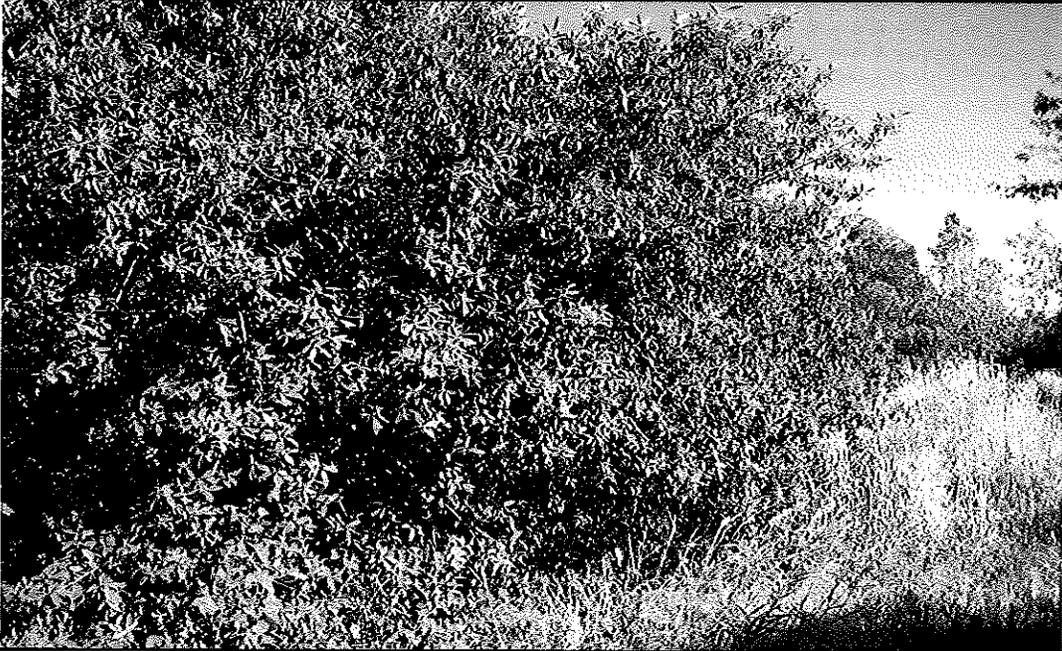
Photo 14. Coffeeberry shrub with excellent new growth emerging from all buds.
