December 9, 2010

Subject: Coyote Creek Trail Master Plan Project (Los Lagos Golf Course to Tully Road) Mitigation Monitoring

**COYOTE CREEK TRAIL MASTER PLAN
PROJECT:
LOS LAGOS GOLF COURSE TO TULLY
ROAD
(REACHES 1 & 2)**

Restoration Monitoring Report

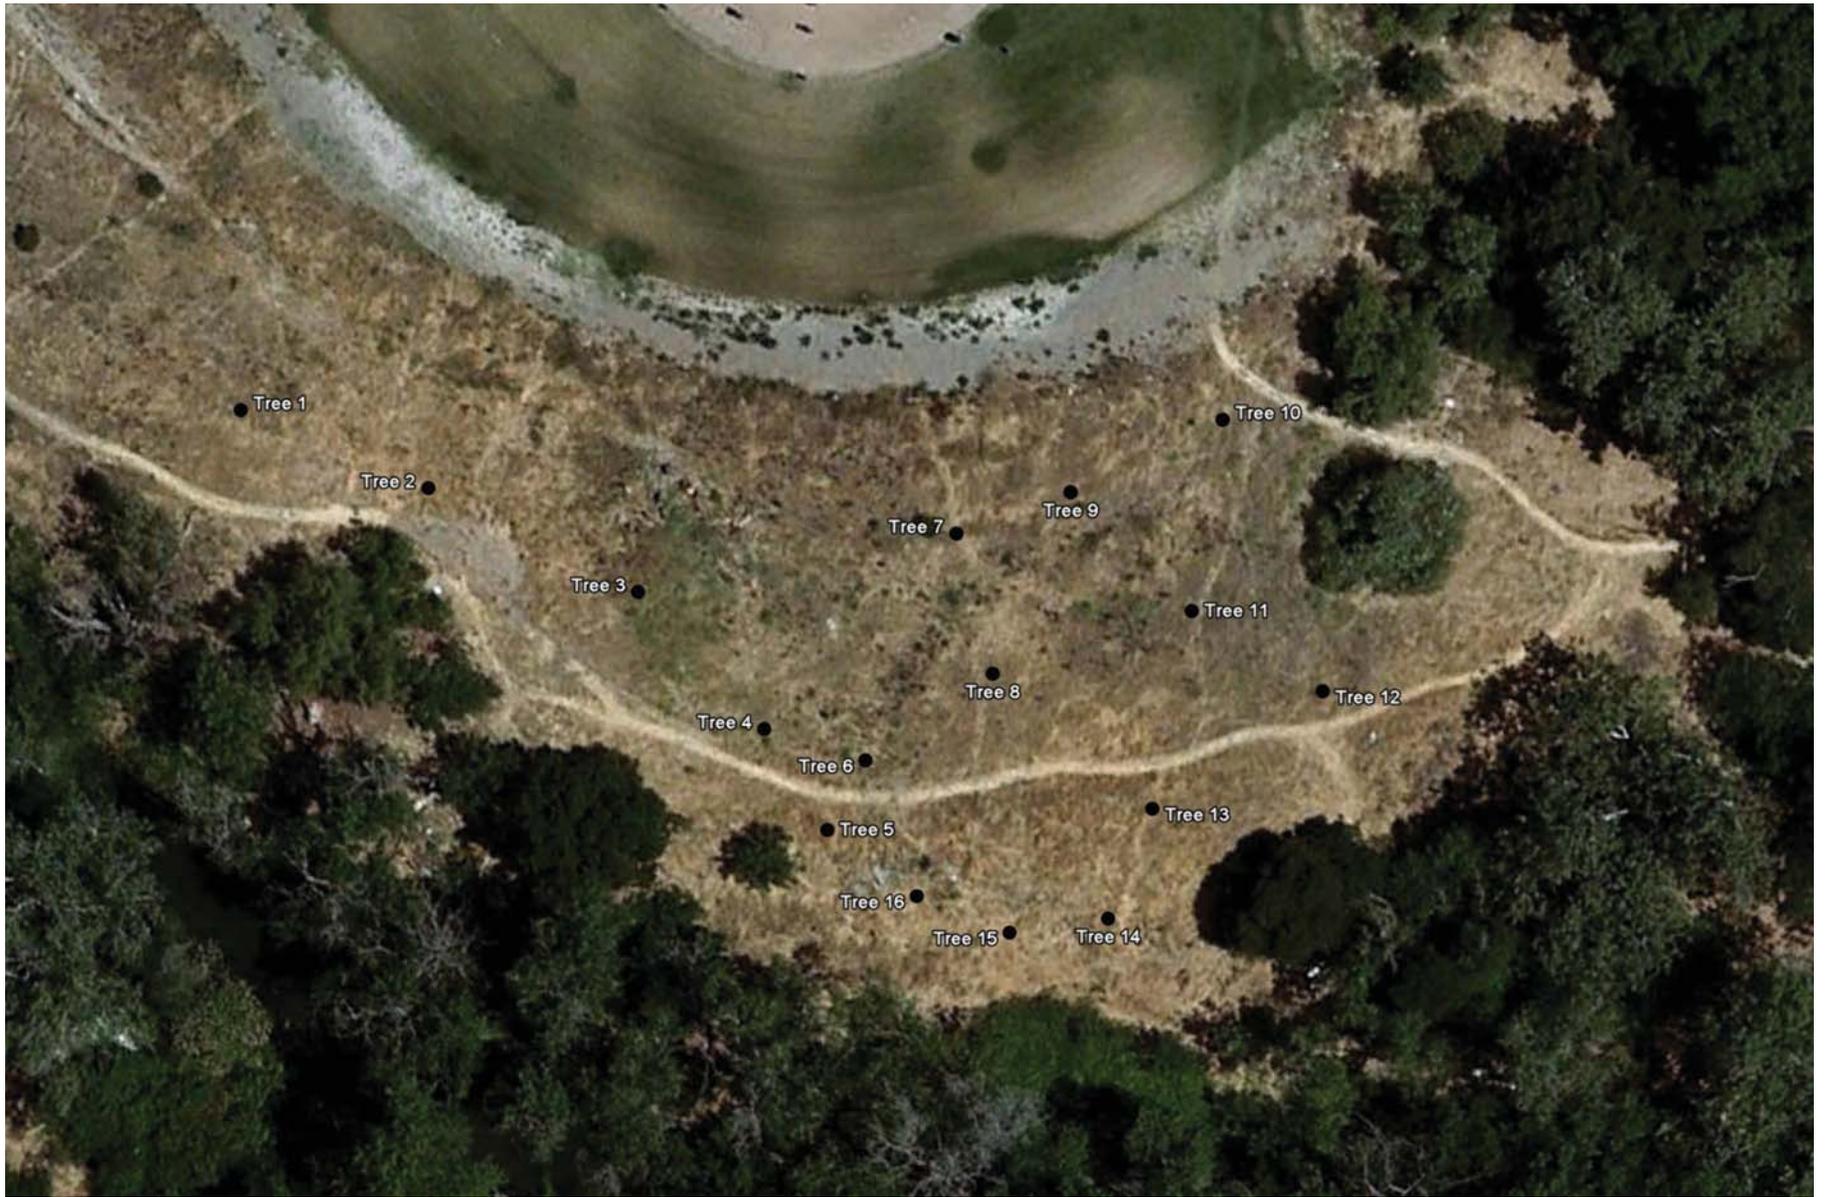
Tree Survey Map

On the August 2009 monitoring visit 12 of the planted trees were in good health, two trees were in fair health and two trees were in poor health. During the November 2009 monitoring visit 15 of the planted trees were observed in good health and one tree (Tree 12, California sycamore) was observed in poor health. On April 8, 2010, 14 of the 16 trees were in good condition and two of the trees were in fair condition. Additionally, tree 12, which was reported in poor condition in the initial monitoring report, was replaced. During this monitoring event the biological monitor was not able to identify the species of tree that had been replanted. On July 6, 2010, 11 of the 16 trees were observed in good condition, two were observed in fair condition and three were observed in poor condition. Tree number 12, which had been replanted before the third monitoring event, was observed in poor condition. Irrigation to this tree may not be functioning and may need maintenance to ensure survival. With the survival rate at 81.25% after the final monitoring event, the mitigation is successful through year one of the monitoring period. Non-native invasive plant species were observed in large numbers and may become dominant on the south end of the restoration area. No vandalism was observed during the last two monitoring events.

1. Trees in poor health should either be replanted and/or the irrigation should be adjusted to ensure their survival through the dry season.
2. Non-native invasive weed eradication/removal should be continued at the restoration site to reduce competitiveness for native riparian plants.
3. Monitoring and reporting should continue through the year five as stated in the restoration plan.
