# FOURTH ANNUAL MONITORING REPORT

QUAIL HOLLOW BRIDGE REPLACEMENT PROJECT  
ALUM ROCK PARK, SAN JOSE, CALIFORNIA

LSA Project No. SJO0607B

December 3, 2009

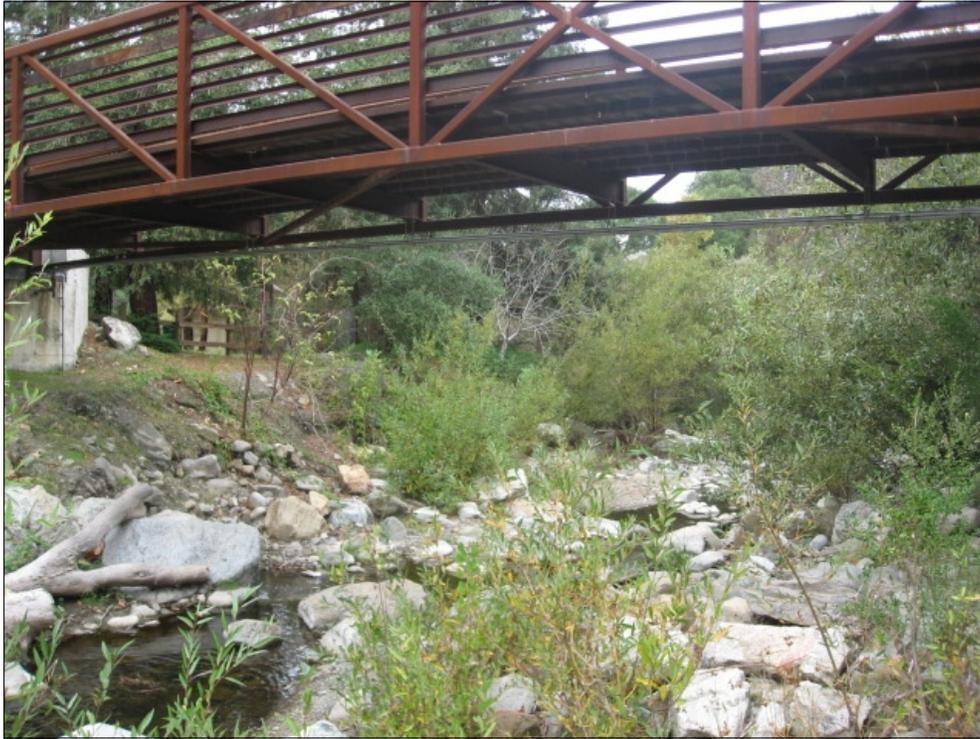
Photo Point 1: Photo taken on November 5, 2009 looking southwest at rock weirs and southwestern bank.

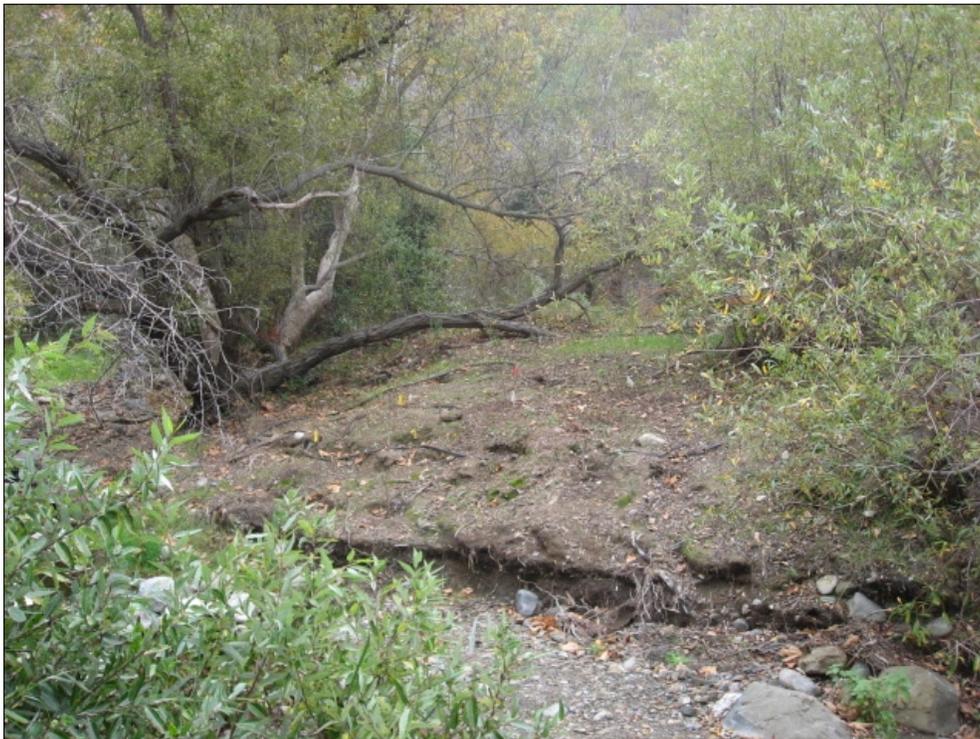
Photo Point 1: Photo taken on November 5, 2009 looking south at southeastern bank.

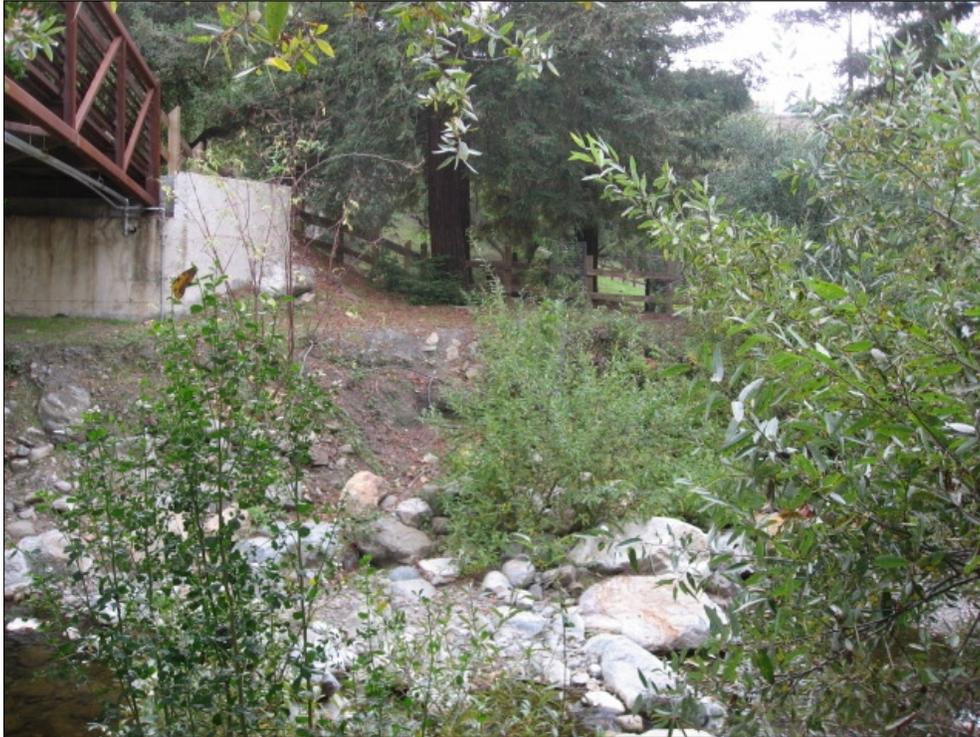
Photo Point 2: Photo taken on November 5, 2009 looking southwest at southwest bank.

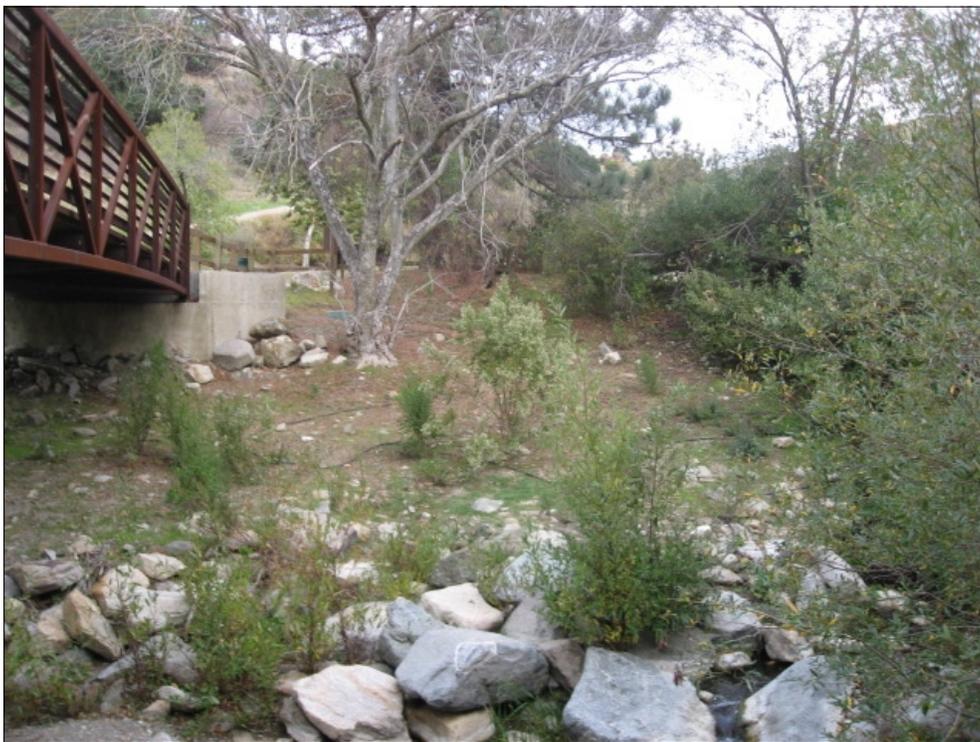
Photo Point 3: Photo taken on November 5, 2009 looking northeast at northeastern bank.

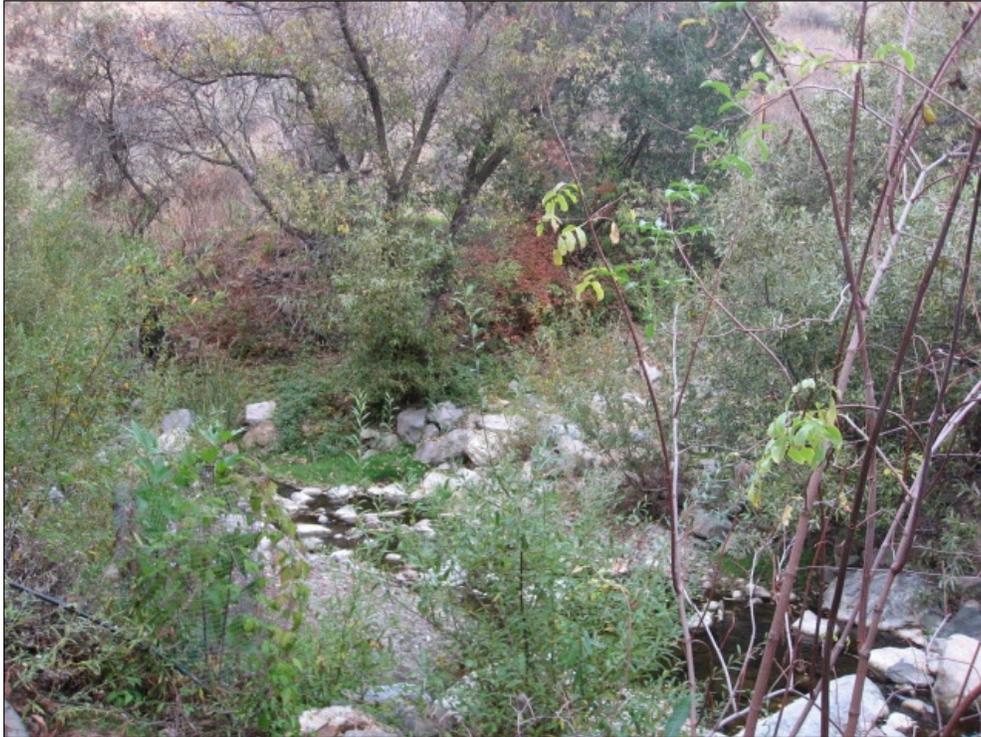
Photo Point 4: Photo taken on November 5, 2009 looking northwest at northwestern bank.

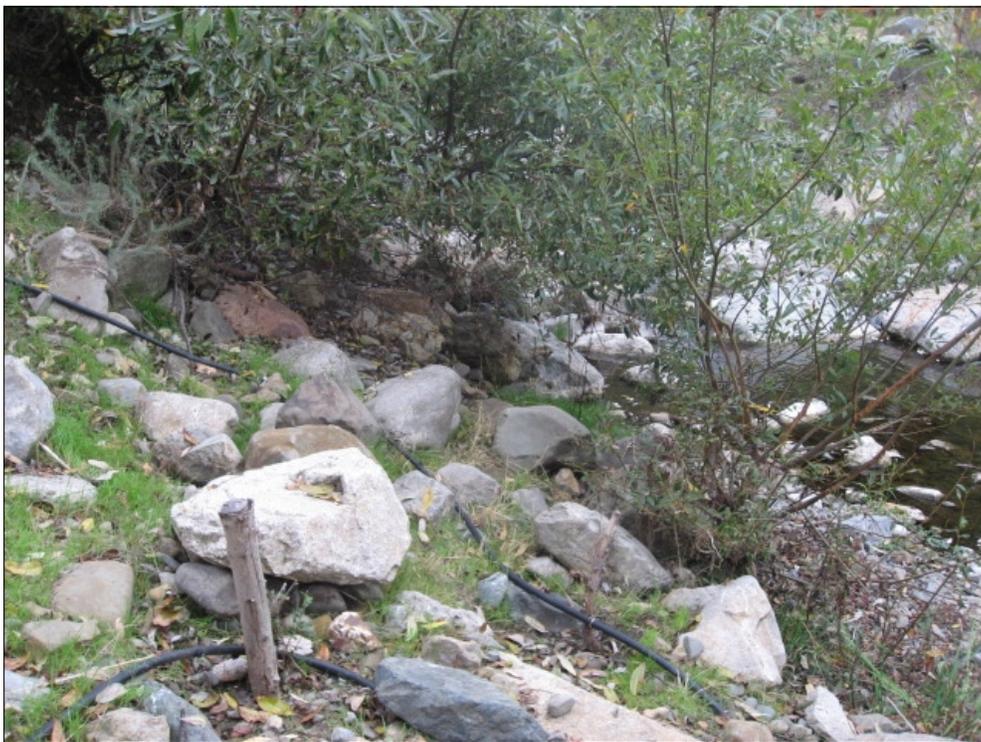
Photo Point 5: Photo taken on November 5, 2009 looking southeast at northwestern bank.

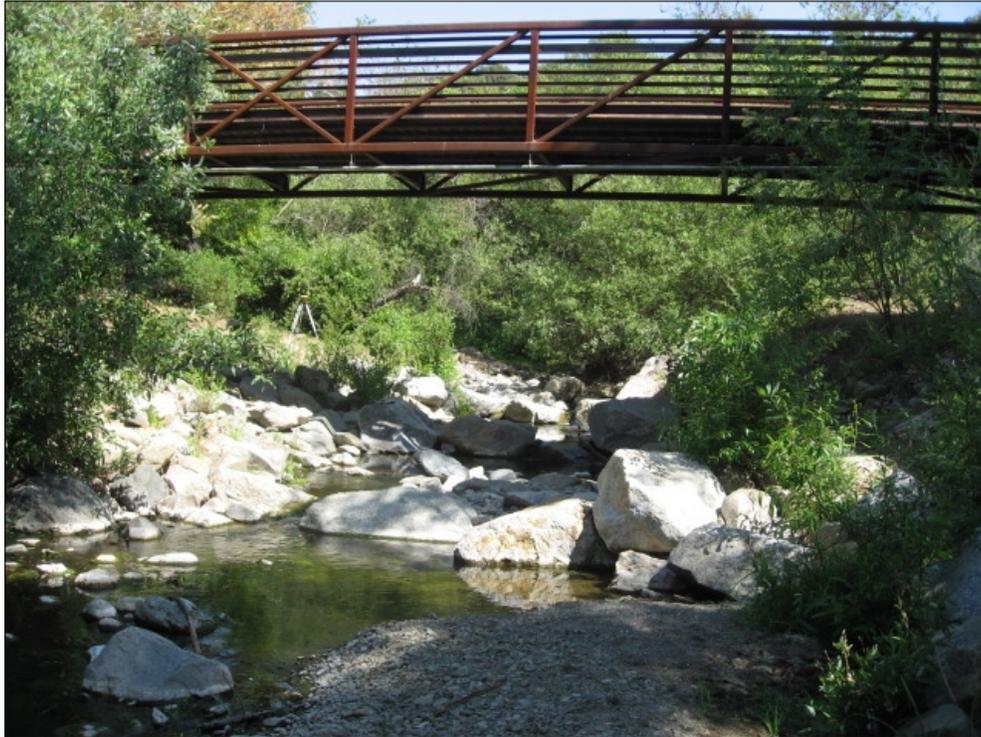
Photo Point 1: Photo taken on June 2, 2009 looking southeast at rock weirs.

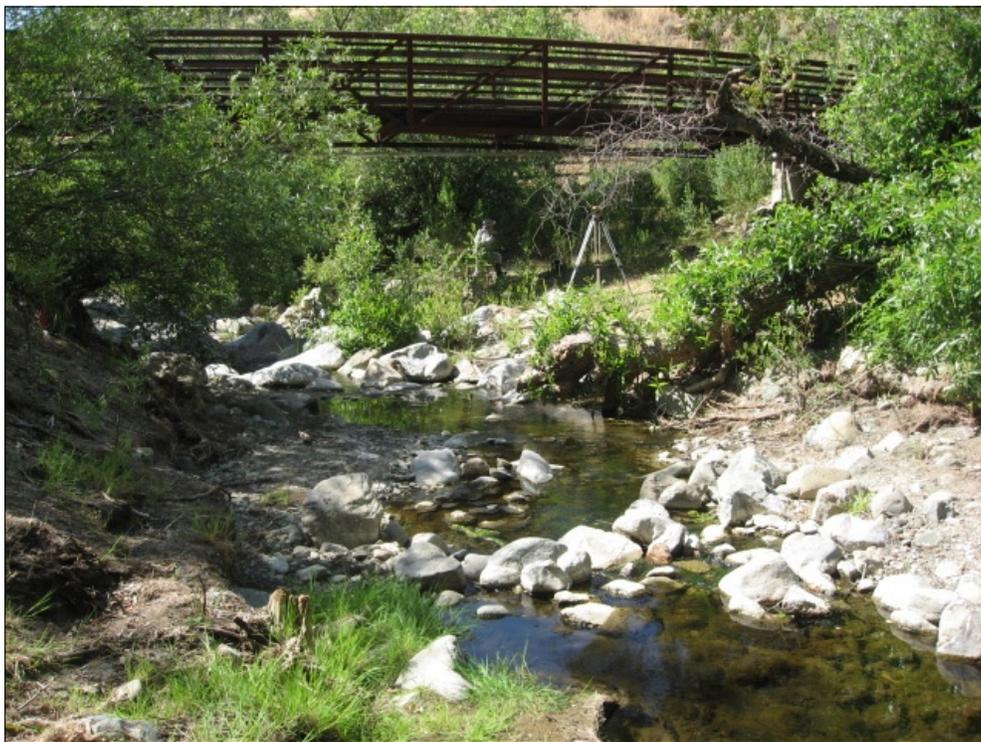
Photo Point 2: Photo taken on June 2, 2009 looking northwest at rock weirs.

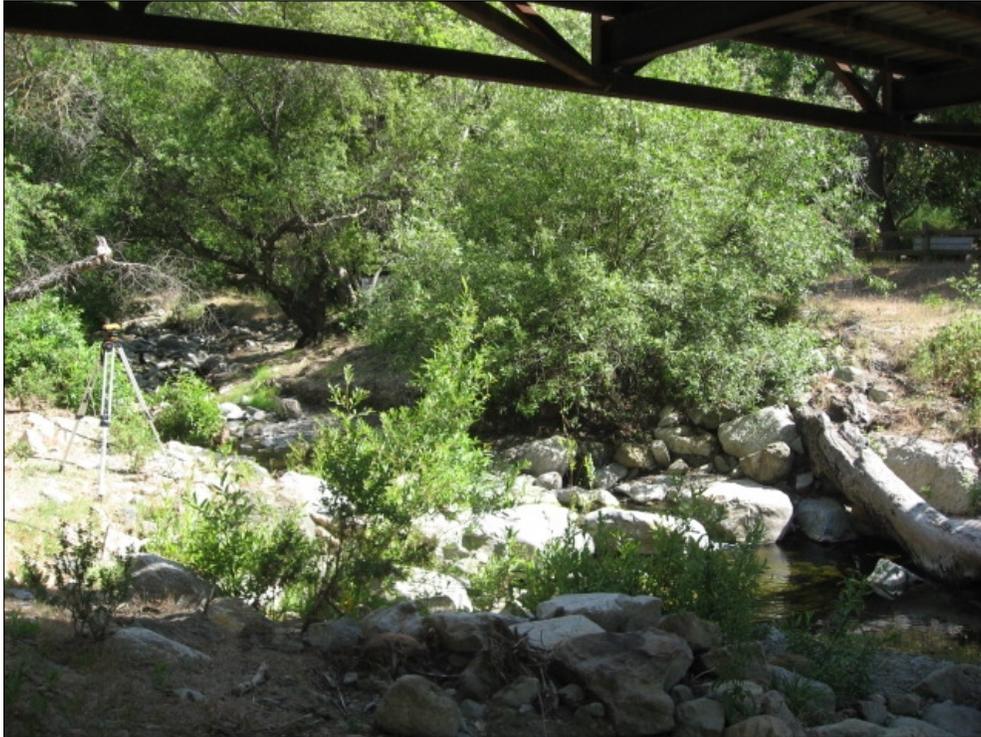
Photo Point 3: Photo taken on June 2, 2009 looking south at rock weirs and southwestern bank.

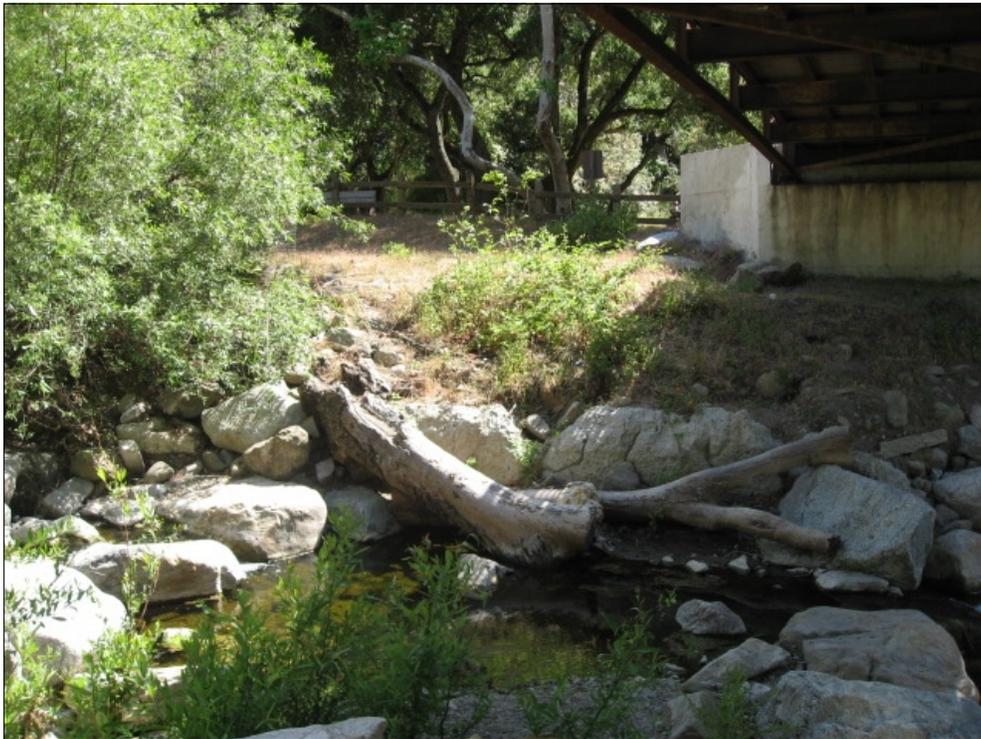
Photo Point 4: Photo taken on June 2, 2009 looking southwest at rock weirs.

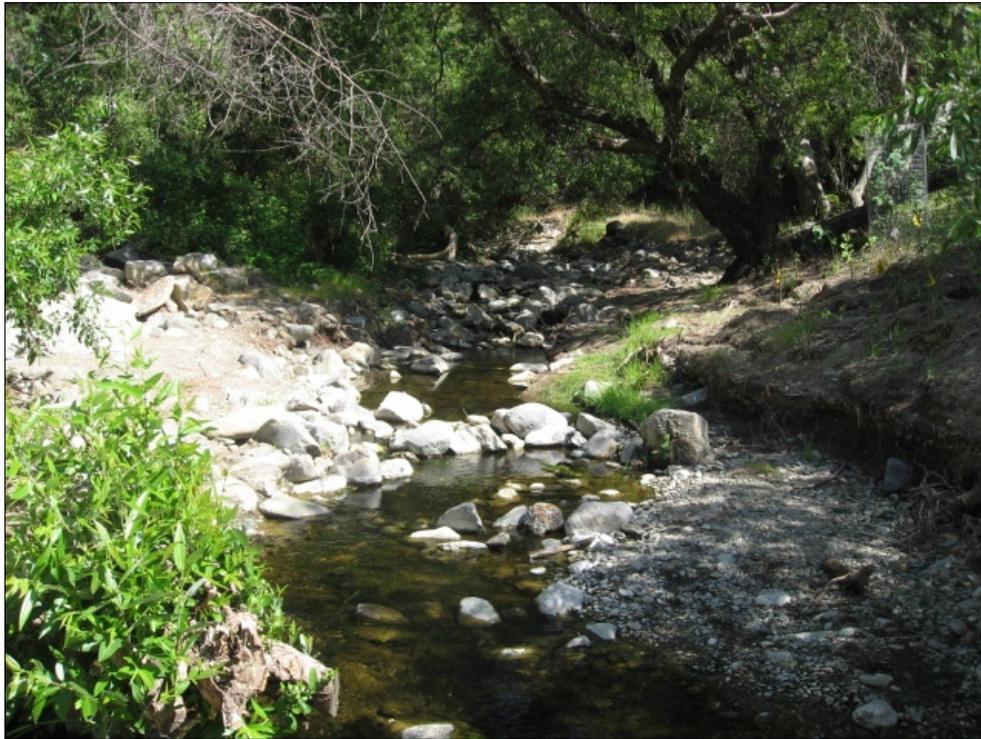
Photo Point 5: Photo taken on June 2, 2009 looking south at rock weir.

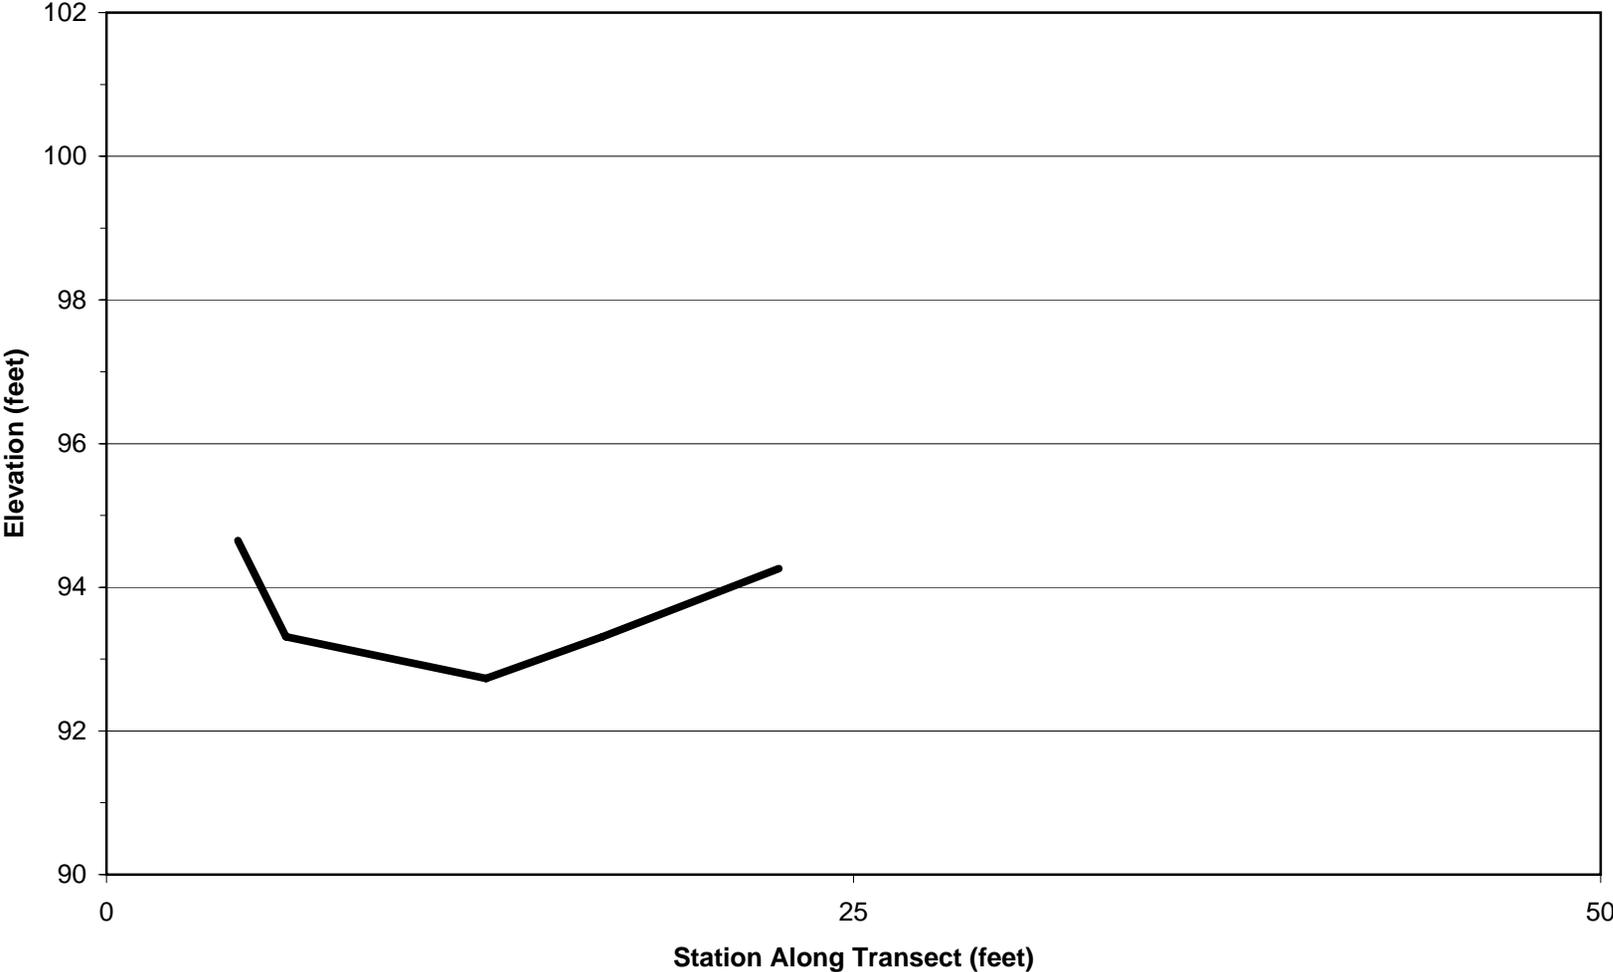
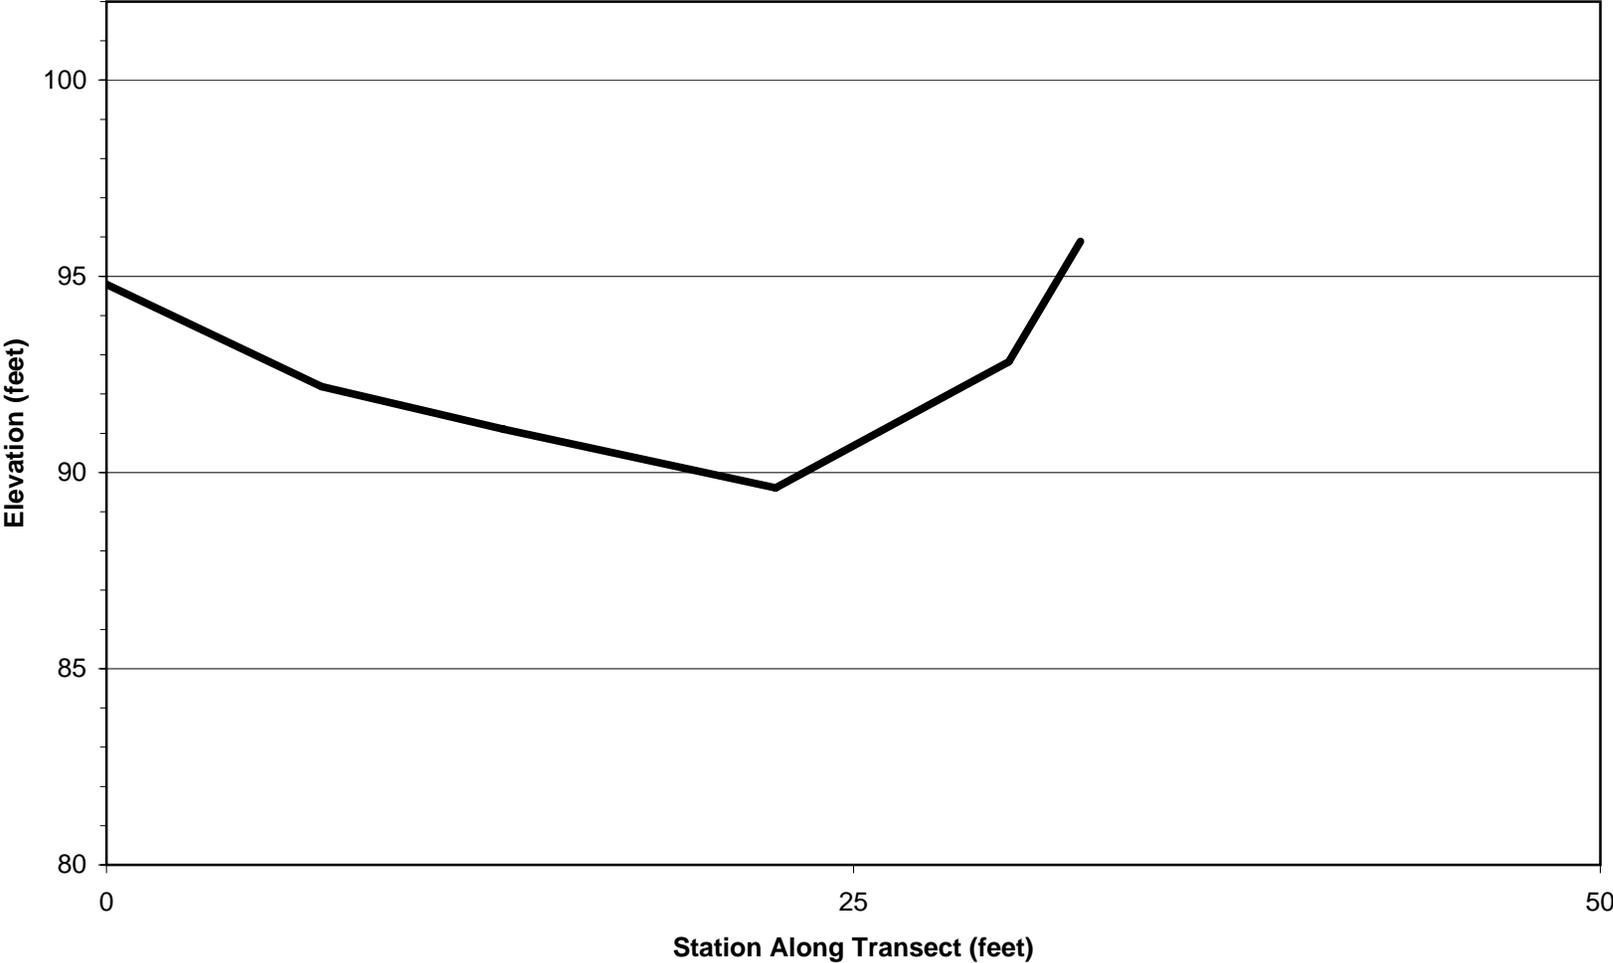
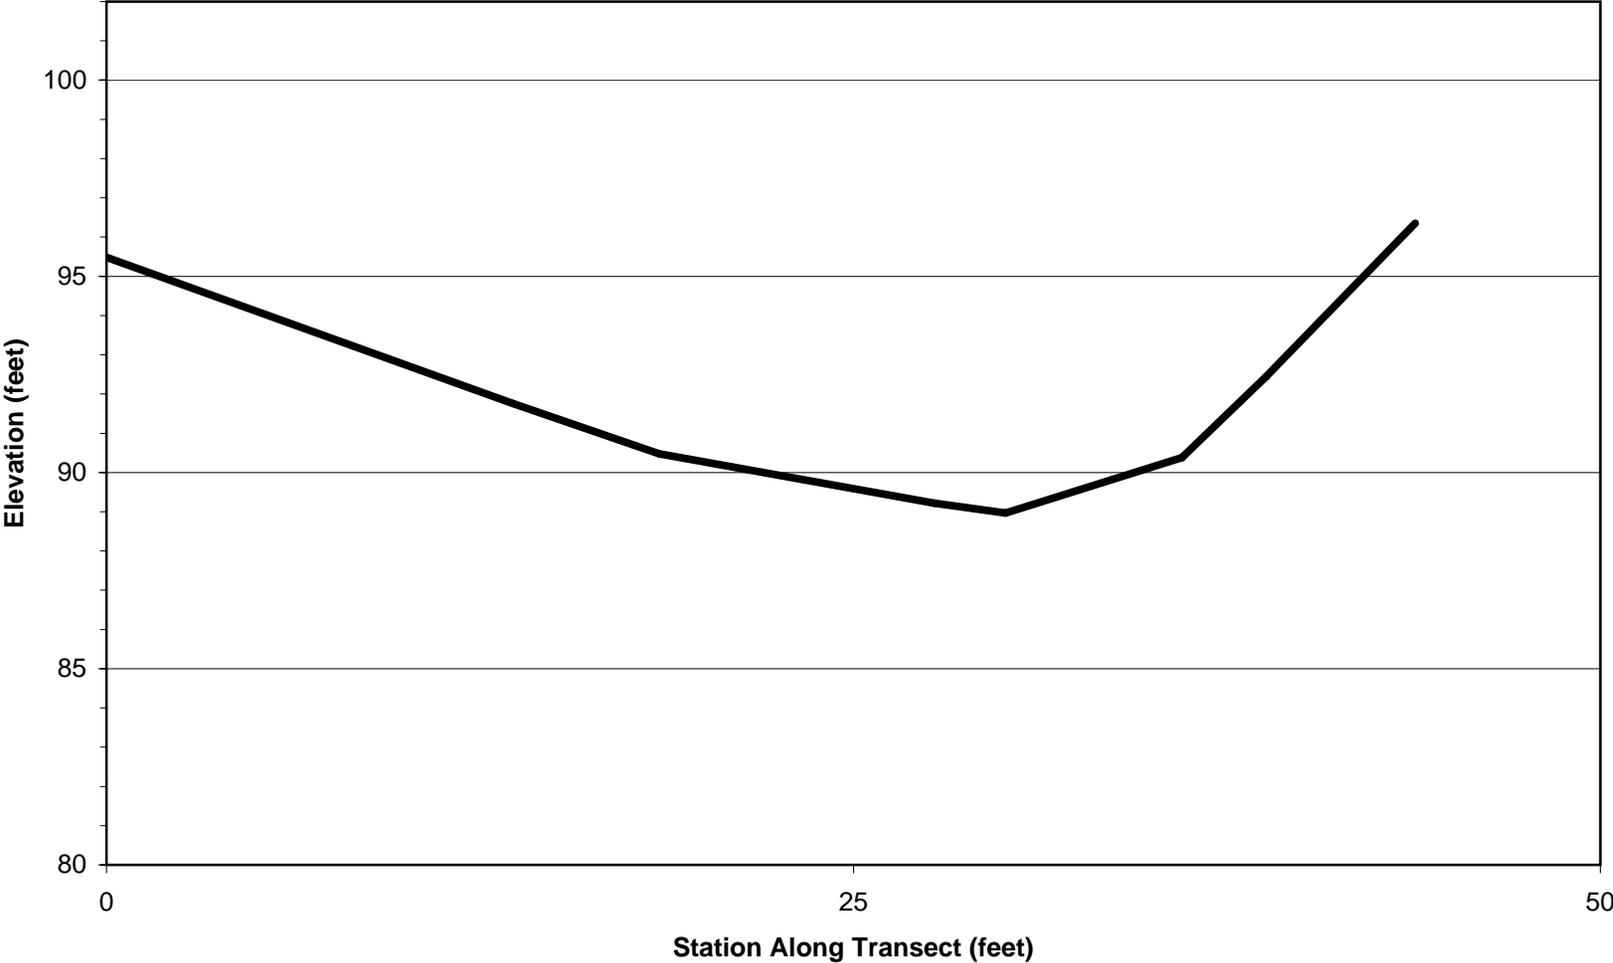
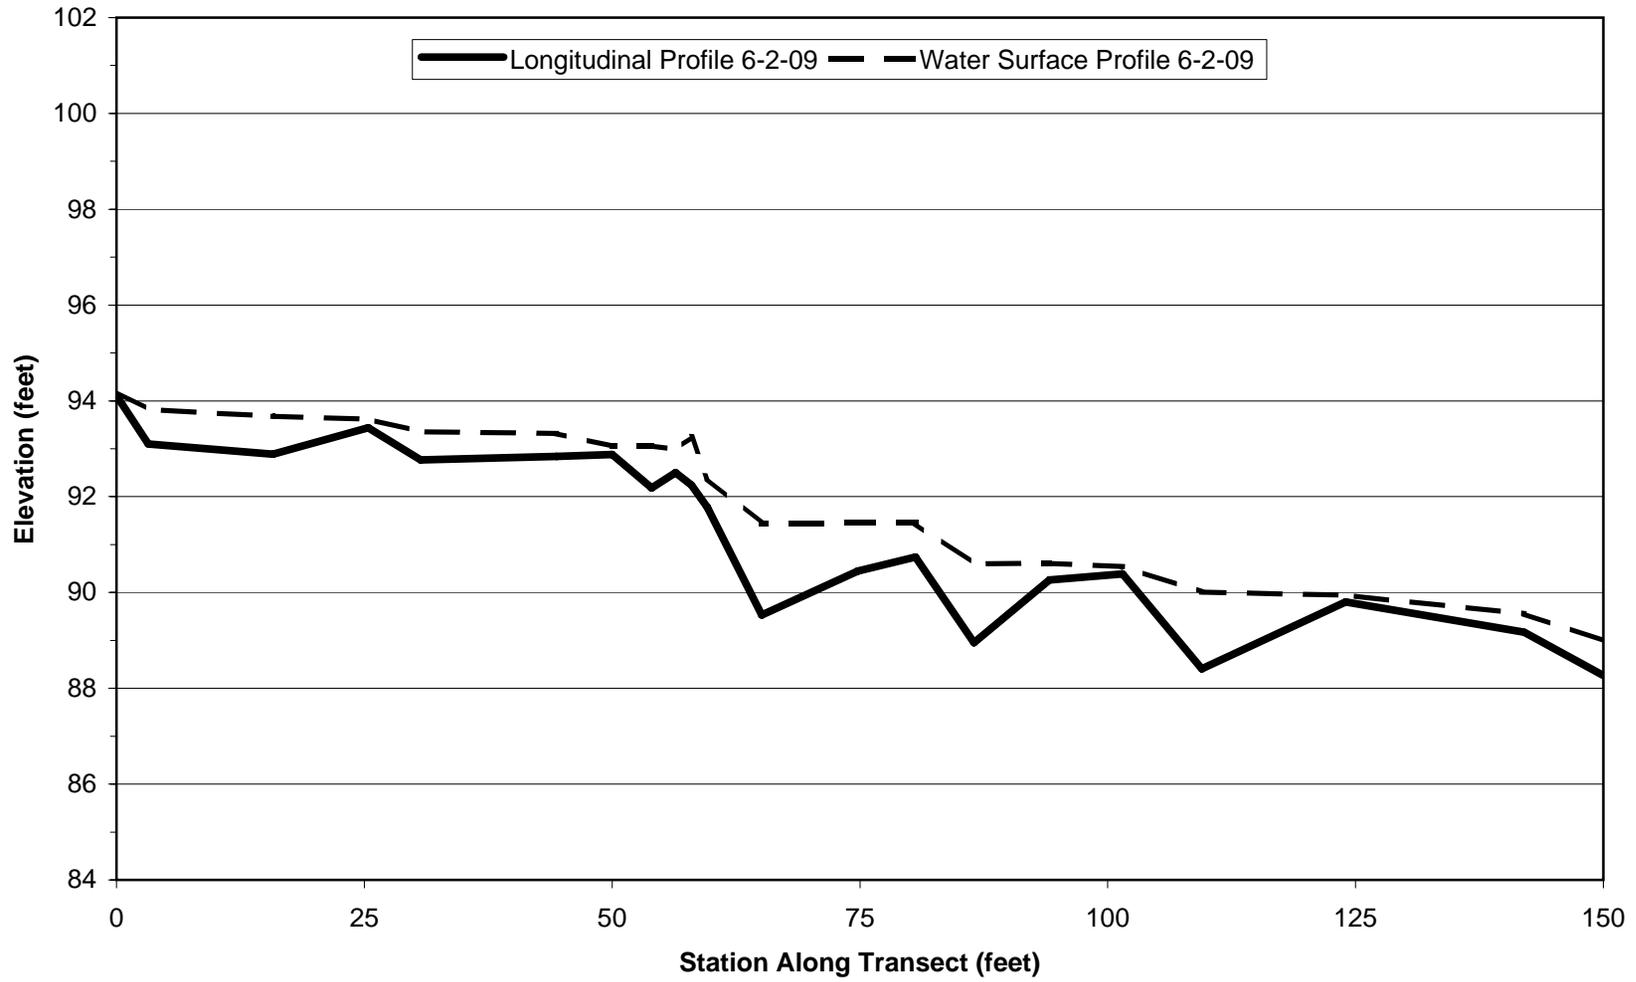
**Performance Measure 6: Geomorphic Stability of Channel.** Based on a visual evaluation of the site during the year 4 geomorphic monitoring, the project is performing well and meeting the design criteria. There was no excessive erosion or sedimentation in the project area. The rock weirs appear to be stable, function well through the winter flows, and provide fish passage. The depth of the step pools continues to perform well and provides aquatic habitat. During the June 2, 2009 geomorphology monitoring, juvenile steelhead and western toad (*Bufo boreas*) larvae were observed within the large pools in the project area. LSA established a permanent longitudinal profile and three permanent cross sections in the project area on June 2, 2009 (Figure 3, Appendix A and Longitudinal Profile and Cross Section Graphs, Appendix D).
