SAN TOMAS AQUINO/SARATOGA CREEK REACH 6 RIPARIAN MITIGATION PROJECT

Fifth Year Monitoring Report

Prepared for
City of San Jose

December 2010

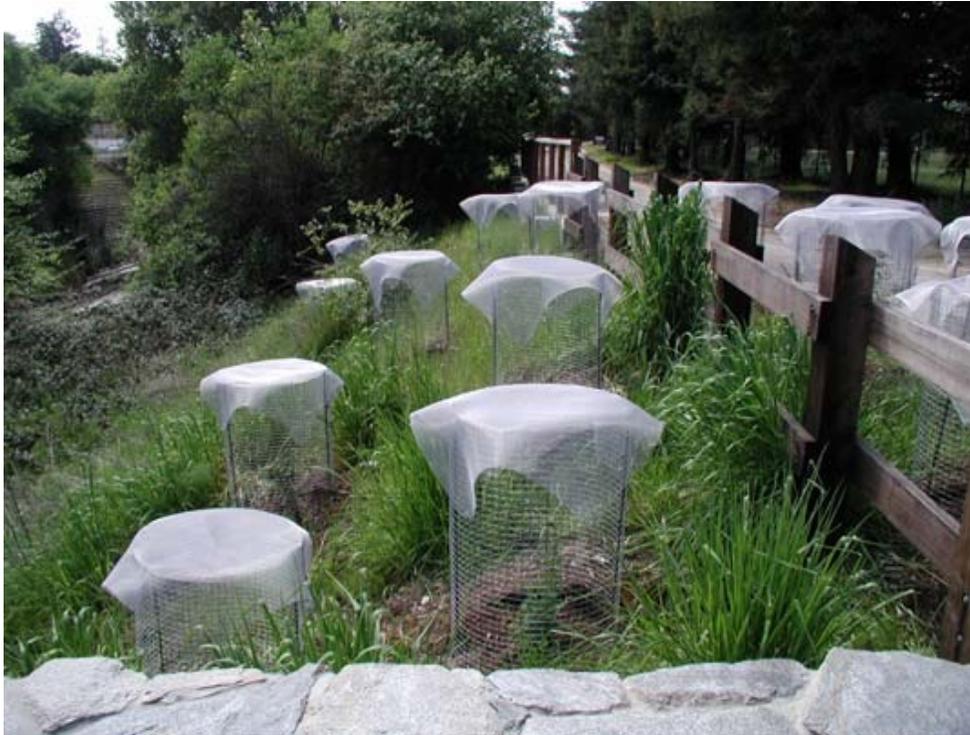
Photo 1: View of riparian plantings. Photo facing south and upstream of the pedestrian bridge. April, 2006.

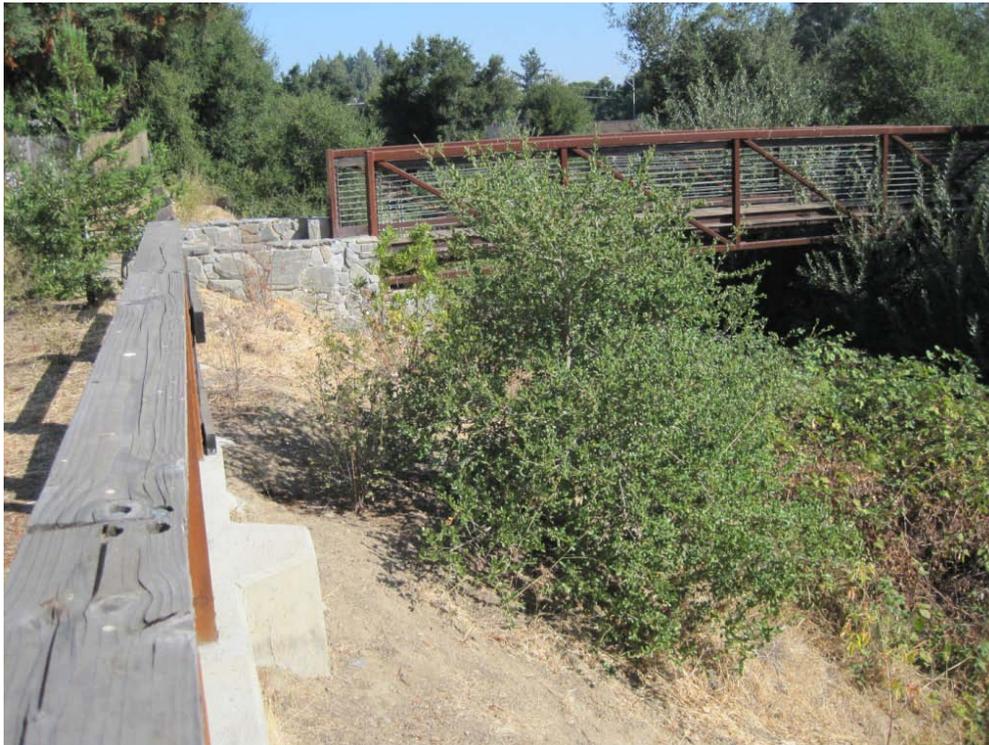
Photo 2: View of riparian plantings near the pedestrian bridge. Photo facing north of the same planting area shown in Photo 1. September, 2010.

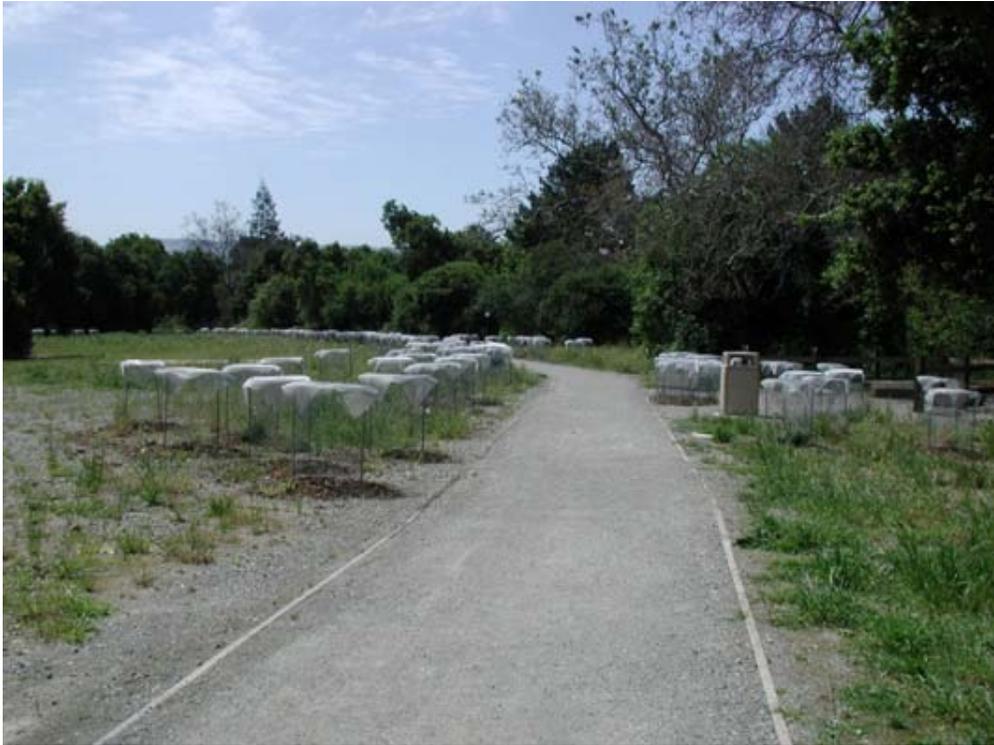
Photo 3: View facing south of riparian plantings on either side of the trail. April, 2006.

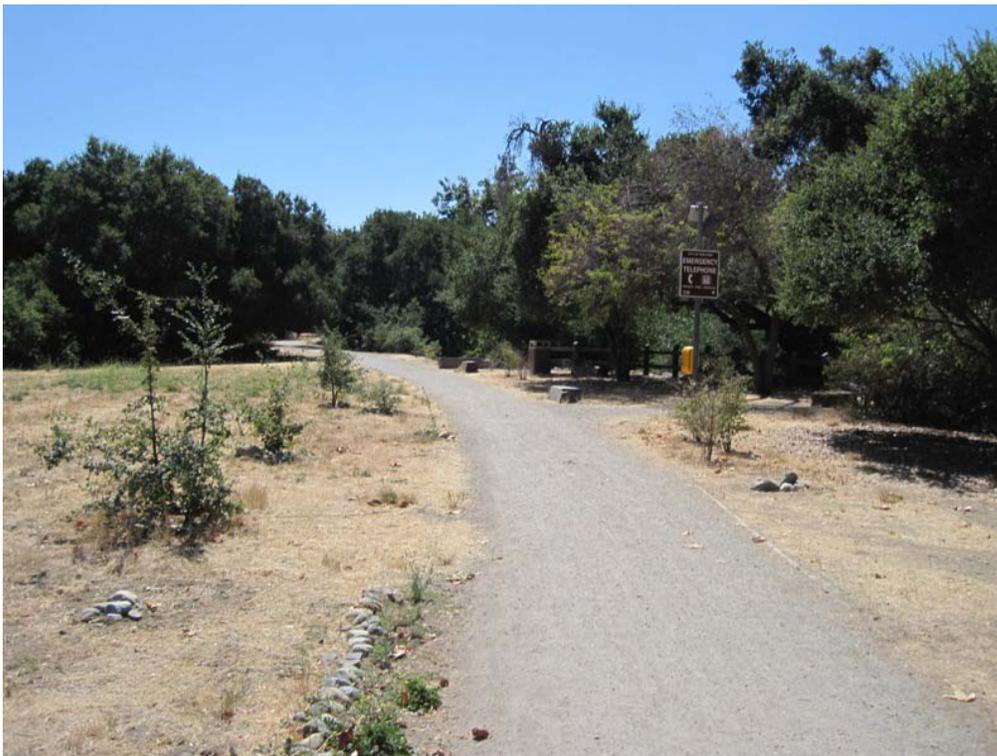
Photo 4: View facing south of the riparian plantings on either side of the trail. Photo is slightly south of Photo 3, but of the same planting area. September, 2010.

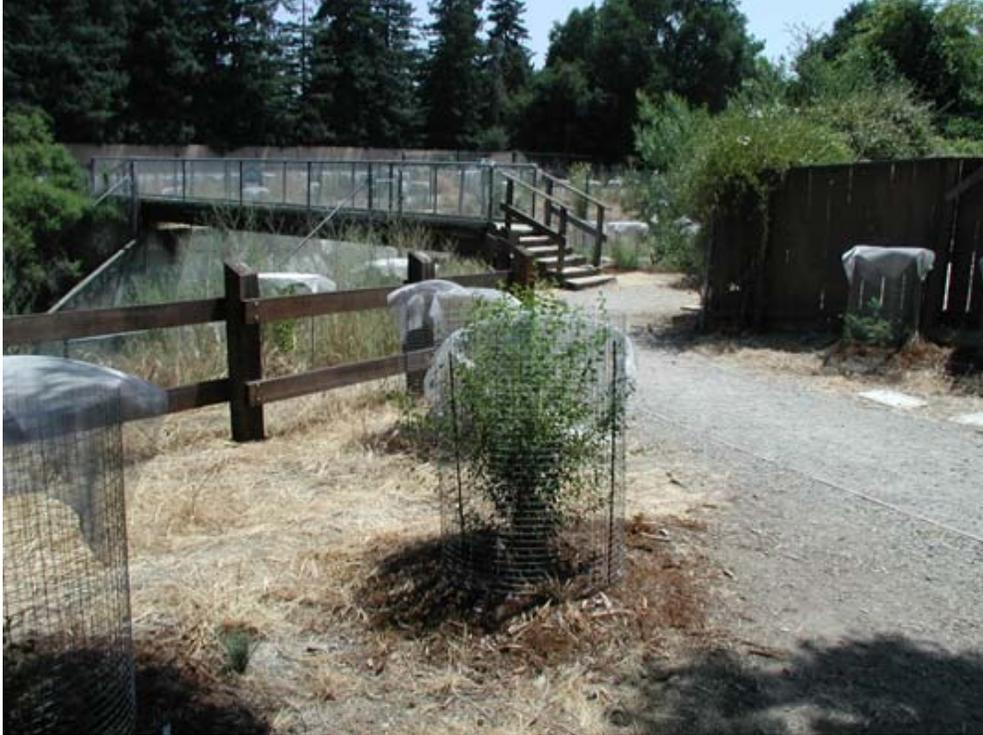
Photo 5: View facing east of riparian plantings near the footbridge at the Oak Knoll Avenue trail entrance. April, 2006.

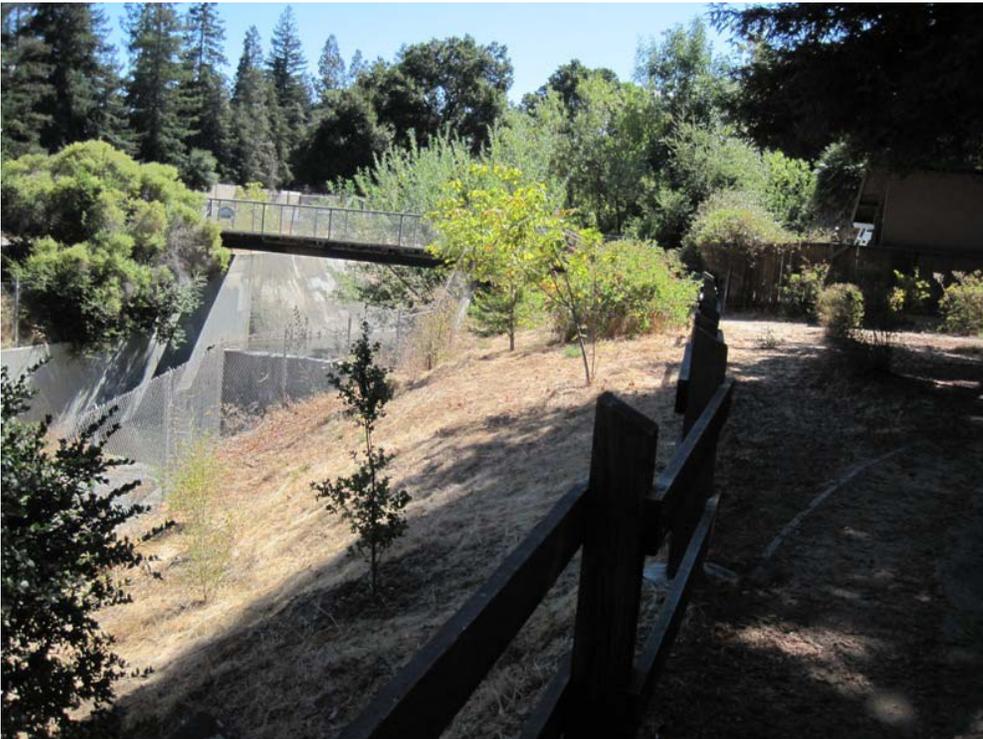
Photo 6: View facing southeast of riparian plantings near the footbridge at the Oak Knoll Avenue trail entrance. Photo of the same planting area shown in Photo 5. September, 2010.

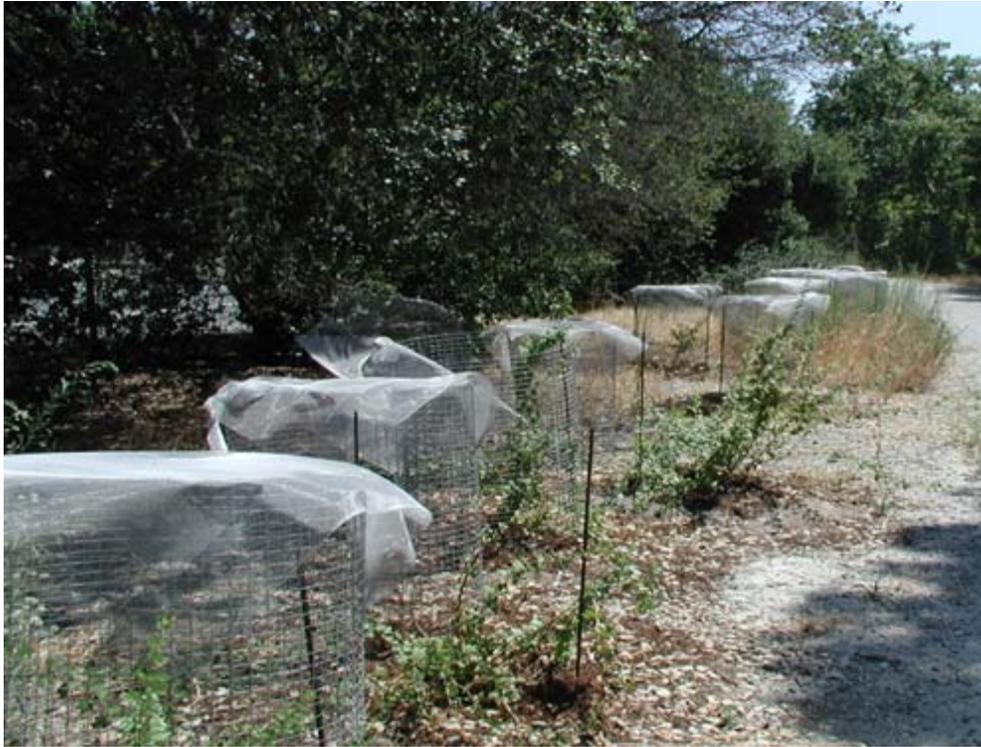
Photo 7: View facing south of gooseberry plantings. April, 2006.

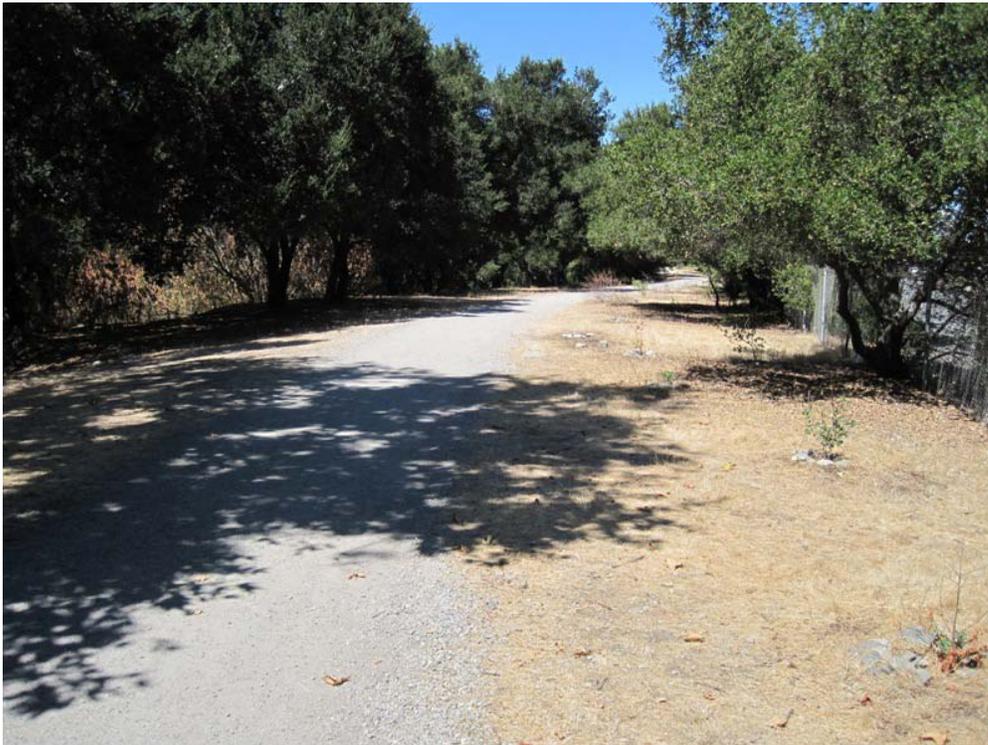
Photo 8: View facing north of riparian plantings. The gooseberry plantings located in Photo 7 are in the far right corner of this photo. September, 2010.
