Preliminary Tree Report
1040-1080 E. Brokaw Road and
1633 Old Oakland Rd.
San Jose CA

PREPARED BY:
HortScience, Inc.
2150 Rheem Dr., Suite A
Pleasanton, CA 94588

January 2010

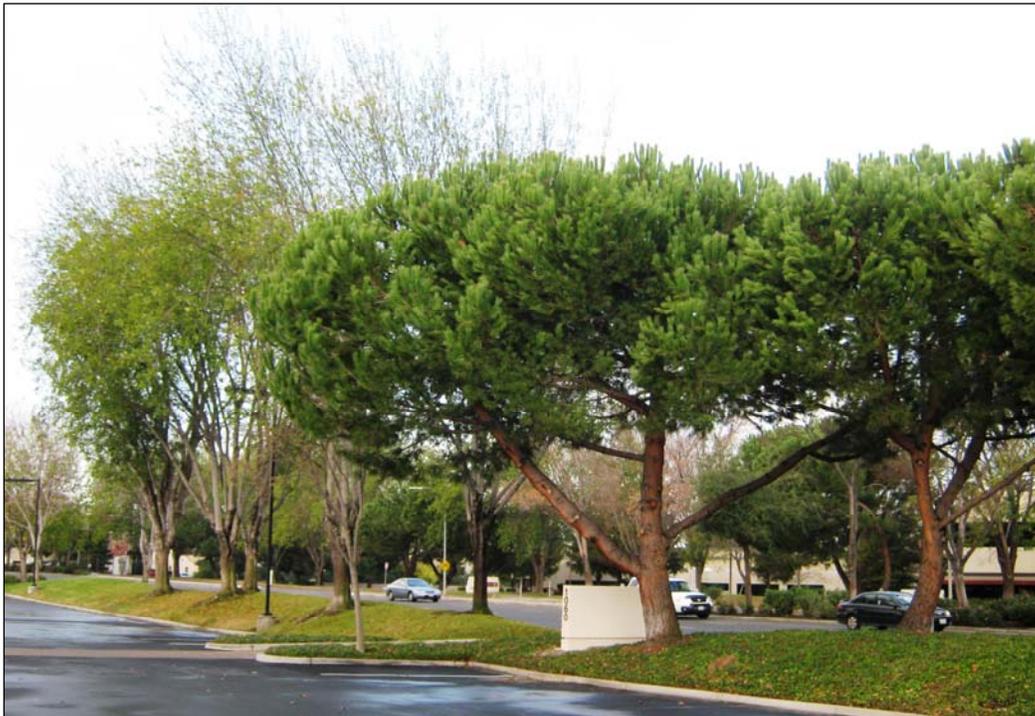
Photo 1: Shamel ash #226-230 (background) and Italian stone pines #231 and 232 had been planted on an earthen berm between on-site parking and Brokaw Road. These were typical of species, size and condition of the mature trees found planted as perimeter landscaping at the site.

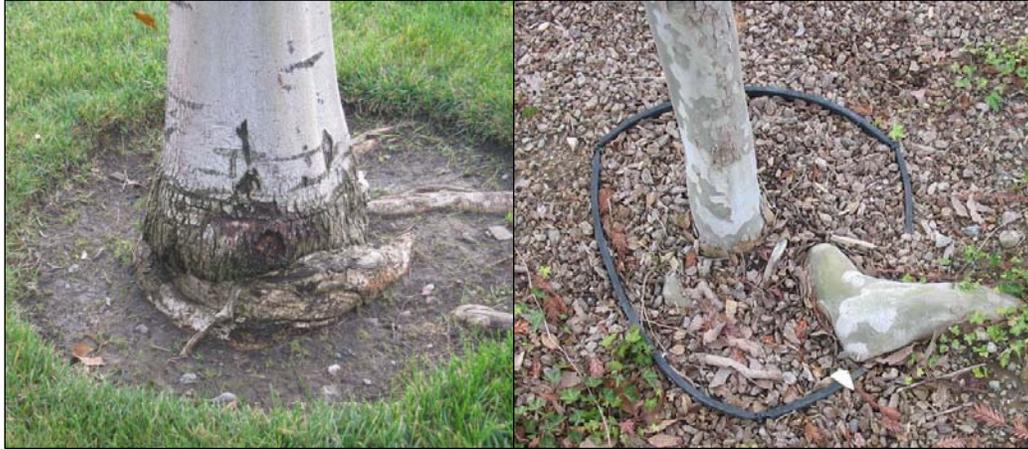
Photo 2: Shows two small-diameter landscape trees with root-related problems commonly seen at the 1040 Brokaw Road site. Raywood ash #205 (left) had several circling, girdling roots, likely an artifact of poor nursery practices, such as failing to transplant the tree in a timely manner. London plane #252 (right) had a large surface root that was kinked and had grown over a root barrier placed around the root ball rather than at the edge of the hardscape.
