Santana Row – Lot 11 Winchester Boulevard and Olsen Drive, San Jose Pre-Construction Tree Survey

Arborwell was retained to prepare a Pre-construction Tree Survey for Lot 11 of Santana Row Shopping Center at Winchester Boulevard and Olsen Drive in San Jose, California. The proposed construction occupies the southeast corner of Lot 11 adjacent to the intersection of the aforementioned streets (see Figure 1). This plan includes an inventory of the trees that will potentially be impacted by construction, including identifying all trees onsite and Geographic Information Systems mapping. The site was visited on February 6th, 2012.

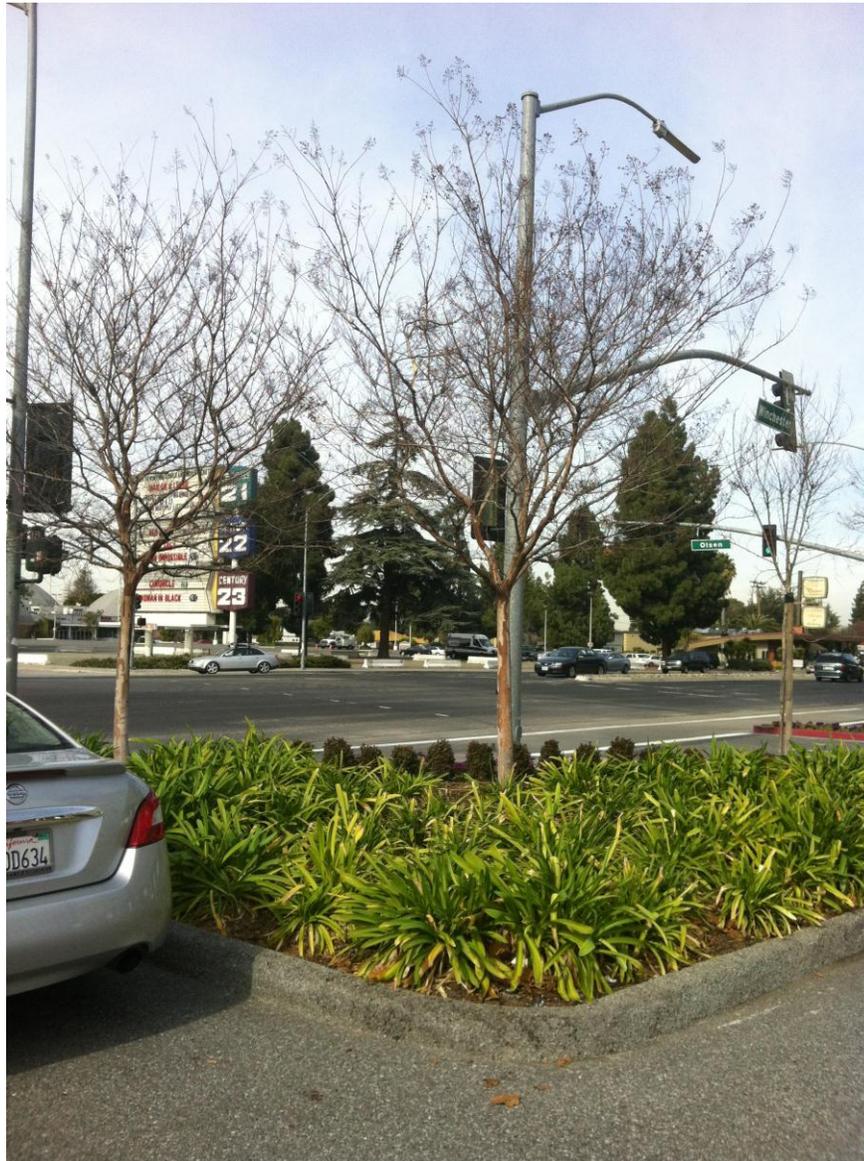
Figure 2: Three crape myrtles, Tree #1, #2, and #3 (from left to right), located in a planting area at the northwest portion of the proposed project. These trees were not indicated on the site plan

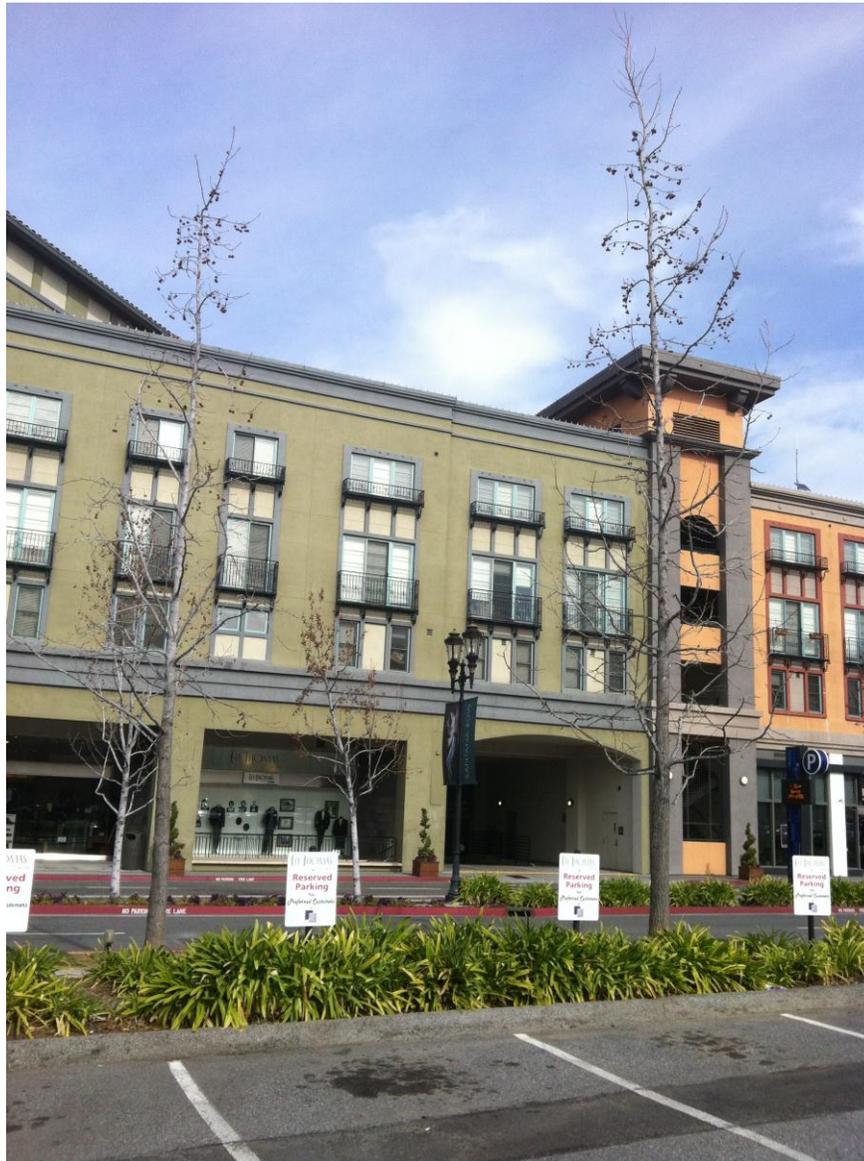
Figure 3: Trees #5 and #6, American sweetgums, located along Olsen Drive. These individuals, along with Tress #8 through #13, are dormant.

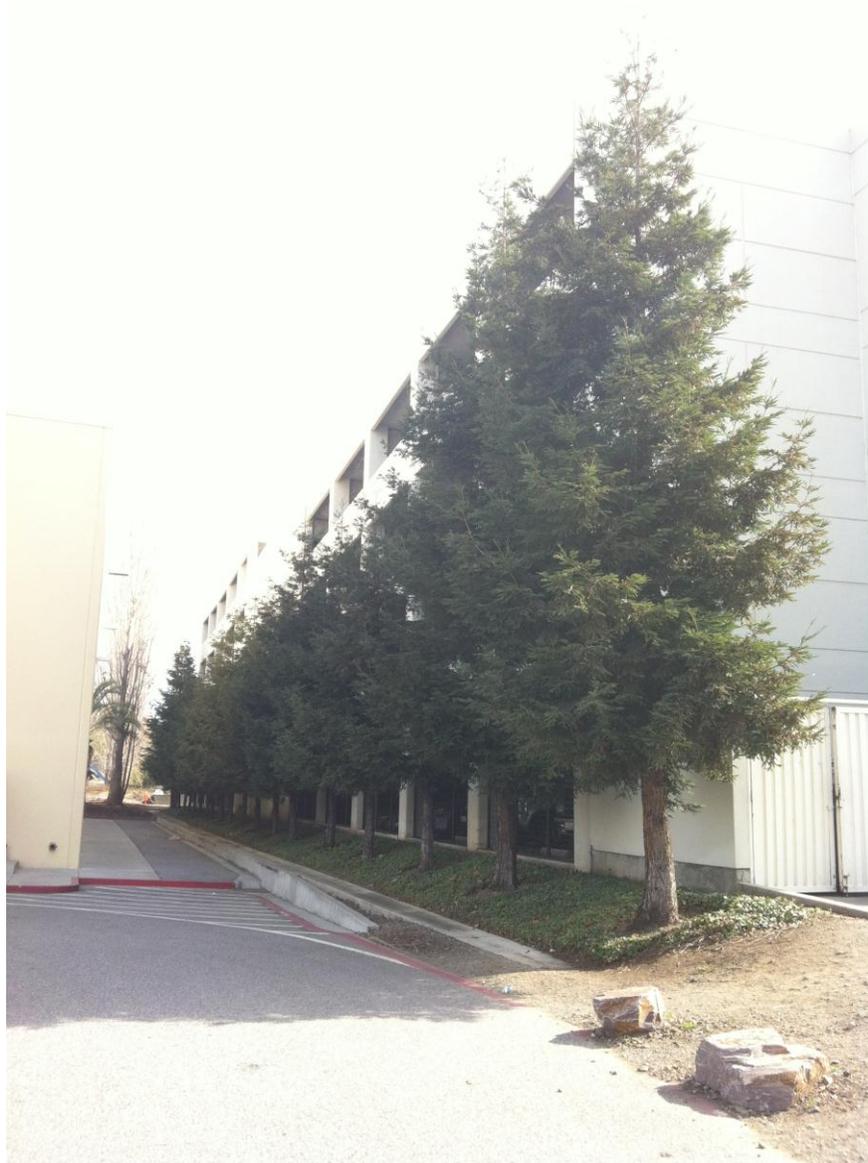
There are nine coast redwoods onsite. These specimens are experiencing overcrowding cause by their close proximity to each other. As a result a slight decline in the trees is observed. All redwood specimens are showing signs of botryosphaeria canker caused by artificial irrigation, apparent by a reddish hue in the foliage.

Figure 4: Trees #14 through #20, coast redwood, extend along the southeast corner of the property. Note that only the first seven (from the right-side of the image) of this row of redwoods are being observed for construction impacts.

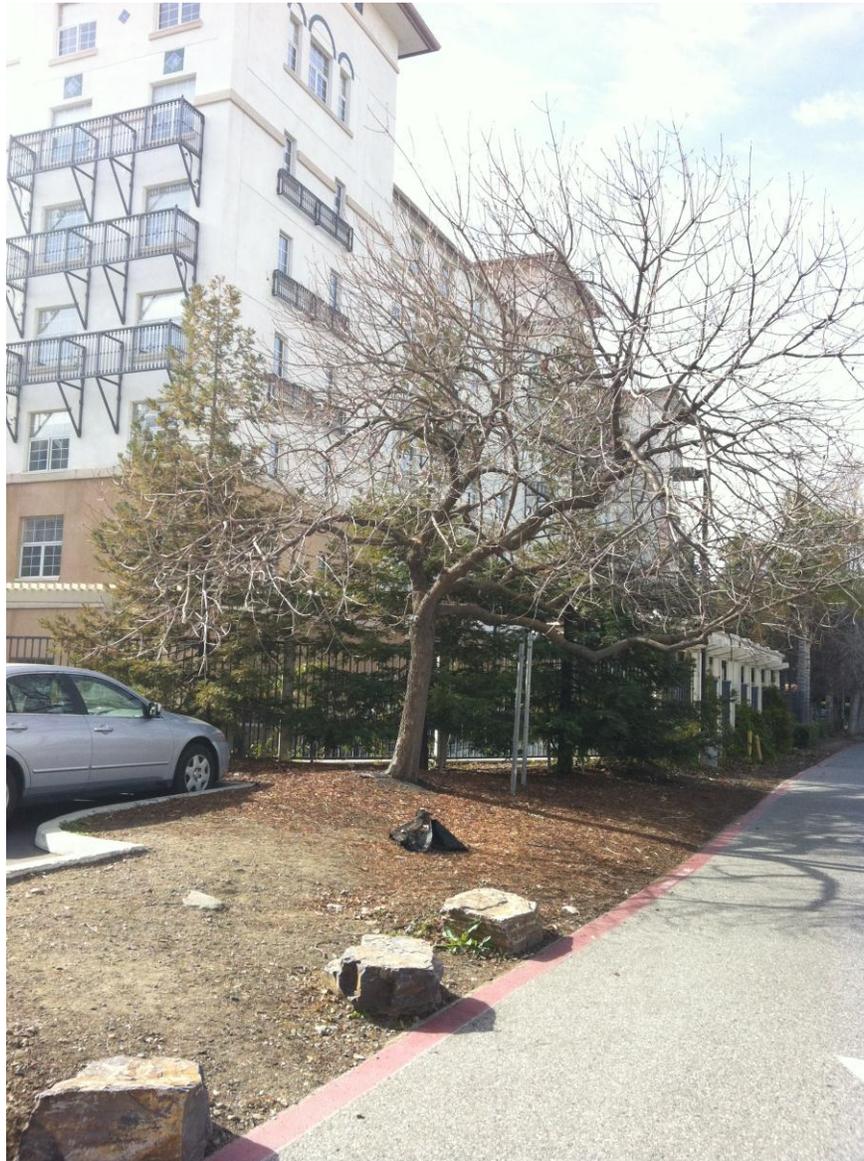
Figure 5: a mature Chinese pistache, Tree #21, which is dormant. Behind it are two coast redwoods that are included in the site plan.

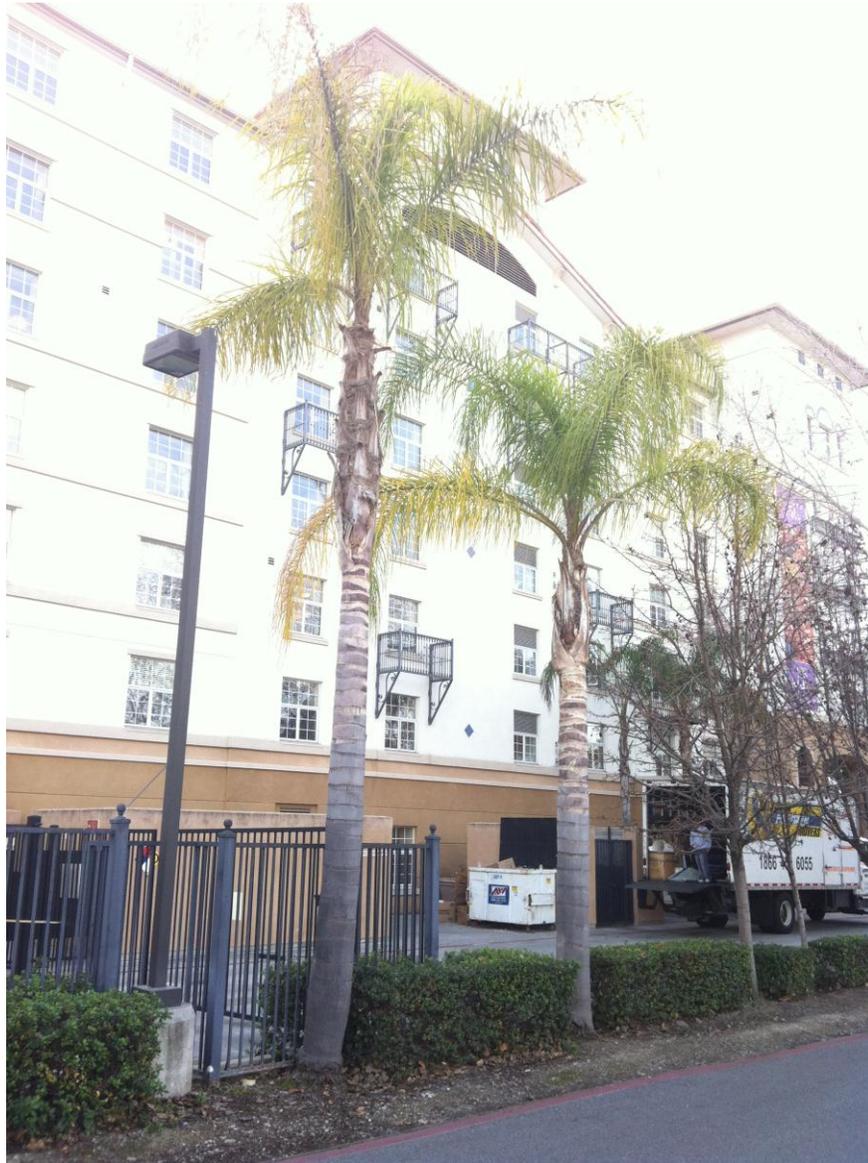
Most species are showing mild external symptoms of stress. This stress is exhibited in as yellowing of the foliage, called chlorosis. A possible cause for this type of symptom is under watering/heat stress. It is recommended that all trees to remain be fertilized yearly to reduce stress caused by malnutrition, fertilizing in fashion consistent to the needs of the species, in addition to supplemental watering of individual suffering from heat stress.

Figure 6: Trees #24 and #25, queen palms. This species is exhibiting chlorosis, indicated by the yellowing of the fronds.

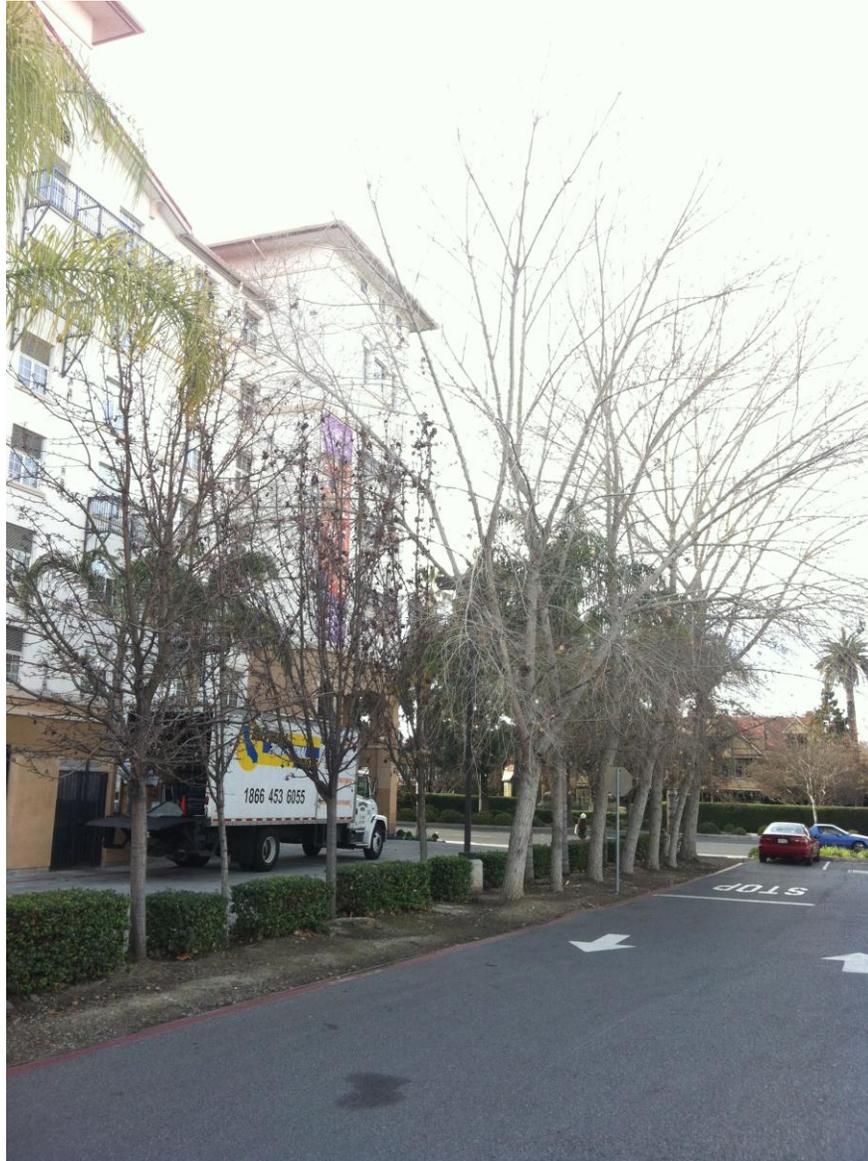
Figure 7: Trees #26through #42. This row of trees is a mixture of mature poplars, ornamental pear trees, and queen palms. Note that some of the trees to be removed are located on the adjacent property.

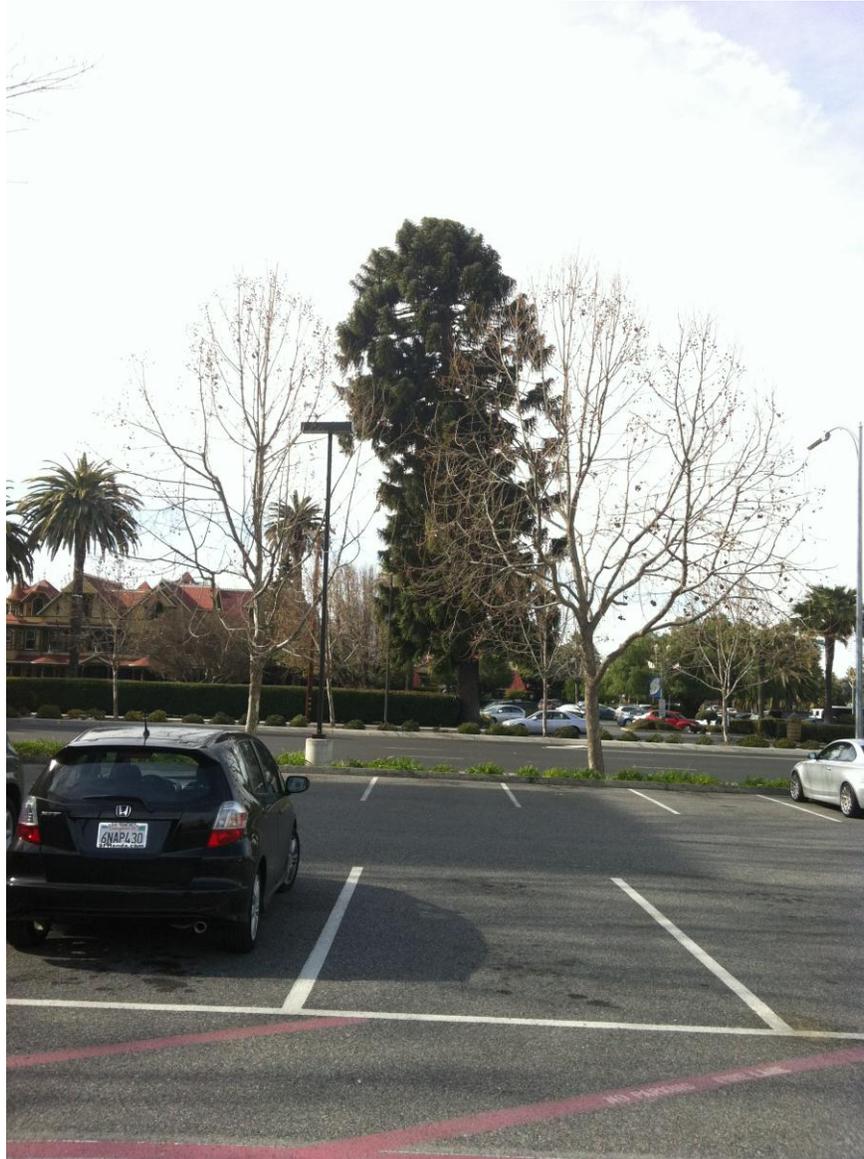
Figure 8: Trees #43 and #45, London plane trees, which were dormant during the survey. Note that this species onsite was planted as street trees along Winchester Boulevard.

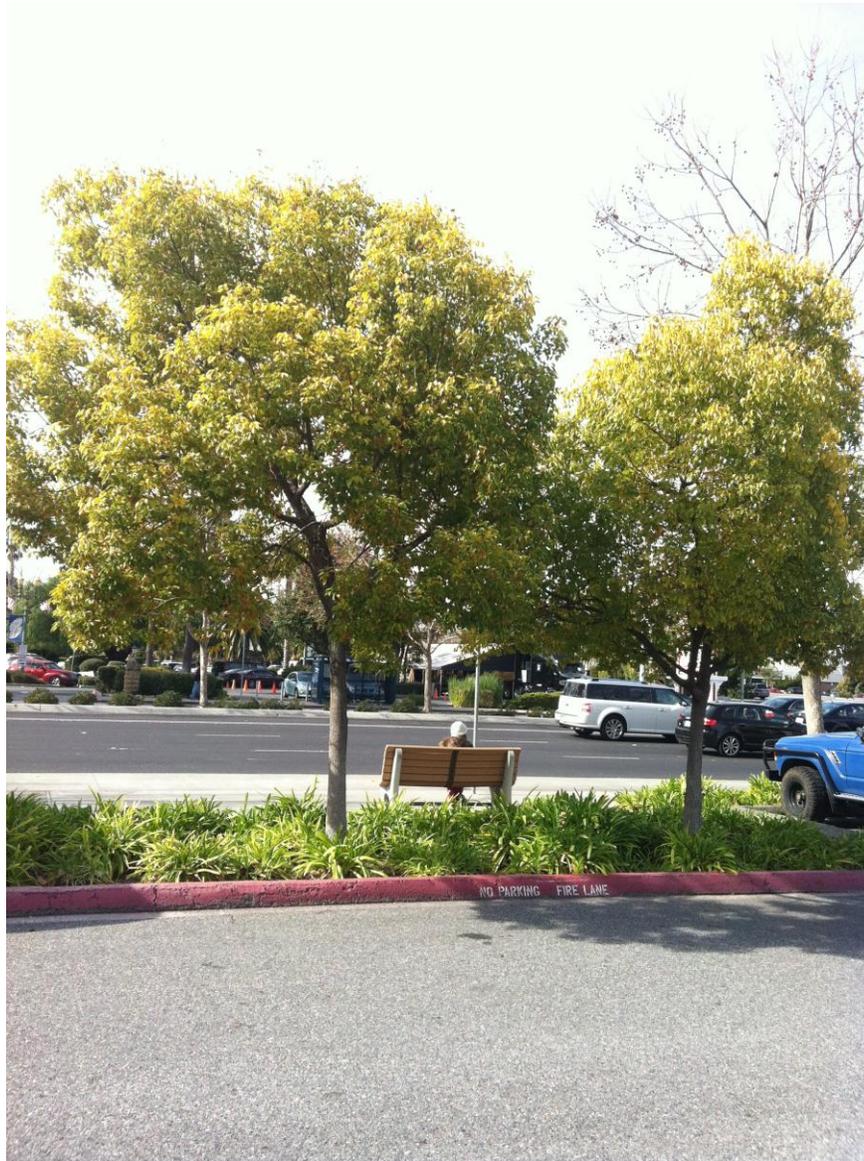
Figure 9: Two camphor trees, Trees #45 and #46, that were not indicated on the site plan. These trees are chlorotic.
