PRELIMINARY TREE REPORT

Monterey Estates
San Jose, CA

May 2006

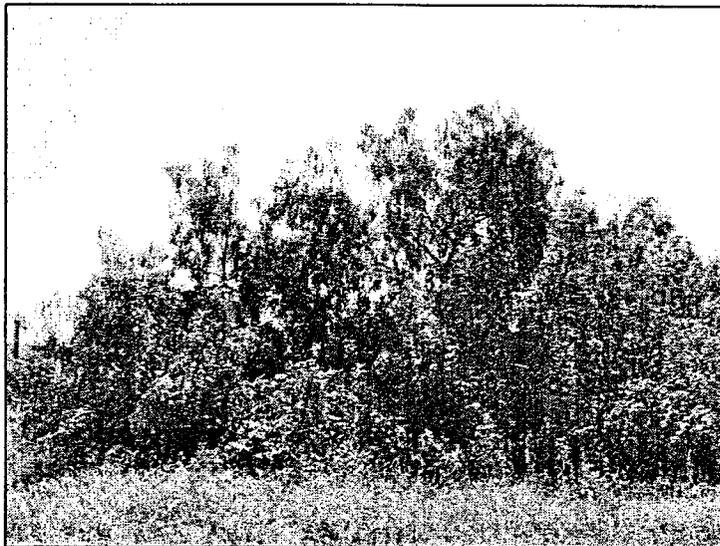
Five (5) of the Peruvian mastic trees were mature in structure and form, the remaining three (3) appeared to be stump-sprouts from previously removed trees. Two of the trees (#73 and 74) were poorly anchored on a rock outcropping (#73) and a retaining wall (#74). Peruvian mastic stump sprouts were formed by several small-diameter stems, one or two of which were upright, and the remainder of which arched to the ground (Photo 1).

Photo 1: Peruvian mastic stump sprout #76 was one of two located south of the driveway. Stump sprouts were formed by several stems. Some stems were upright, but most were bowed to the ground.

76	Peruvian mastic	6,5,4	4	Moderate	Stump sprout; branches to ground; debris has been piled around tree.	18	12	12	10	18
77	Peruvian mastic	37	4	Moderate	Codominant trunks at 5'; good form and structure; south side pruned for overhead utilities.	22	18	20	30	50

Thirteen (13) trees are preliminarily recommended for preservation, including the three (3) Peruvian mastic stump sprouts and two (2) mature Peruvian mastic trees west of the existing house. Peruvian mastic stump sprouts #75 and 76 should be pruned to remove stems that are bowed to the ground, while preserving upright stems. This will also facilitate the removal of the debris around the base of the trees.
