## Berryessa Asphalt Recycling Plant Riparian Revegetation Project

### Year 3 (2008) Monitoring Report

# BERRYESSA ASPHALT RECYCLING PLANT RIPARIAN REVEGETATION PROJECT

## YEAR 3 (2008) MONITORING REPORT

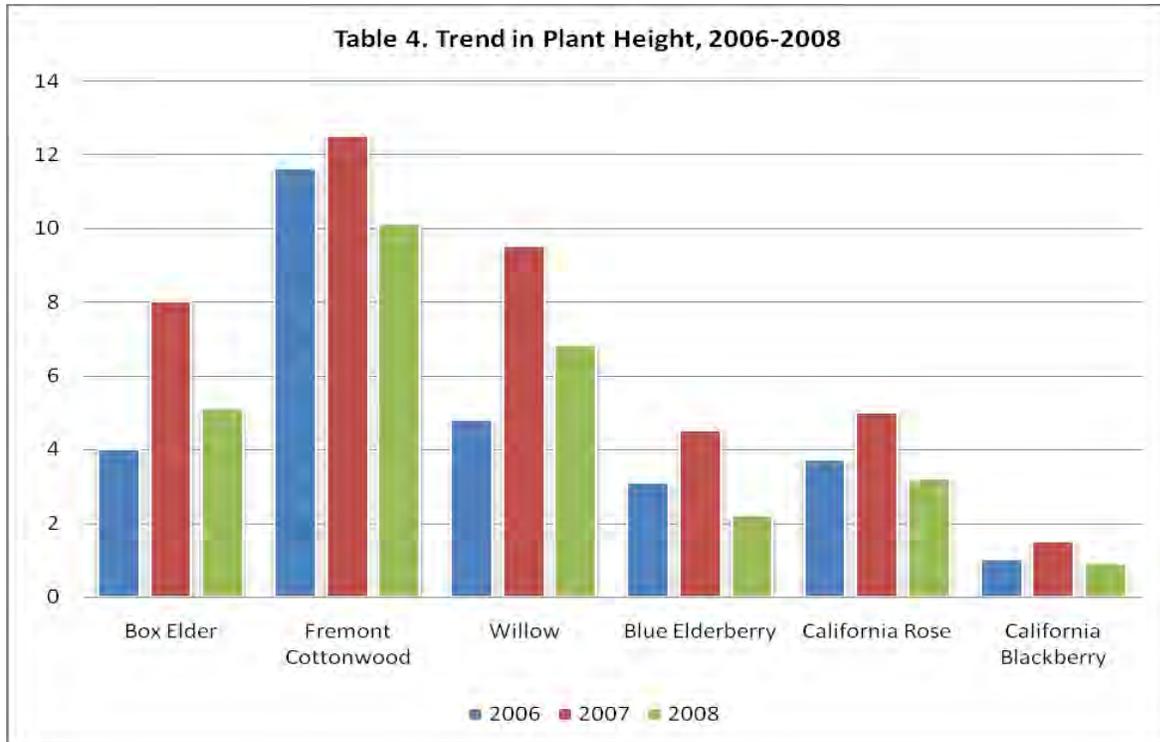
The trend in plant height, in feet by species, from Year 1 (2006) to Year 3 (2008) is depicted in Table 4. The average plant height for each species decreased in 2008 due to some stem dieback (willows and cottonwoods) and the low stature of the replacement plantings (box elder, blue elderberry and California rose). An increase in average plant height is expected to increase as the replacement plants mature.

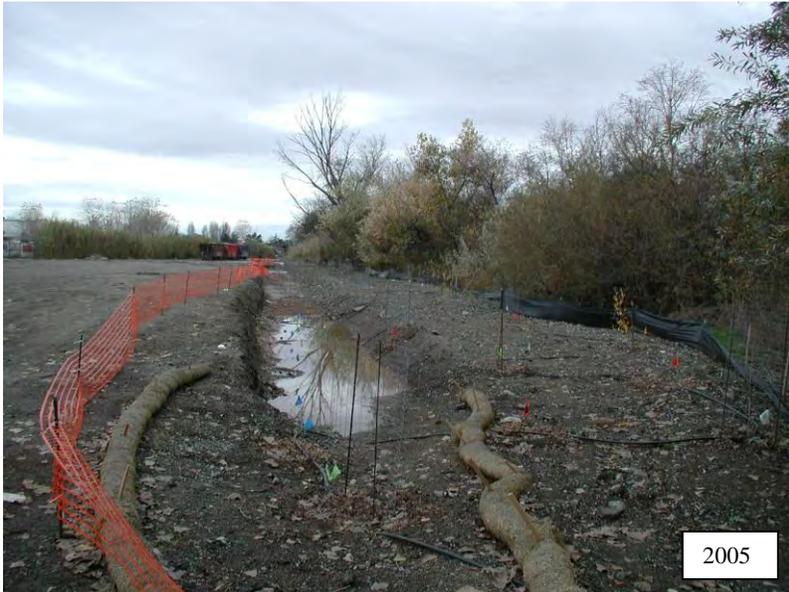
Figure 3A. Photo Station #1, taken from southern end of revegetation area, looking northward along the top edge of Coyote Creek, December 2005.

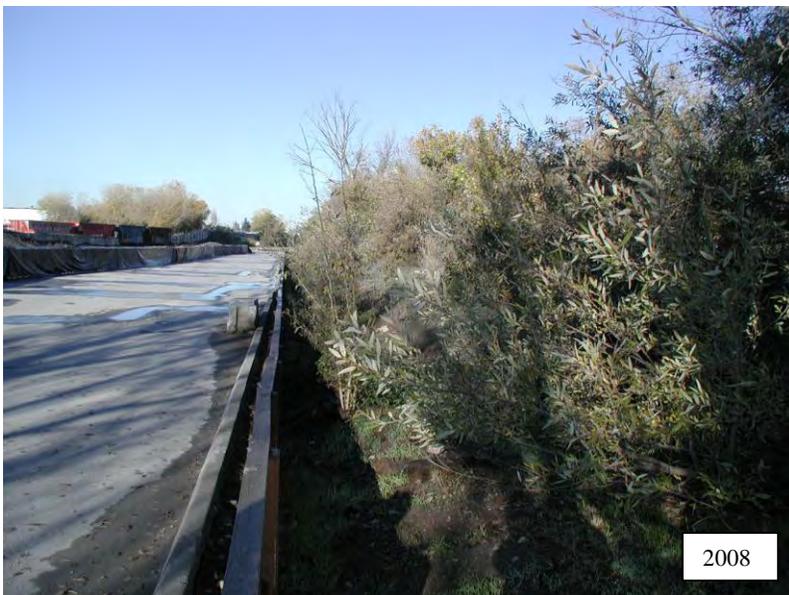
Figure 3B. Photo Station #1, taken from southern end of revegetation area, looking northward along the top edge of Coyote Creek, December 2008.

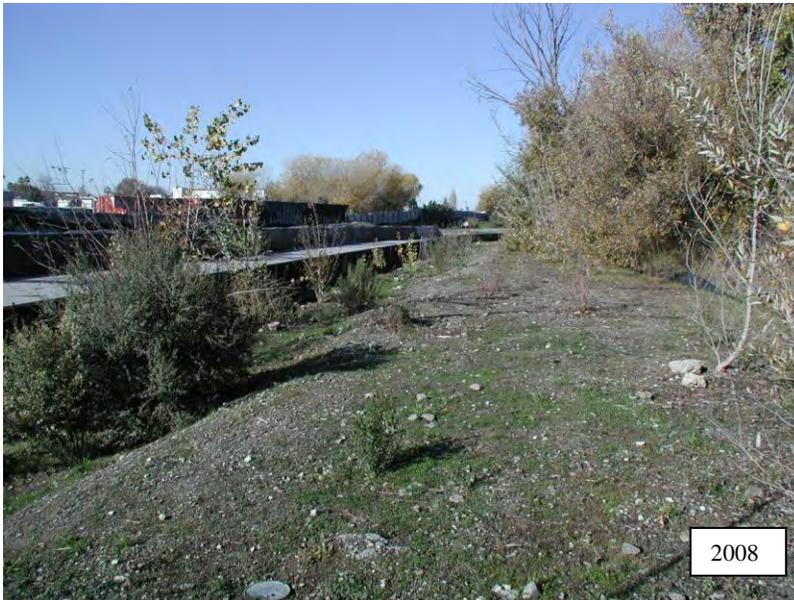
Figure 4B. Photo Station #2, looking eastward along top edge of Coyote Creek, December 2008.

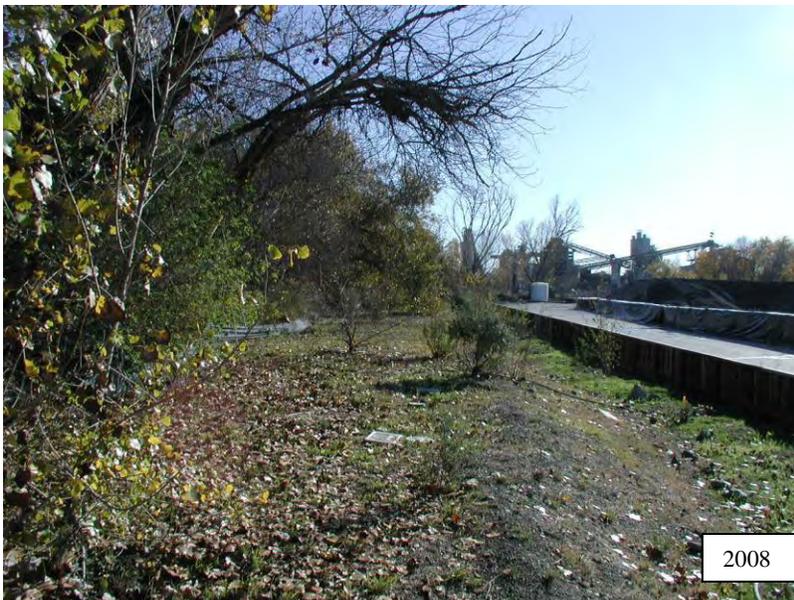
Figure 5B. Photo Station #3, looking southward along the top edge of Coyote Creek, December 2008.

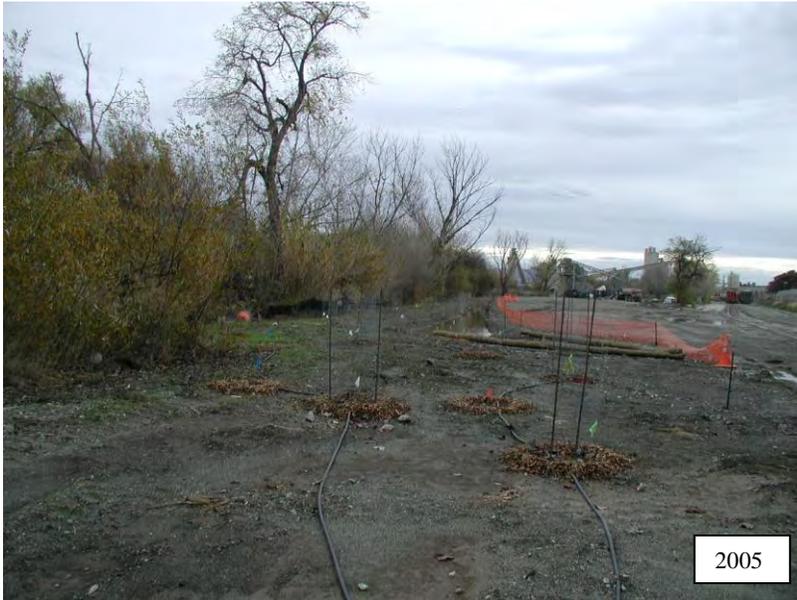
Figure 6A. Photo Station #4, taken from northern end of revegetation area, looking southward along the top edge of Coyote Creek, December 2005.

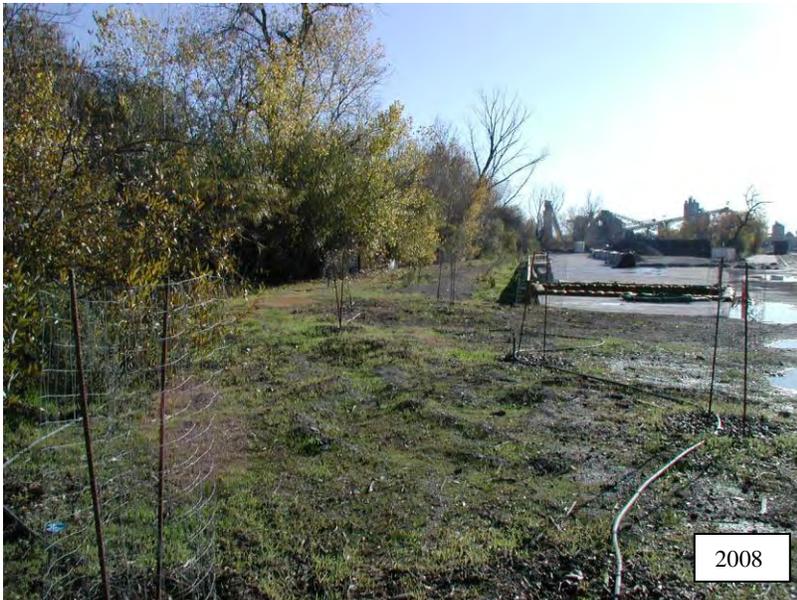
Figure 6A. Photo Station #4, looking southward along the top edge of Coyote Creek, December 2008.
