Biotic Resources Group

Berryessa Asphalt Recycling Plant Riparian Revegetation Project

Year 4 (2009) Monitoring Report

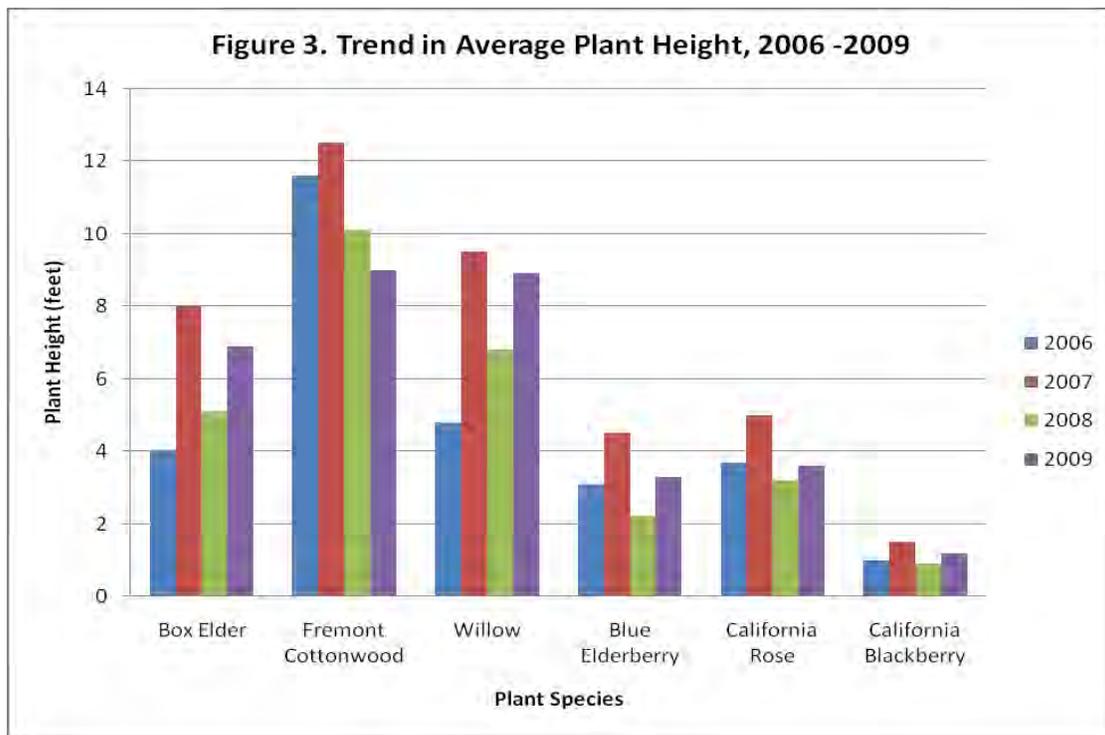
The Year 4 monitoring results are presented in Table 3. The trend in plant height, in feet by species, from Year 1 (2006) to Year 4 (2009) is depicted in Figure 3. The average plant height for all installed plantings increased in 2009. The average height of all Fremont cottonwood declined slightly in 2009 when volunteer plantings are included in the height data. A 4-year old Fremont cottonwood which is over 15 feet tall is depicted in Figure 4.

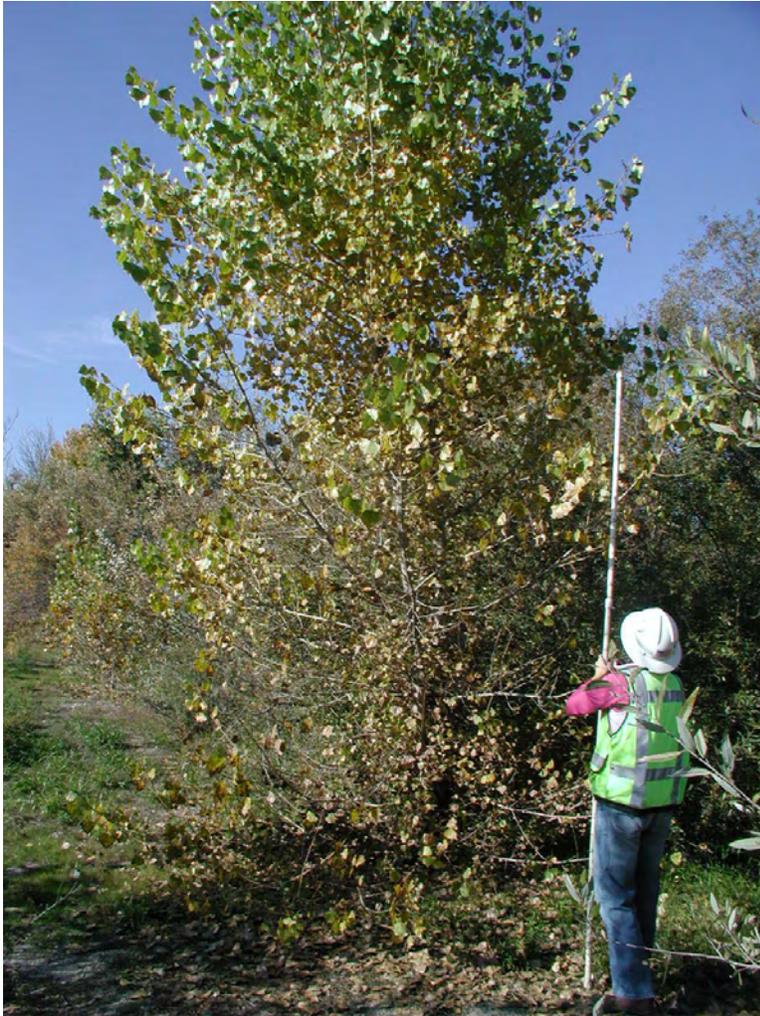
Figure 4. Fremont cottonwood exceeding 15 feet tall at Year 4, November 2009.

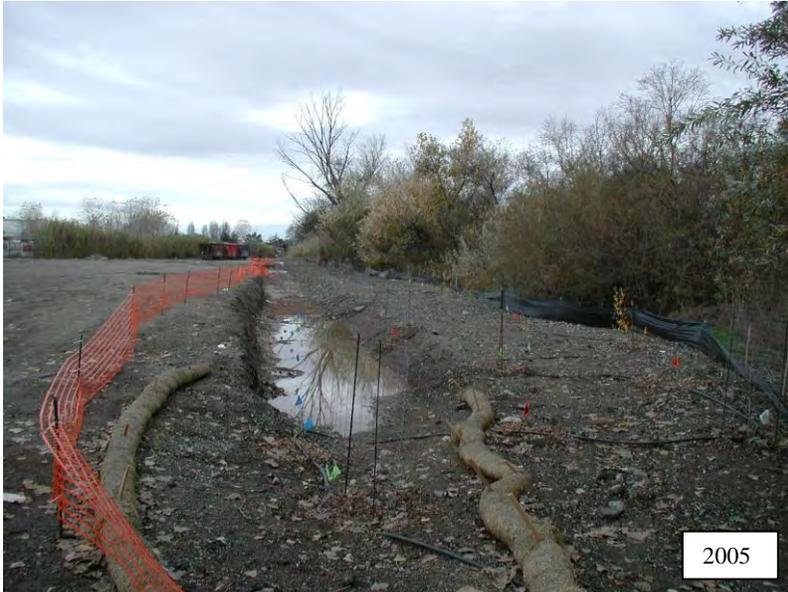
Photo Station 1

Figure 5A. Photo Station #1, taken from southern end of revegetation area, looking northward along the top edge of Coyote Creek, December 2005.

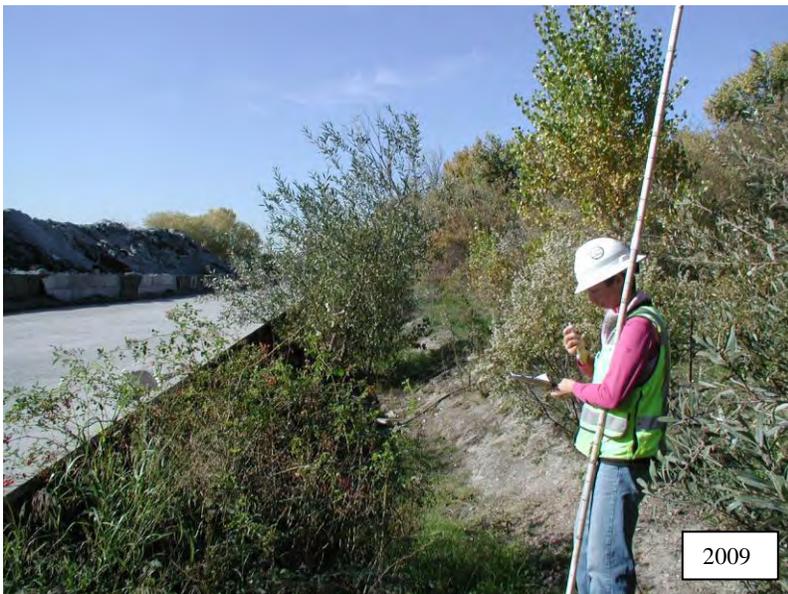
Figure 5B. Photo Station #1, taken from southern end of revegetation area, looking northward along the top edge of Coyote Creek, November 2009.

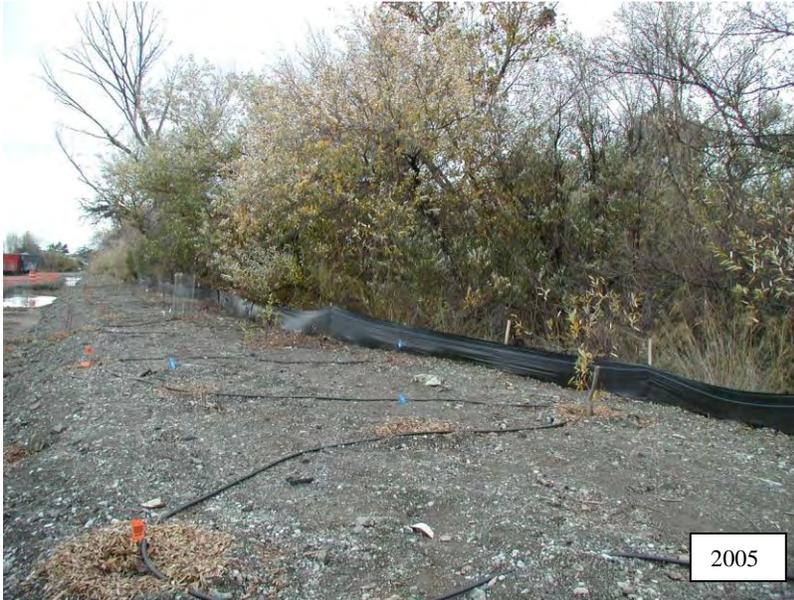
Photo Station 2

Figure 6A. Photo Station #2, taken from mid section of revegetation area, looking eastward toward top edge of Coyote Creek, December 2005.

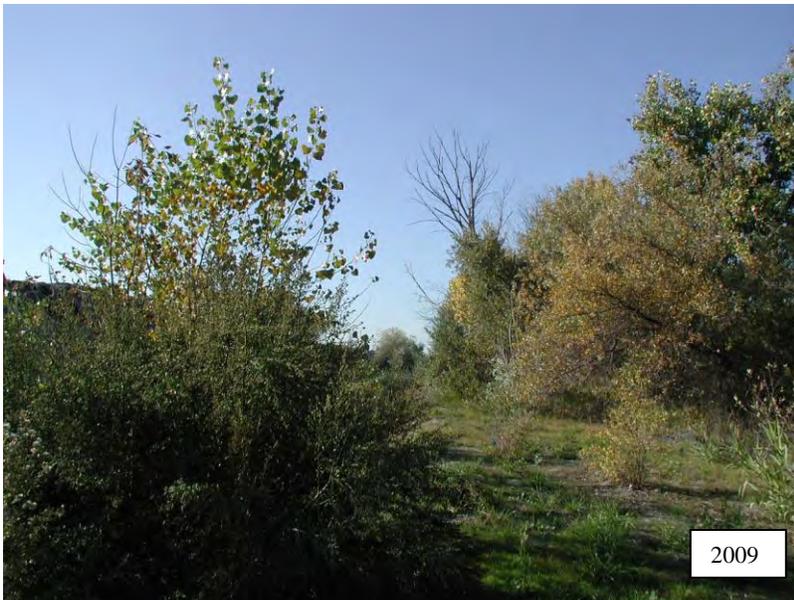
Figure 6B. Photo Station #2, looking eastward along top edge of Coyote Creek, November 2009.

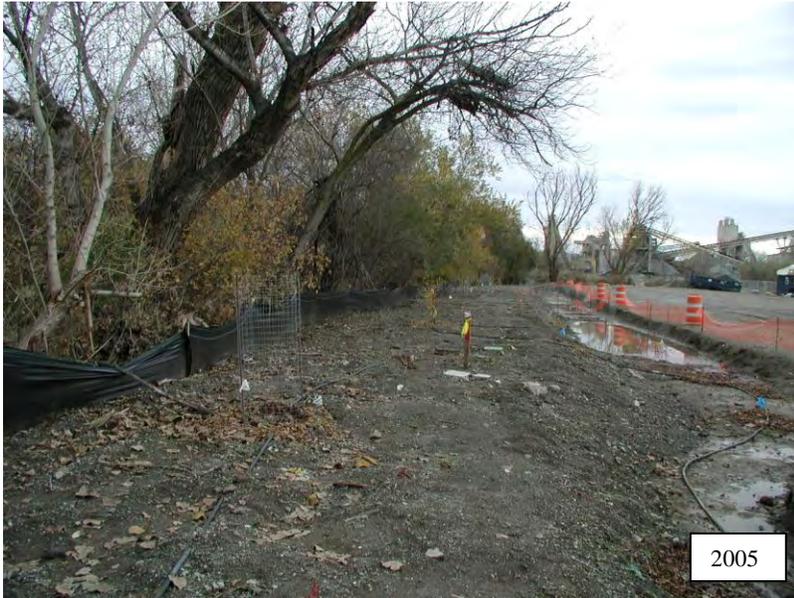
Photo Station 3

Figure 7A. Photo Station #3, taken from mid section of revegetation area, looking southward along the top edge of Coyote Creek, December 2005.

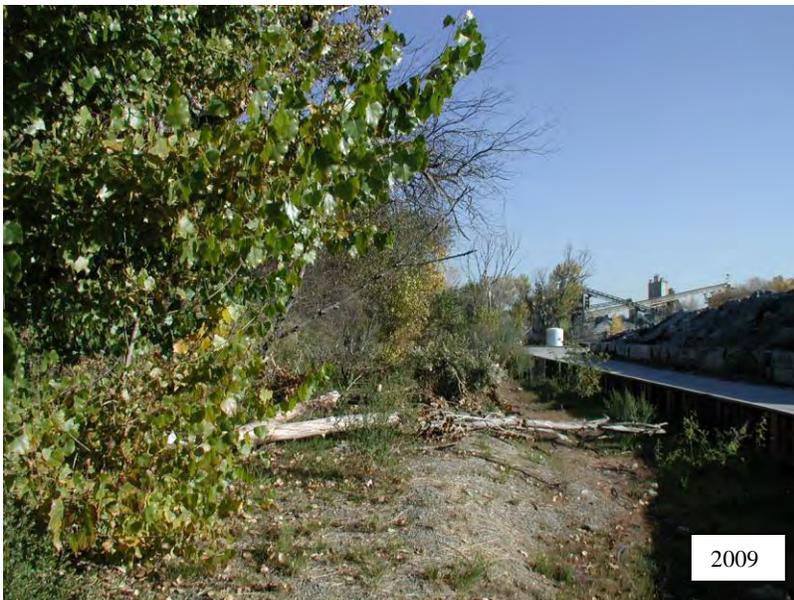
Figure 7B. Photo Station #3, looking southward along the top edge of Coyote Creek, November 2009.

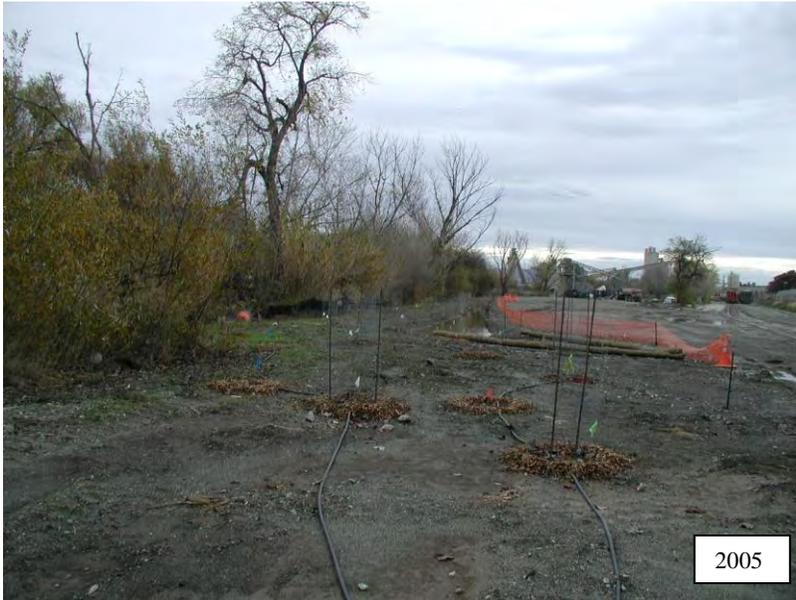
Photo Station 4

Figure 8A. Photo Station #4, taken from northern end of revegetation area, looking southward along the top edge of Coyote Creek, December 2005.

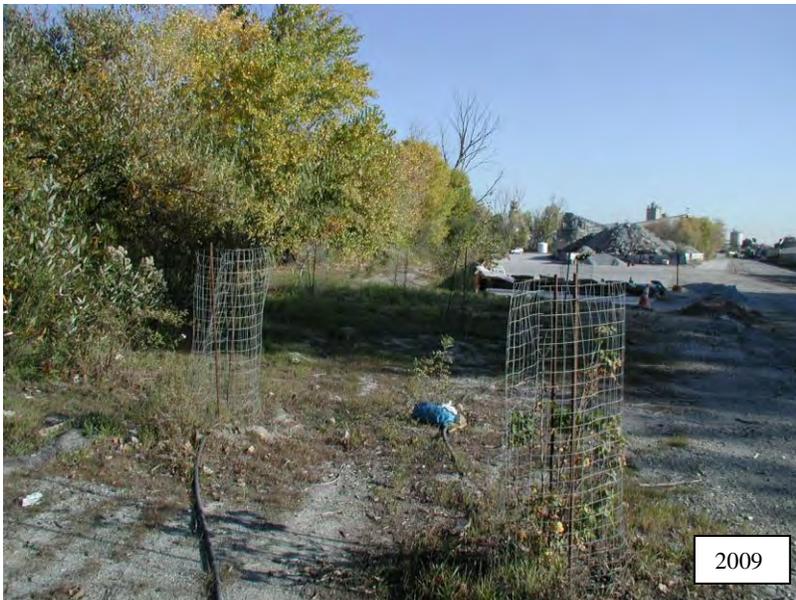
Figure 8A. Photo Station #4, looking southward along the top edge of Coyote Creek, November 2009.
