YEAR 5 (2007)

MITIGATION/MONITORING REPORT

**RIPARIAN IMPACTS ASSOCIATED WITH THE
RUBINO APARTMENT PROJECT**

SAN JOSE, CALIFORNIA

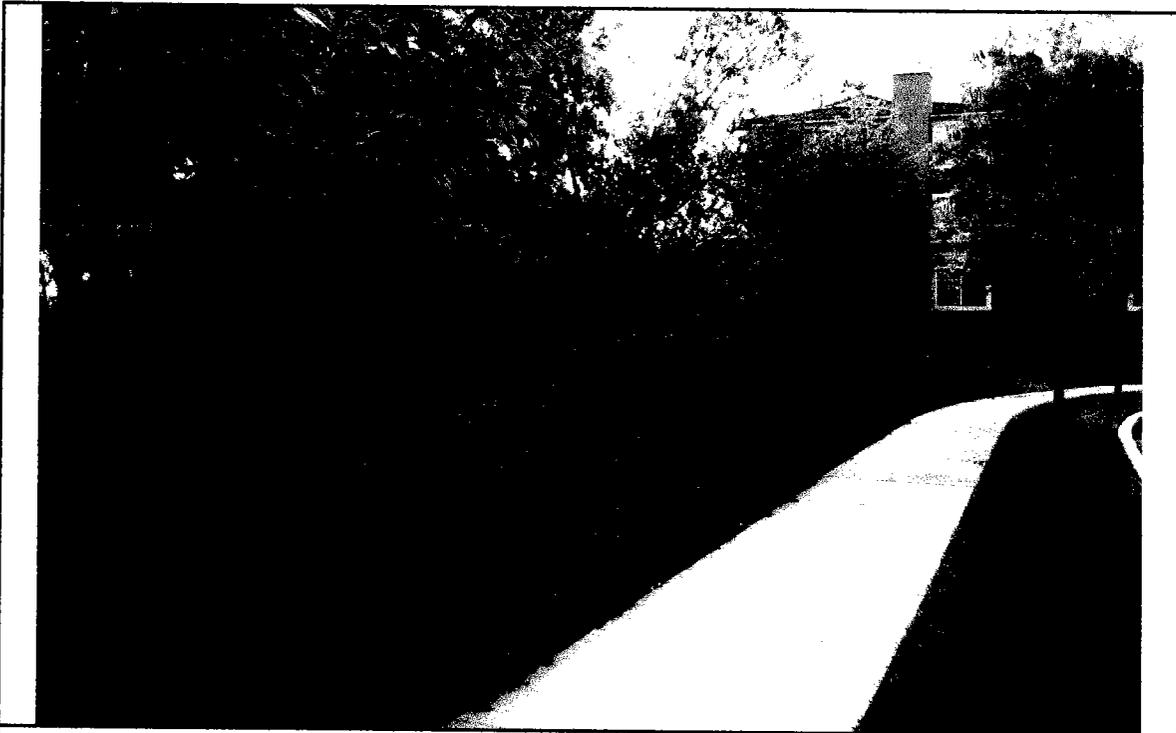
Photo No. 1. View to the southeast of the Archstone Restoration area along Brevins Loop.
