HAPPY HOLLOW PARK AND ZOO

First Year Riparian Habitat Monitoring Report

Prepared for
City of San Jose

December 2010

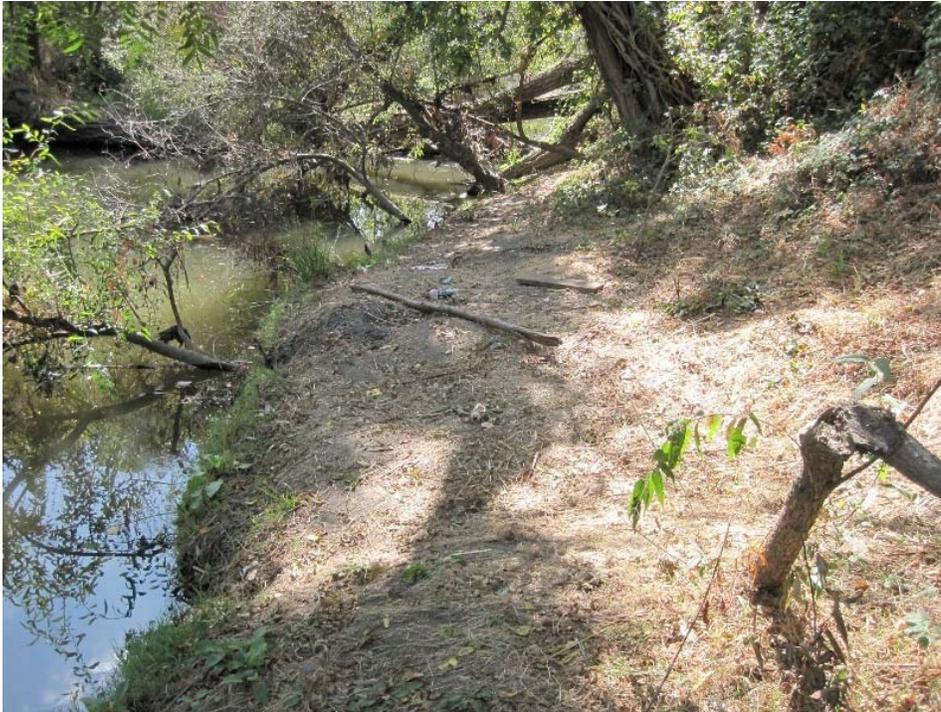
Photo 3: Shaded Riverine Aquatic Habitat Restoration Area from Photo Point 3 (September, 2010)

At the SRA mitigation area, all of the willows were removed and the cottonwoods were trampled by transients. The willows should be planted at another location that is less likely to be disturbed.

Since all of the willow plantings within the SRA mitigation area were removed, this area is not performing well. The cottonwoods at the site have also been trampled from human disturbance. Although percent plant cover was not formally assessed this year, it was visually very low and would have drastically brought down the total percent cover over the entire mitigation site.

- 1 mugwort
 - 2 coffeeberry
 - 1 snowberry
 - 2 blue elderberry
- Since all willows in the SRA area have been lost, they need to be replanted. At least four willow poles should be installed at an alternate site where there is less chance of disturbance from a homeless encampment. Successful willow replanting is necessary for the site to be considered successful.
