Los Lagos Golf Course  
Environmental Mitigation Monitoring  
Year 7 (2008) Monitoring Report

## Los Lagos Golf Course Environmental Mitigation Monitoring Year 7 (2008) Monitoring Report

Biotic Resources Group  
Kathleen Lyons, Plant Ecologist

November 14, 2008

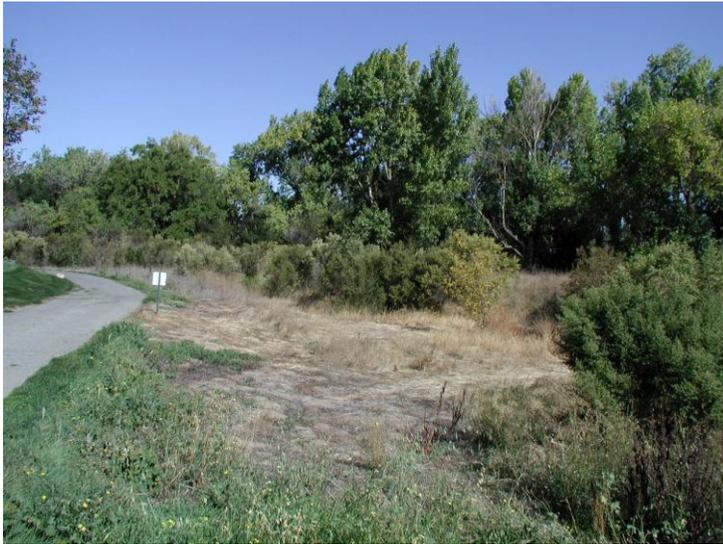
This planting area is located in the northwest corner of the golf course, immediately west of Coyote Creek (Figure 1). The sample plot data yielded 29% cover by herbaceous species, 58% cover by shrubs, and 13% cover by trees. Natural recruitment of native trees and shrubs provided 1% of the plant cover; volunteer California walnut and coyote brush were documented. Invasive plant species were limited to a small patch of Jimson weed.

Figure 4. View of northwest planting area, looking south, October 2008.

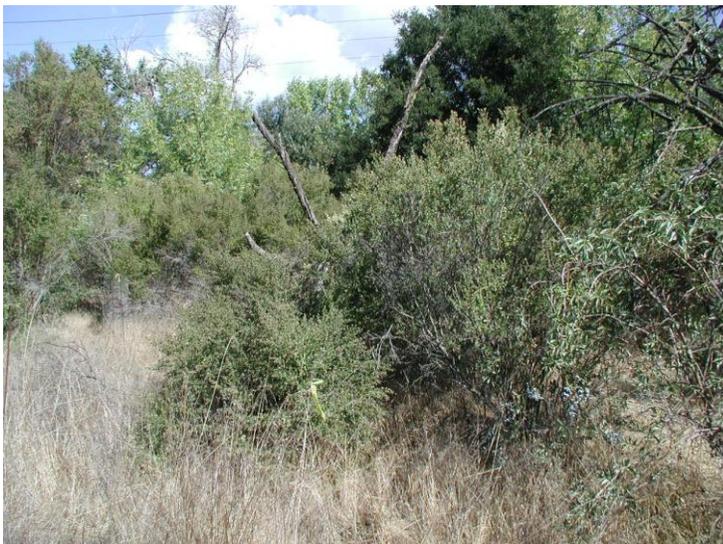
The sample plot data documented that most plants exhibited excellent health and vigor (Table 3). Valley oak trees are the tallest plants, averaging 8.5 feet. Valley oak tree plantings average 6.4 feet tall, although individual trees were recorded at 15 feet. Box elder trees average 7 feet tall. Coyote brush continues to provide significant plant cover. Plant heights average 8.7 feet, although individuals were recorded at 15

Figure 5. Growth of shrubs and trees within northwest planting area, October 2008.

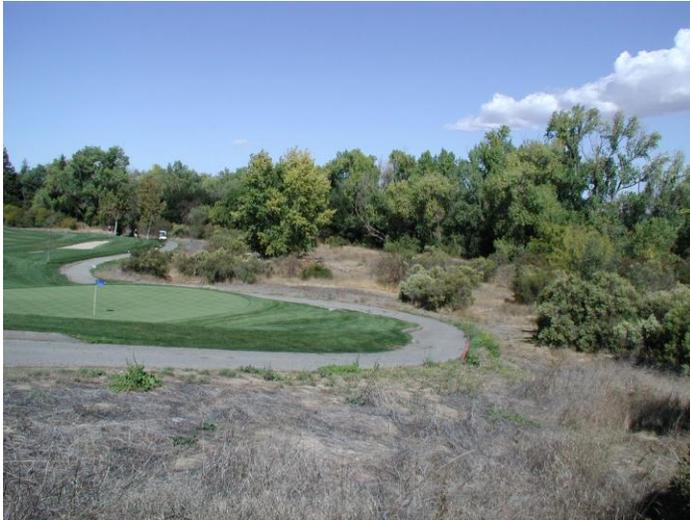
This planting area is located in the southwest portion of the golf course, immediately west of Coyote Creek. The sample plot data yielded 20% cover by herbaceous species, 62% cover by shrubs, and 8% cover by trees. Natural recruitment of native trees and shrubs provided <1% of the plant cover; volunteer coyote brush were documented. Invasive plant species provided 10% plant cover, which was provided by yellow star thistle, milk thistle, and Italian thistle.

Figure 7. View of southwest planting area, looking north, October 2008.

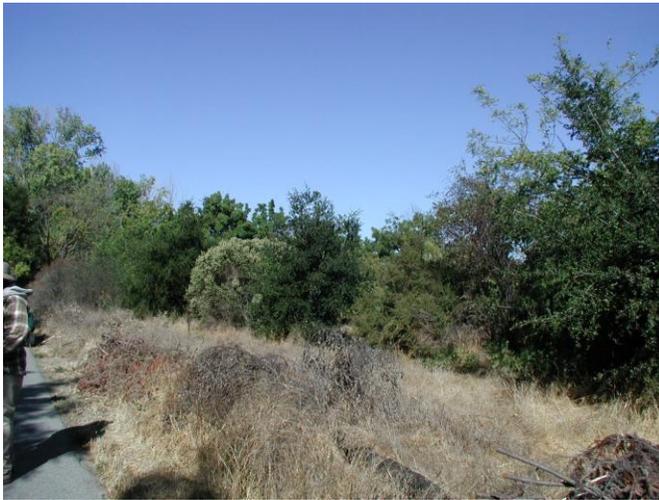
Piles of cut tree/shrub materials were observed along the edge of the trail and the southeast mitigation area, resulting in a continuous line of tree limbs, logs, and other golf course cuttings/debris. The piles also include cut turf and soil. This material should not be deposited within the mitigation area (or elsewhere along the Coyote Creek corridor) and is not allowed in the *Tuers-Capitol Golf Course Riparian Mitigation and Monitoring Plan*. The debris also makes it difficult for maintenance workers to control the invasive weeds (thistles and poison hemlock) that are present along the trail/mitigation area edge.

This planting area is located in the southeast portion of the golf course, immediately east of Coyote Creek, near Hole 9. The sample plot data yielded 21% cover by herbaceous species, 61% cover by shrubs, and 19% cover by trees. Natural recruitment of native trees and shrubs provided 2% of the plant cover; volunteer California walnut, California blackberry, poison oak, and coyote brush were documented. Invasive plant species provide <1% cover, primarily by poison hemlock.

Figure 9. View of southeast planting area, September 2008.

In addition, woody debris and golf course trimmings (including turf/sod pieces) that have been placed along the edge of the southeast mitigation area should be removed. Golf course debris is not allowed in the mitigation areas. All remaining tree stakes (i.e., rebar) should be removed; the irrigation system can be turned off, with drip emitters plugged or removed.

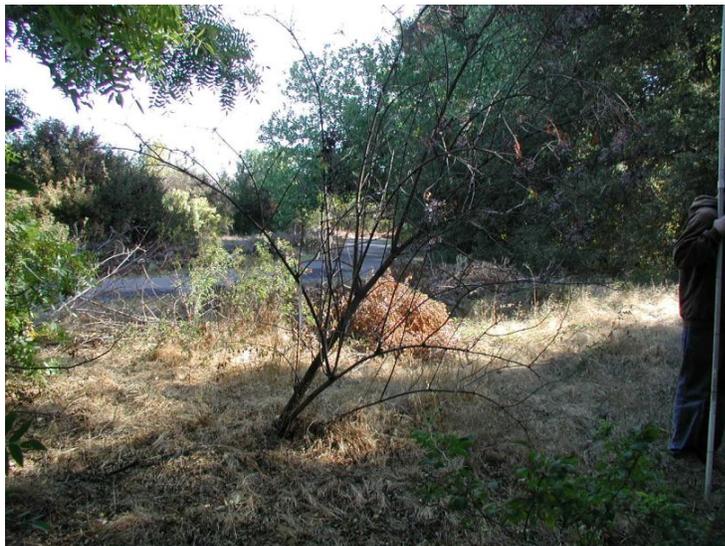
This planting area is located in the southeast portion of the golf course, immediately east of Coyote Creek, near the Coyote Creek Trail (Figure 3). The sample plot data yielded 33% cover by herbaceous species, 50% cover by shrubs, and 14% cover by trees. Natural recruitment of native trees and shrubs provided 5% of the plant cover; volunteer California walnut and poison oak were documented. Invasive plant species were limited to Himalaya berry that has runners into the revegetation area from the adjacent riparian woodland.

Figure 11. View of portion of sycamore cottonwood planting area, October 2008.

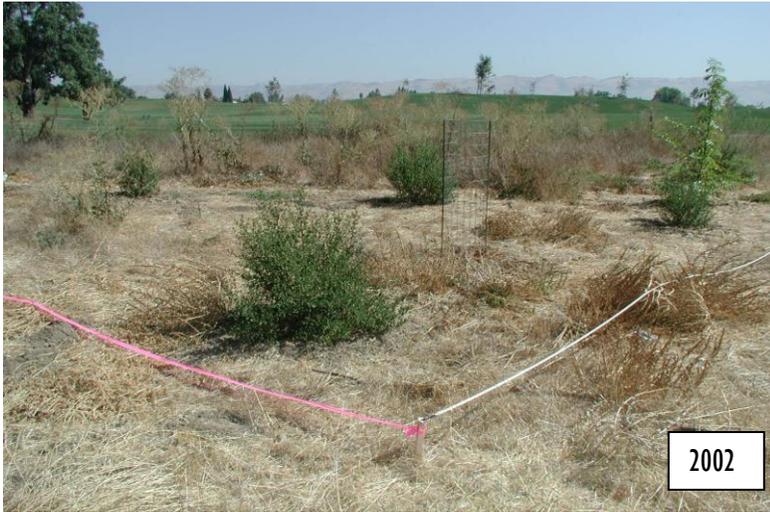
Figure 17a. View of **Sample Plot I, Southeast Planting Area, September 2002**. Sample plot contains 3 coyote brush (alive) and one dead plant. Herbaceous cover is 95%; shrub cover is 5% and tree cover is 0%.

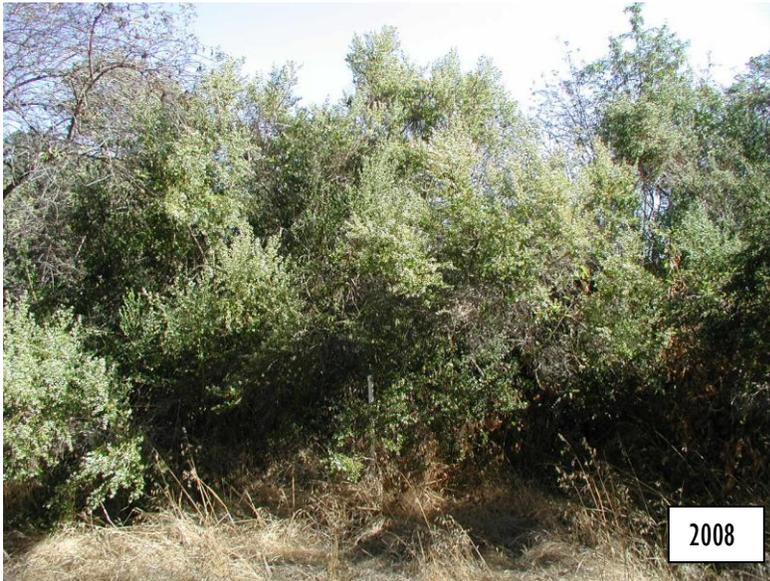
Figure 17b. View of **Sample Plot I, Southeast Planting Area, October 2008**. Herbaceous cover is 0%; shrub cover is 90% and tree cover is 10%.

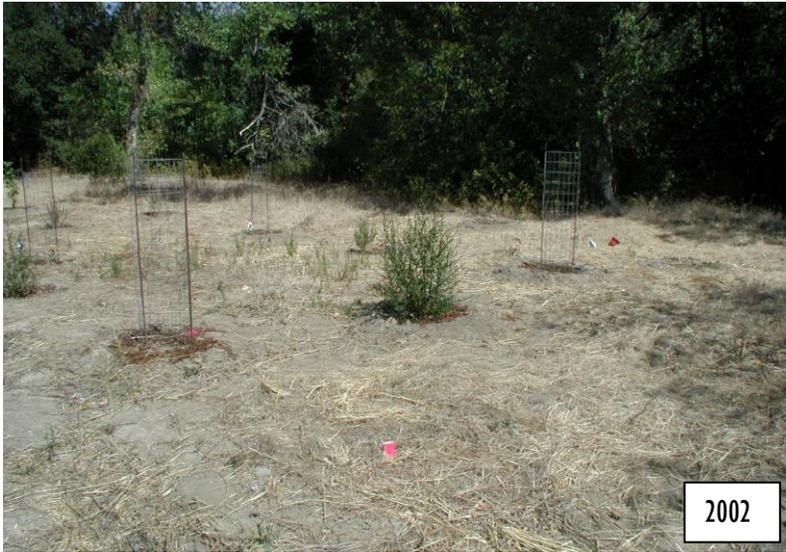
Figure 18a. View of **Sample Plot I, Northwest Planting Area, September 2002**. Sample plot contains 3 coyote brush (alive) and two dead plants. Herbaceous cover is 70%; shrub cover is 5% and tree cover is 0%.

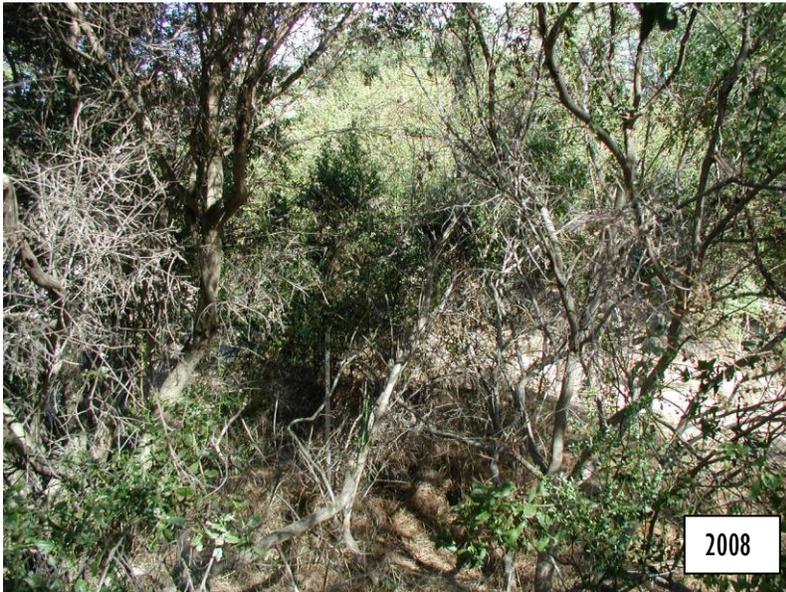
Figure 18b. View of **Sample Plot I, Northwest Planting Area, October 2008**. Herbaceous cover is 5%; shrub cover is 90% and tree cover is 5%.

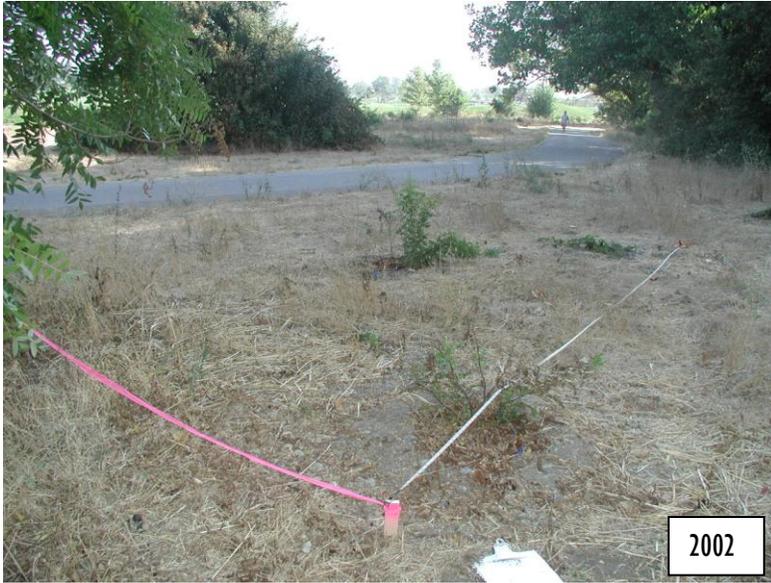
Figure 19a. View of Sample Plot 1, Sycamore/Cottonwood Planting Area, September 2002. Sample plot contains 1 blue elderberry, 1 California rose and 1 California blackberry. Herbaceous cover is 95%; shrub cover is 5% and tree cover is 10% (from adjacent trees).

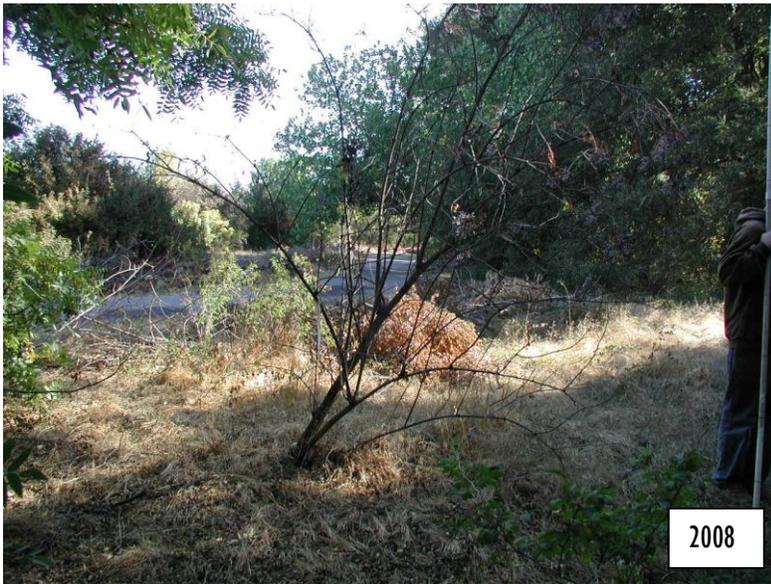
Figure 19b. View of Sample Plot 1, Sycamore/Cottonwood Planting Area, October 2008. Herbaceous cover is 60%; shrub cover is 30% and tree cover is 10%.

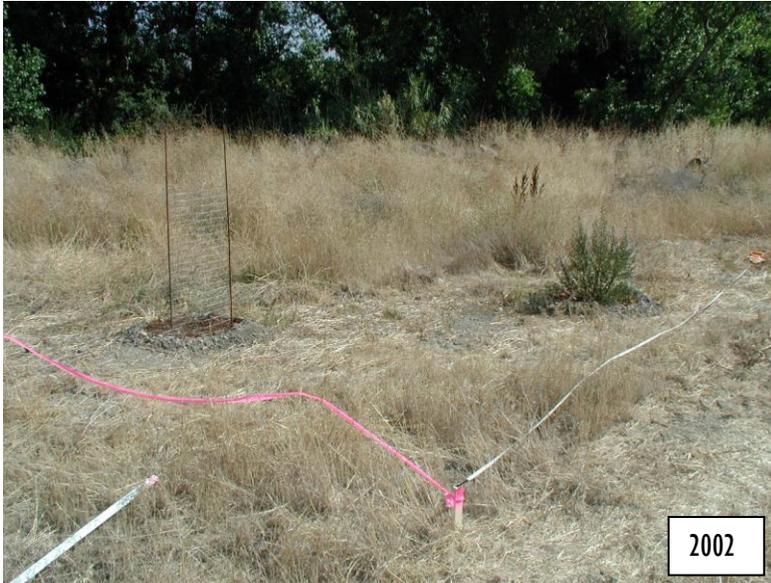
Figure 20a. View of **Sample Plot 6, Southwest Planting Area, September 2002**. Sample plot contains 2 coyote brush, one coast live oak and one empty planting site. Herbaceous cover is 95%; shrub cover is 5% and tree cover is 10%. Yellow star thistle provides 75% of the herbaceous plant cover.

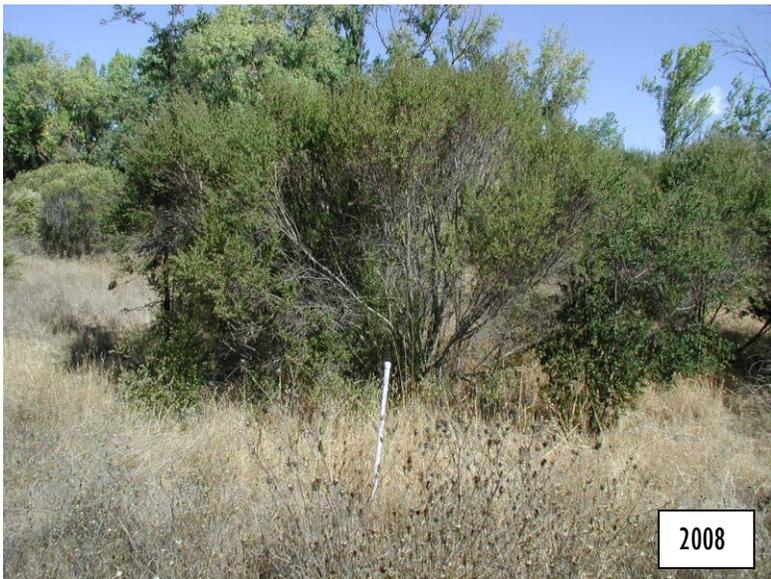
Figure 20b. View of **Sample Plot 6, Southwest Planting Area, October 2008**. Herbaceous cover is 10%; shrub cover is 70% and tree cover is 20%. Yellow star thistle provides 50% of the herbaceous plant cover.

The mitigation areas should continue to be weeded; the weeding should be focused on seasonal weed whipping to control invasive, non-native plant species (e.g., yellow star thistle, milk thistle, Italian thistle, jimson weed, tree tobacco). Particular attention should be given to the timing of weed control so as to reduce seed production and maximize the effectiveness of the weeding operations.

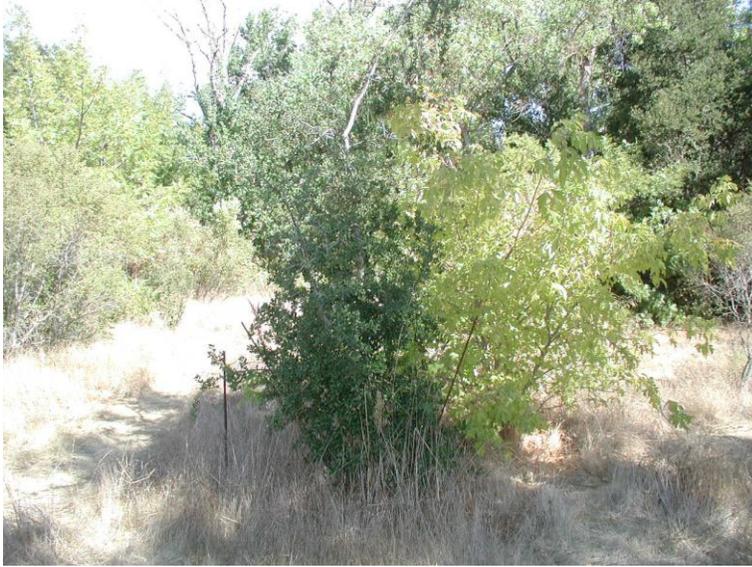
Figure 21. Coast live oak and box elder within Northwest Planting Area, October 2008.

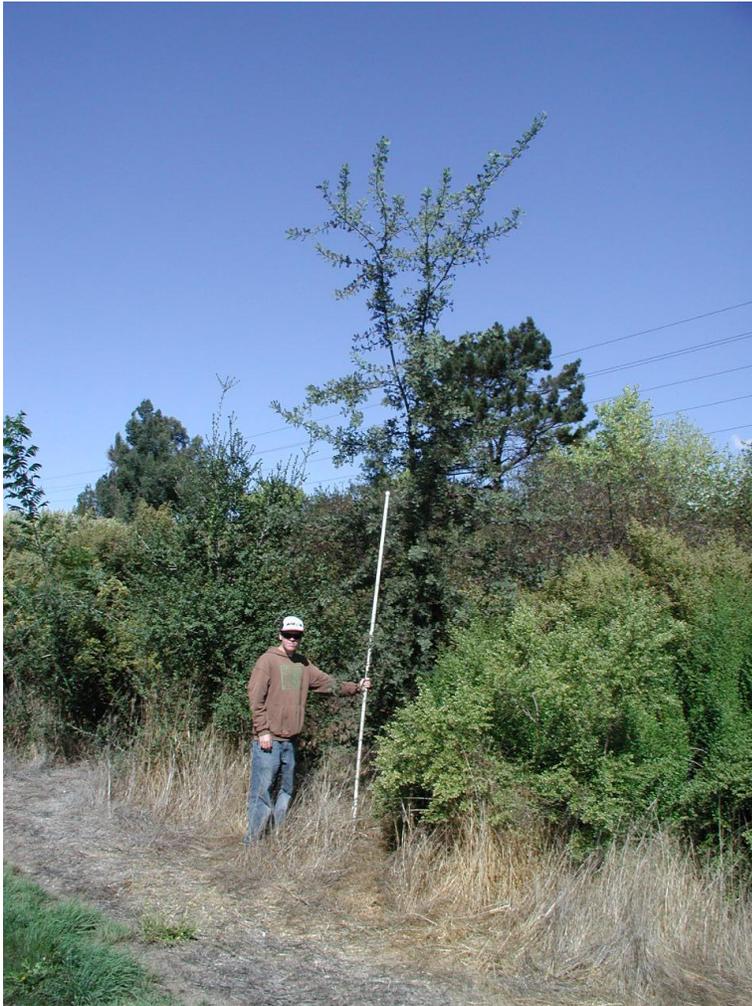
Figure 22. Seven-year oak valley oak over 18 feet tall within Northwest Planting Area, October 2008.
