**SECOND AND THIRD ANNUAL
MONITORING REPORT**

**QUAIL HOLLOW BRIDGE REPLACEMENT PROJECT
ALUM ROCK PARK, SAN JOSE, CALIFORNIA**

LSA Project No. SJO0607B

July 17, 2009

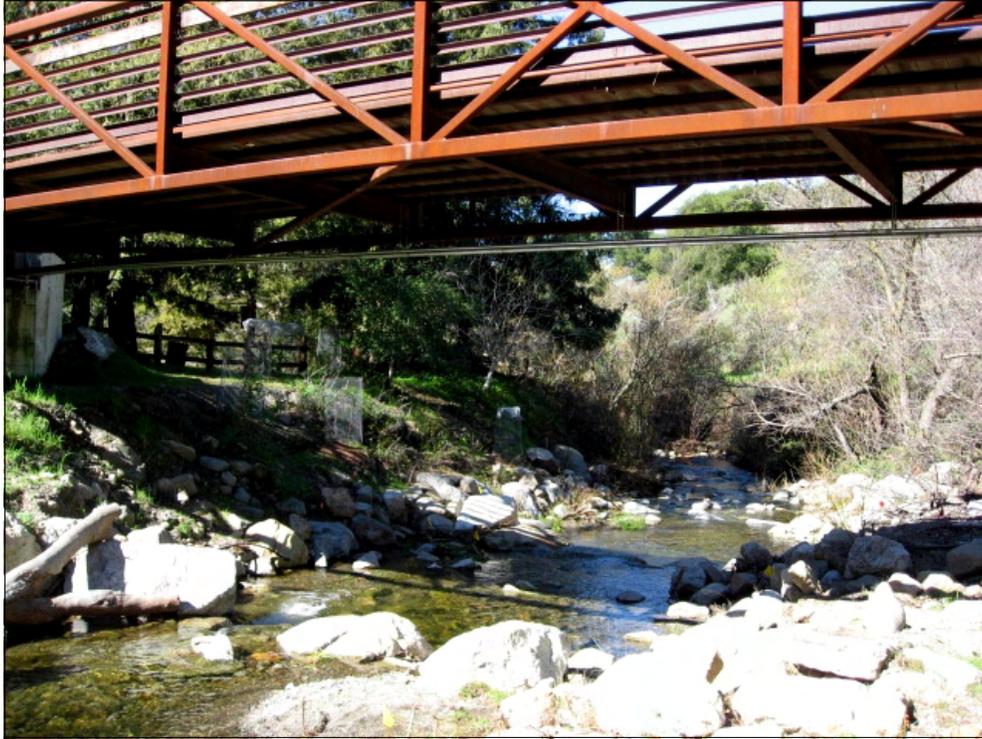
Photo Point 1: Photo taken on February 14, 2008 looking southwest at rock weirs and southwestern bank.

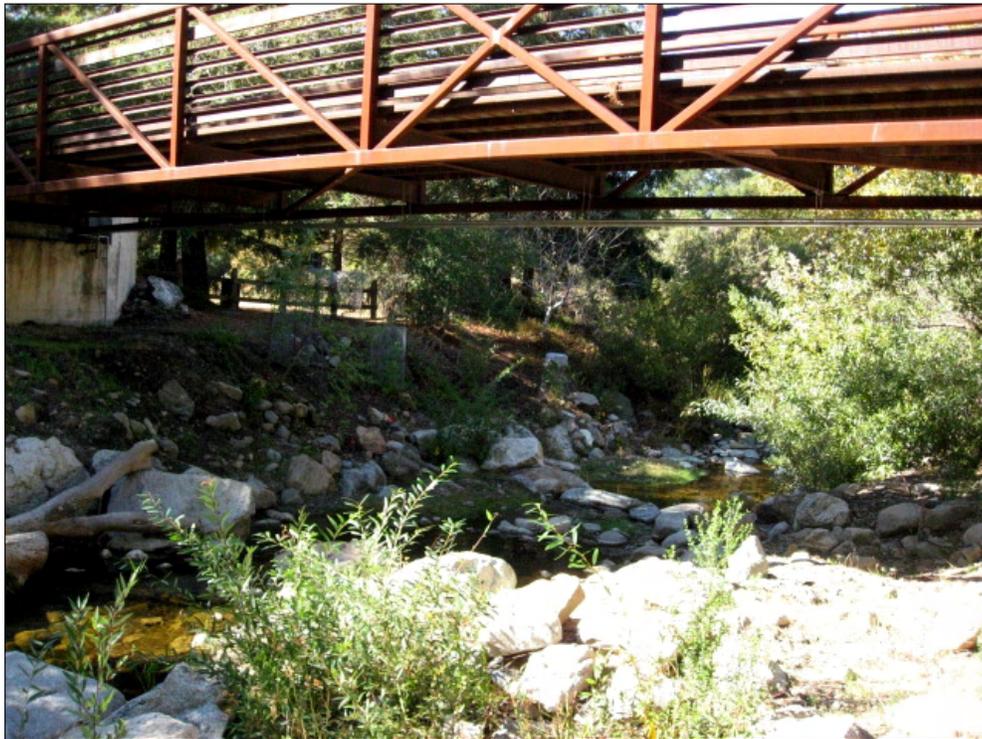
Photo Point 1: Photo taken on November 6, 2008 looking southwest at rock weirs and southwestern bank.

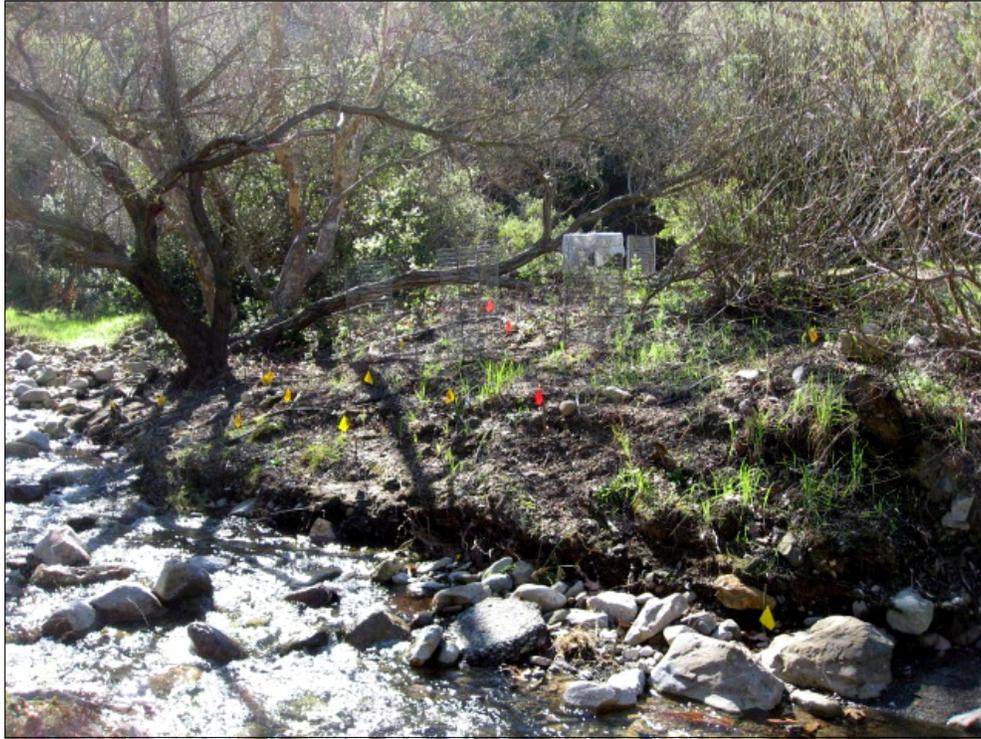
Photo Point 1: Photo taken on February 14, 2008 looking southeast at southeastern bank.

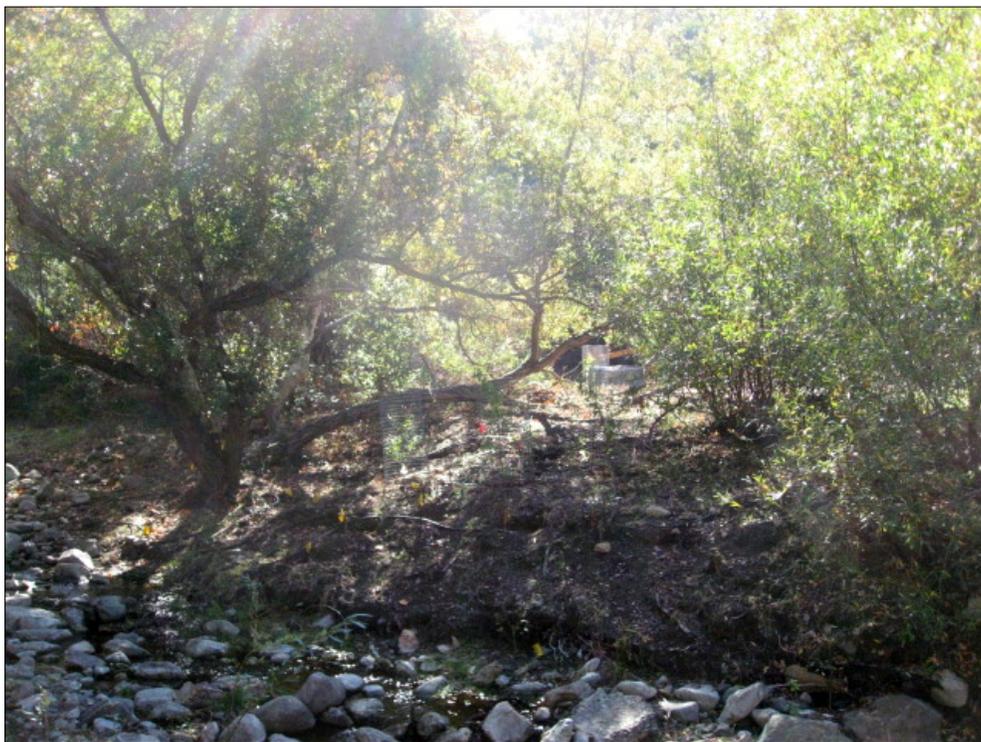
Photo Point 1: Photo taken on November 6, 2008 looking southeast at southeastern bank.

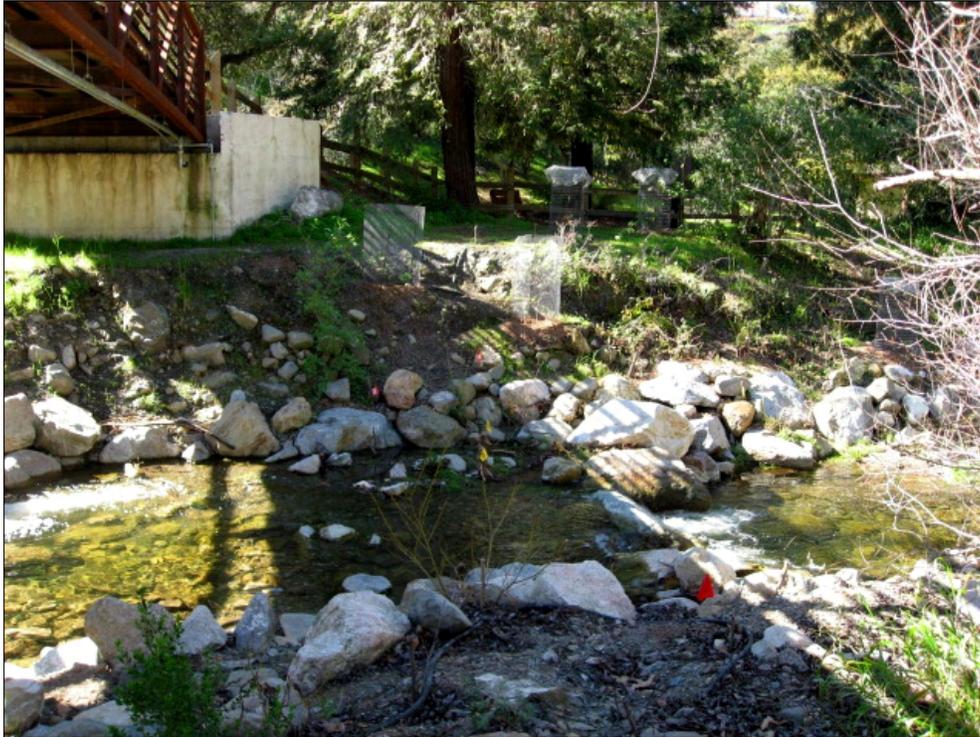
Photo Point 2: Photo taken on February 14, 2008 looking south at southwest bank.

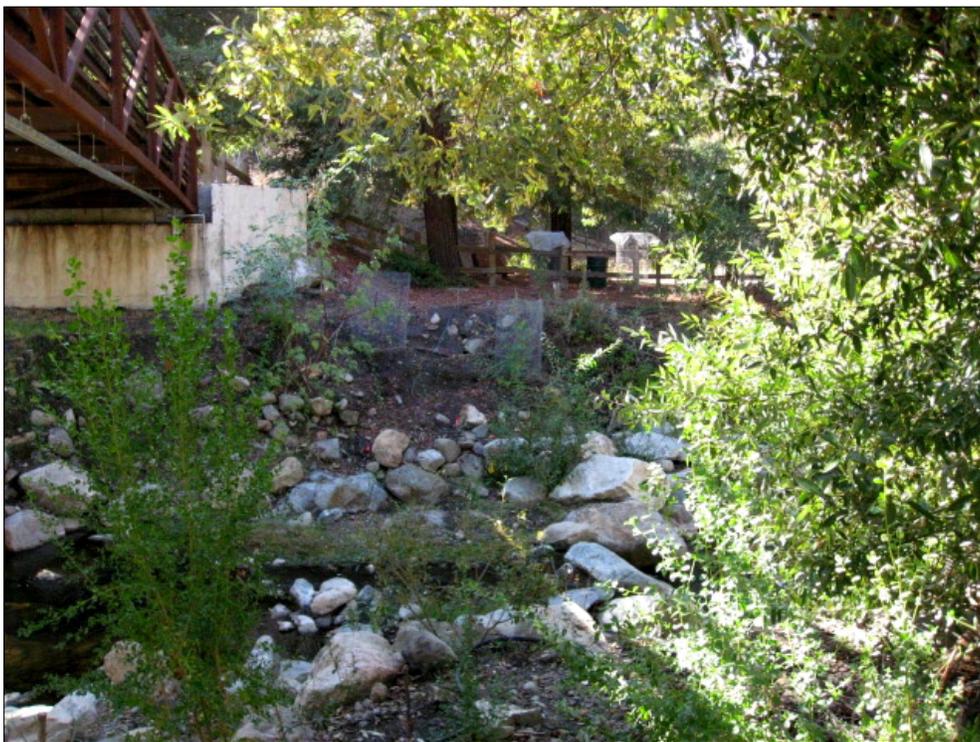
Photo Point 2: Photo taken on November 6, 2008 looking south at southwest bank.

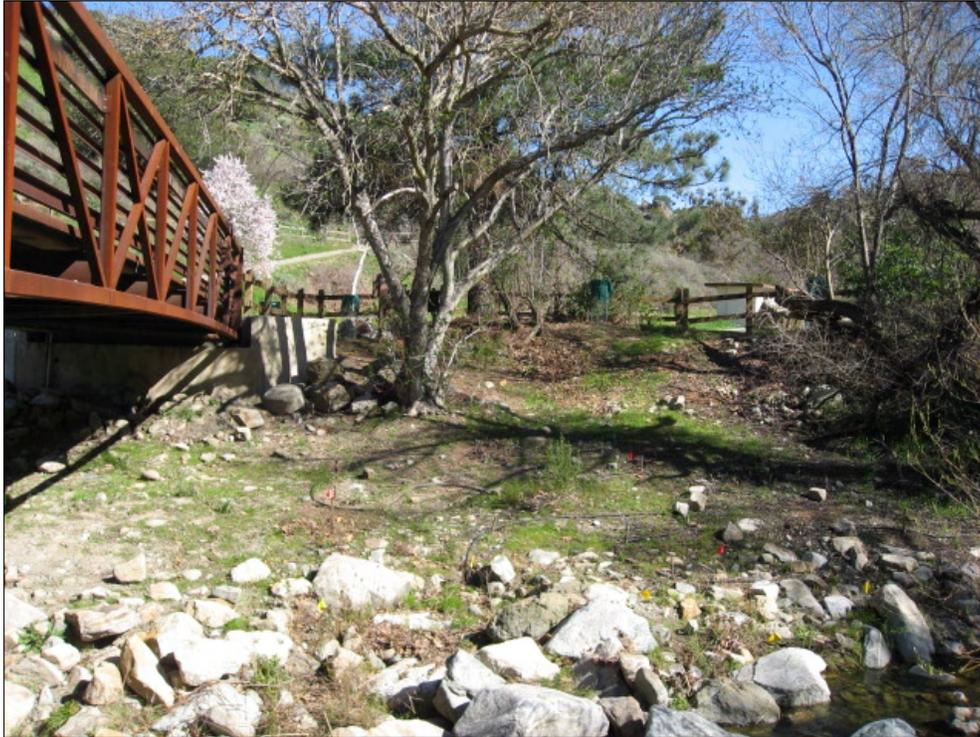
Photo Point 3: Photo taken on February 14, 2008 looking north at northeastern bank.

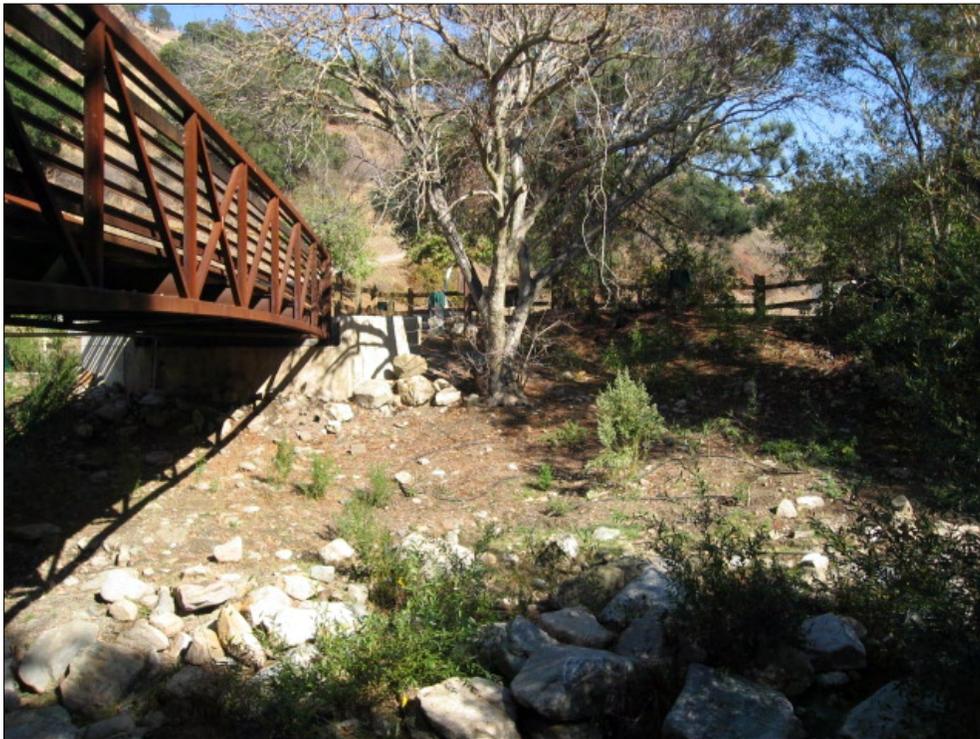
Photo Point 3: Photo taken on November 6, 2008 looking north at northeastern bank.

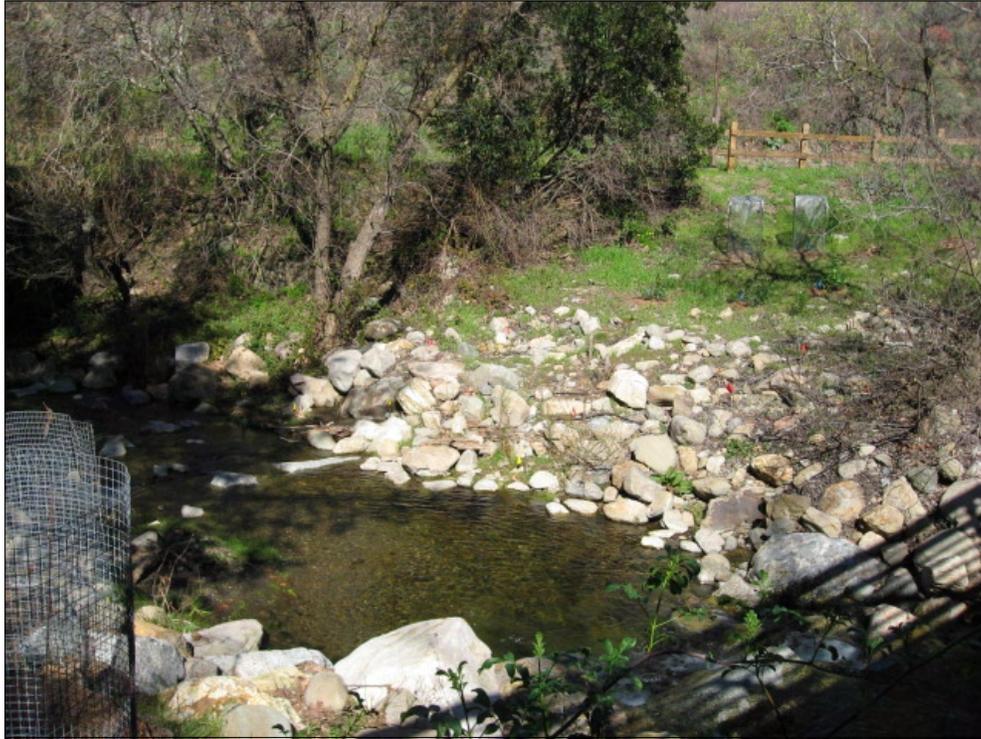
Photo Point 4: Photo taken on February 14, 2008 looking northwest at northwestern bank.

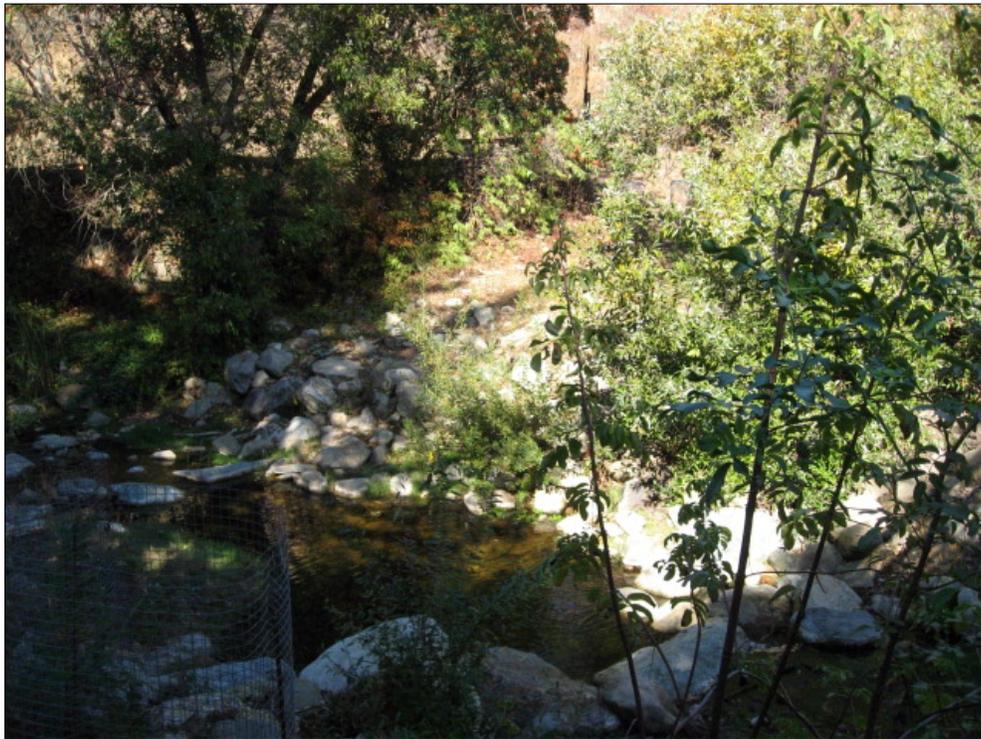
Photo Point 4: Photo taken on November 6, 2008 looking northwest at northwestern bank.

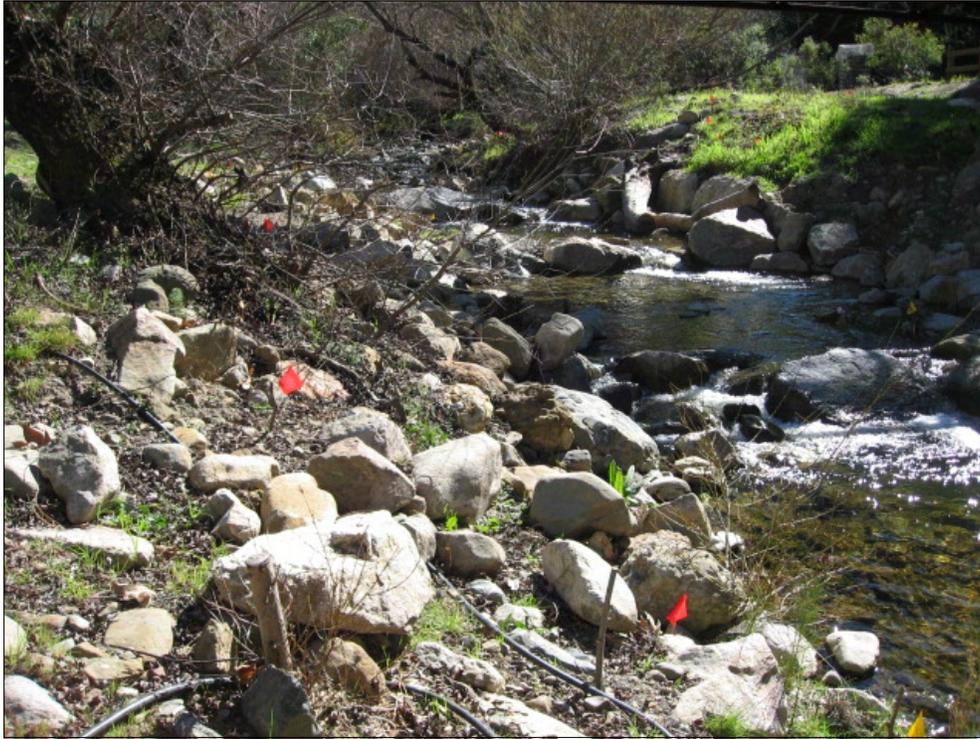
Photo Point 5: Photo taken on February 14, 2008 looking east at northwestern bank.

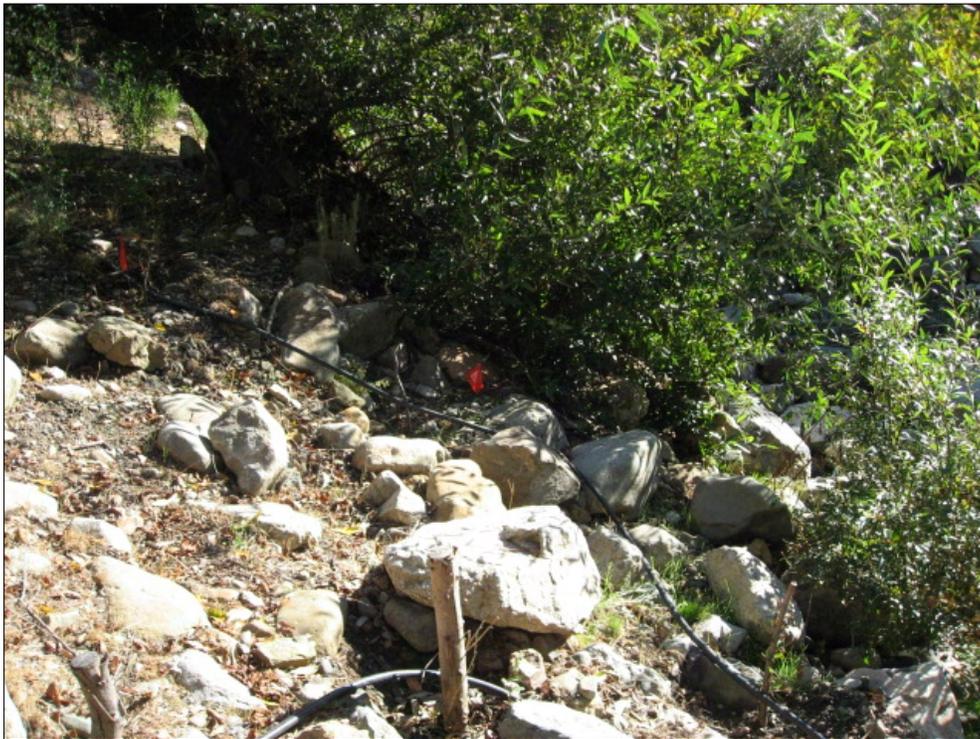
Photo Point 5: Photo taken on November 6, 2008 looking east at northwestern bank.
