LIVE OAK ASSOCIATES, INC.

CINNABAR HILLS GOLF CLUB YEARS 1-7 RIPARIAN MONITORING REPORT

December 17, 2007

PN 294-07

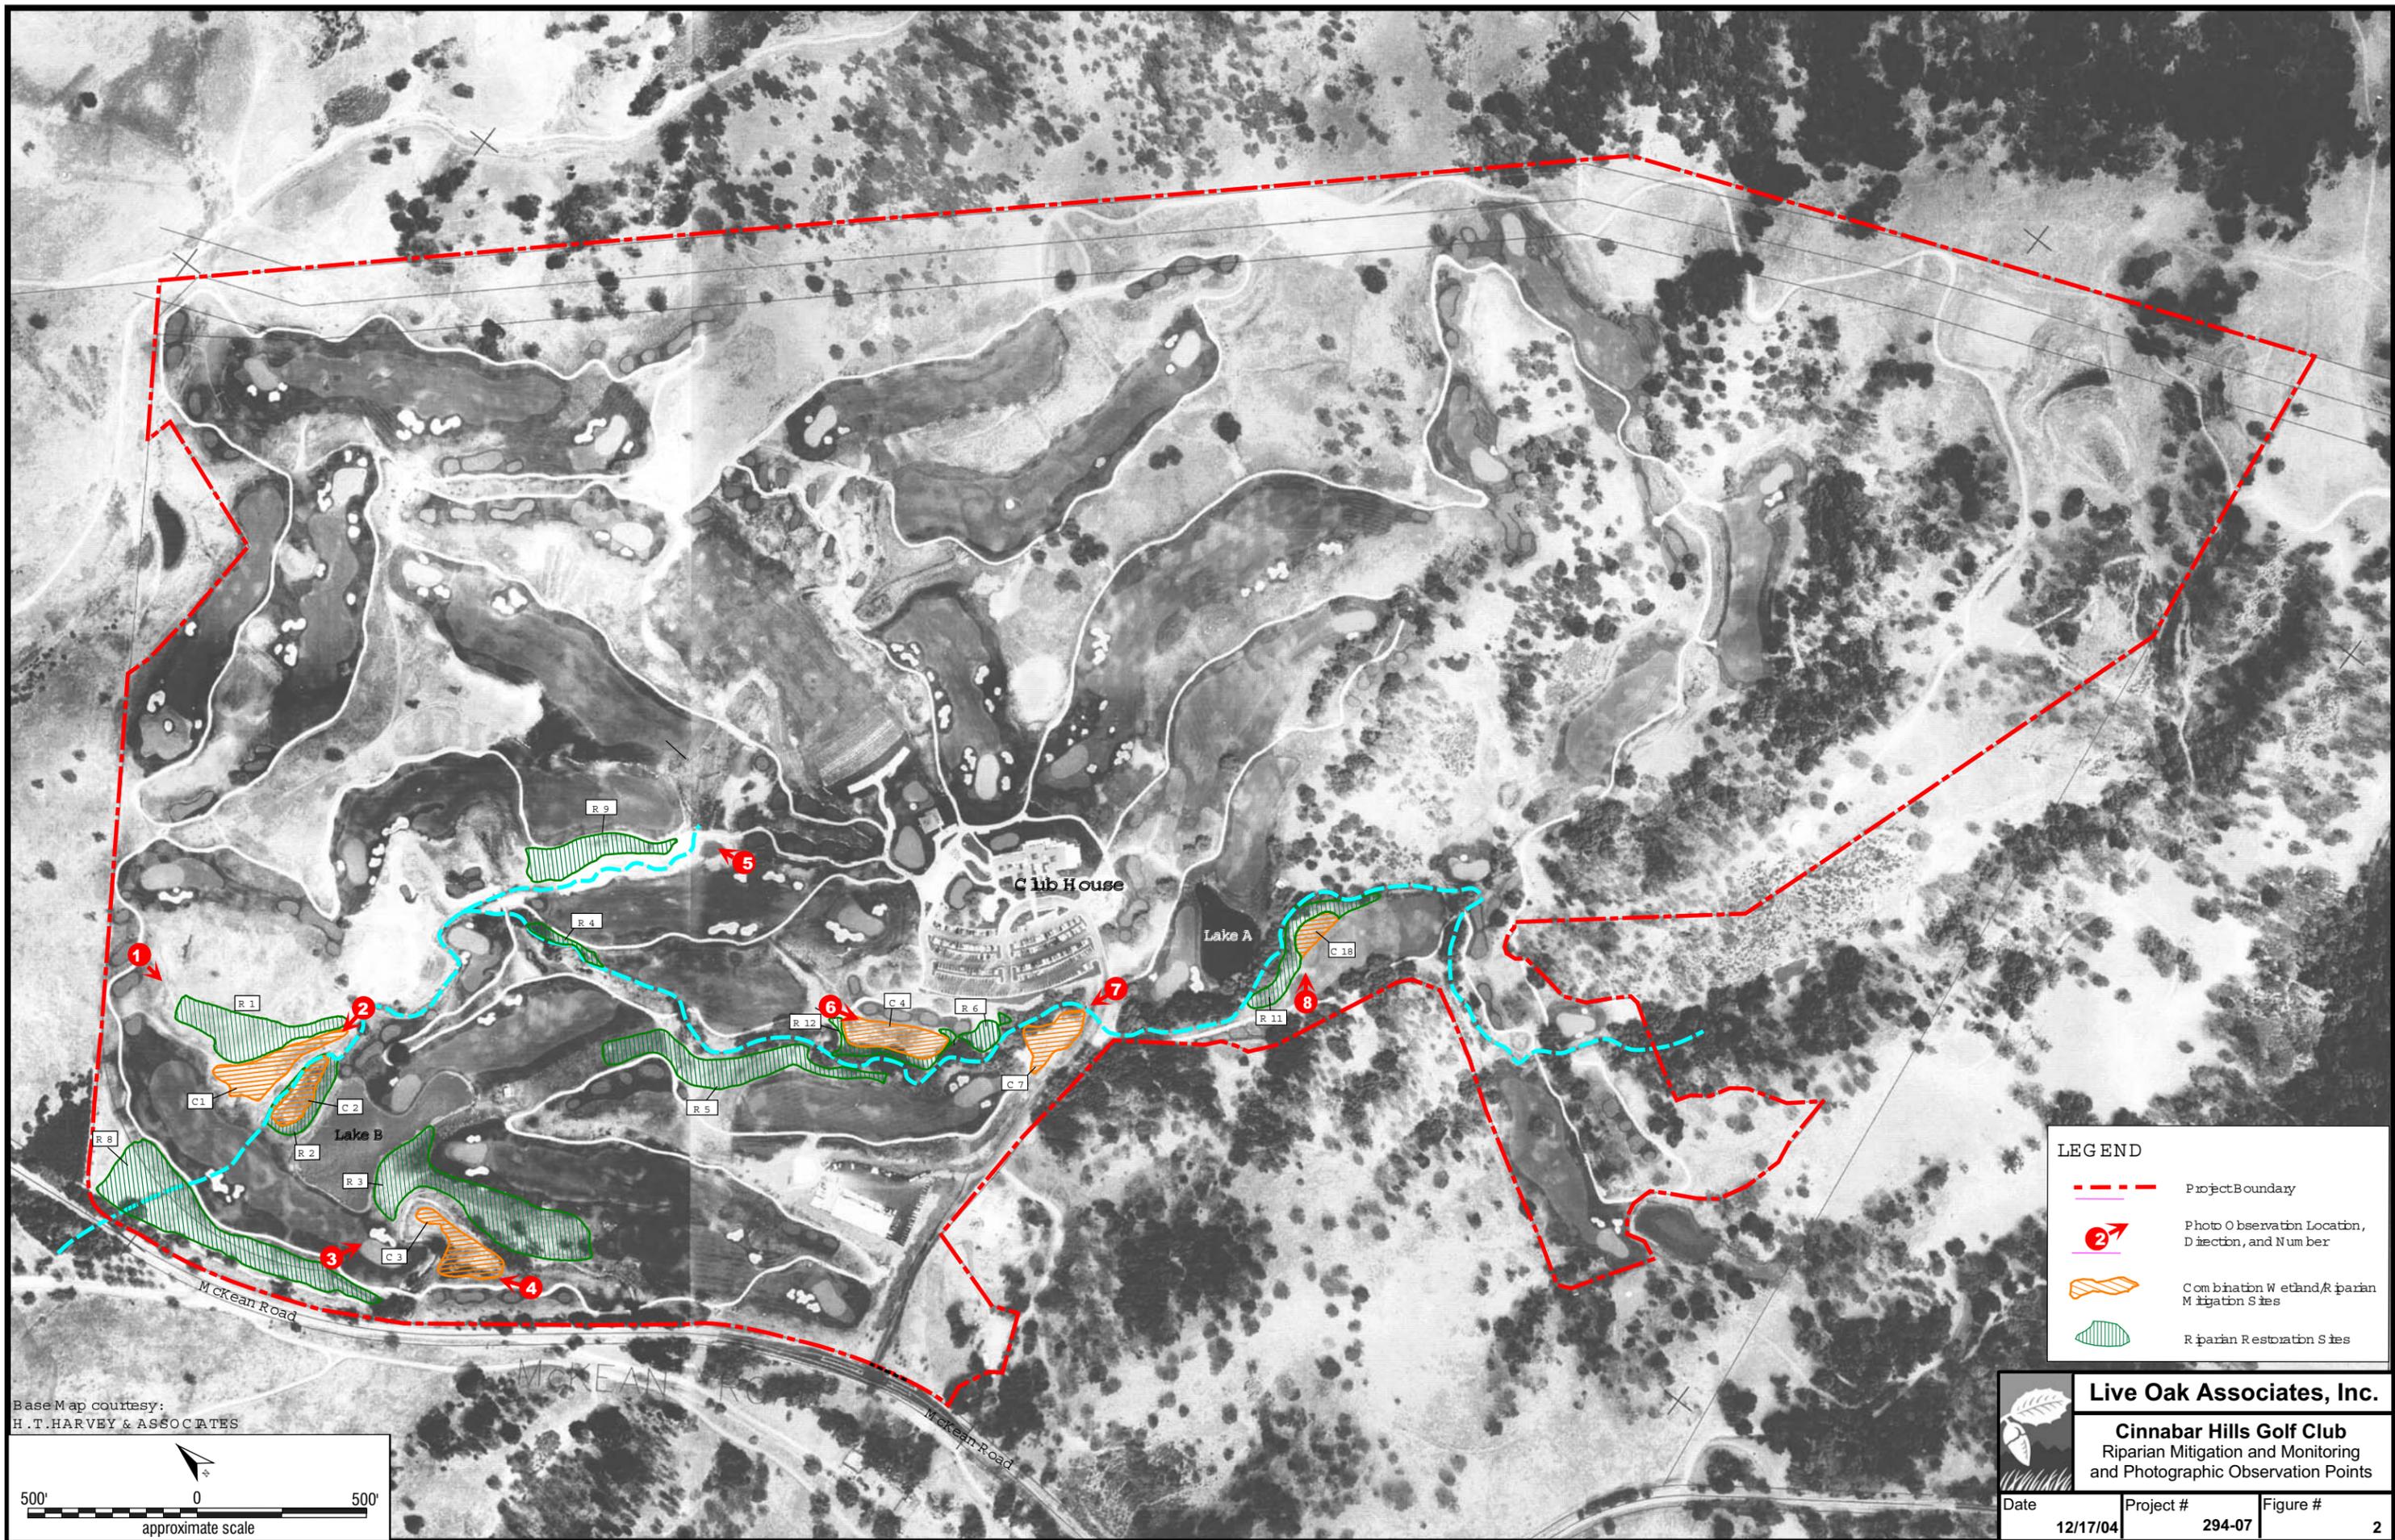
Date	Project #	Figure #
12/17/04	294-07	2

Cinnabar Hills Golf Club
Riparian Mitigation and Monitoring
and Photographic Observation Points

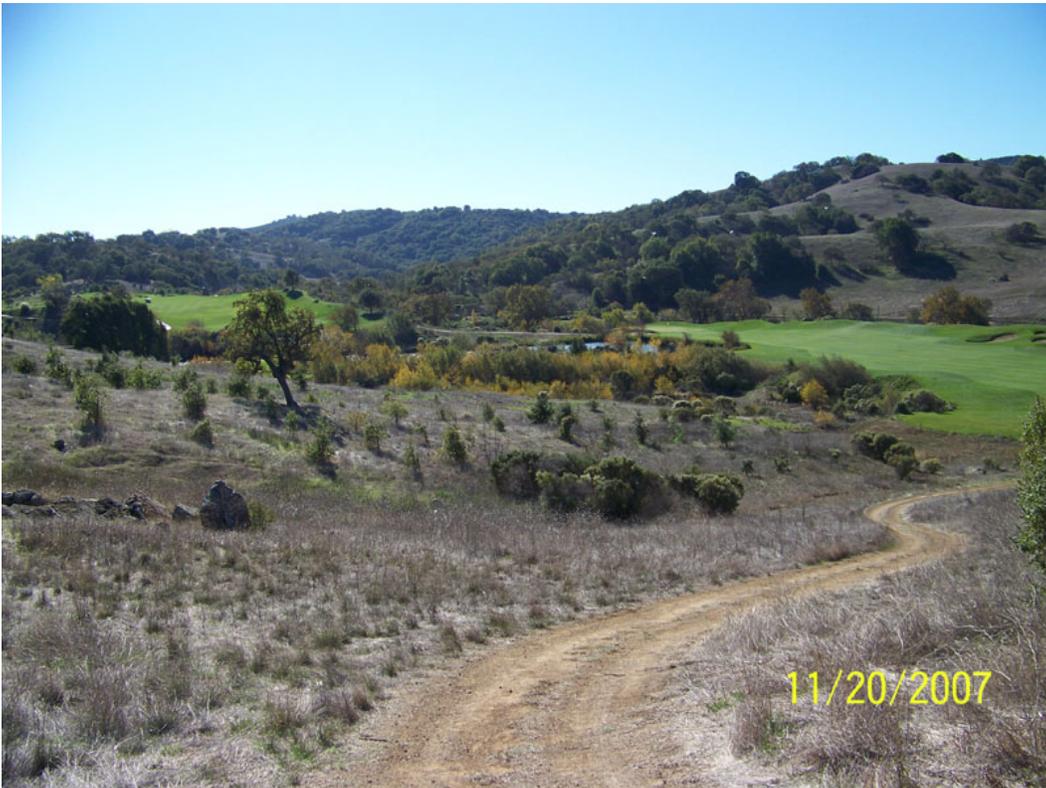
Site R1 (Year 6)

In 2007, a number of valley oaks and coast live oaks near the base of the slope of R1 appeared to be dead or dying during this year’s monitoring. This is likely due to a combination of suboptimal soil conditions and microclimate. While the site had greater than 80% survivorship, it does not achieve a continuous riparian canopy cover with the adjacent site C1. Therefore, we will recommend replanting trees at the base of the slope. The irrigation system in this mitigation

In addition to sites C3 and R8, we recommend replanting the dead oaks at the base of the slope of R1 with a mix of valley oaks and coast live oaks (Table 11). The irrigation system and schedule should be closely monitored at this site. This planting recommendation is optional but strongly recommended in order to maintain a continuous riparian canopy cover with the adjacent site C1. If the continuous canopy cover is not achieved, the California Department of Fish and Game, the agency that will sign off on the riparian mitigation, may not count this site towards the overall necessary riparian mitigation acreage once the ten-year monitoring is complete.
