**Old Oakland Road Habitat Mitigation Project
Story Road Mitigation Site #2**

Year 6 (2010) Monitoring Report

HABITAT MITIGATION MONITORING REPORT

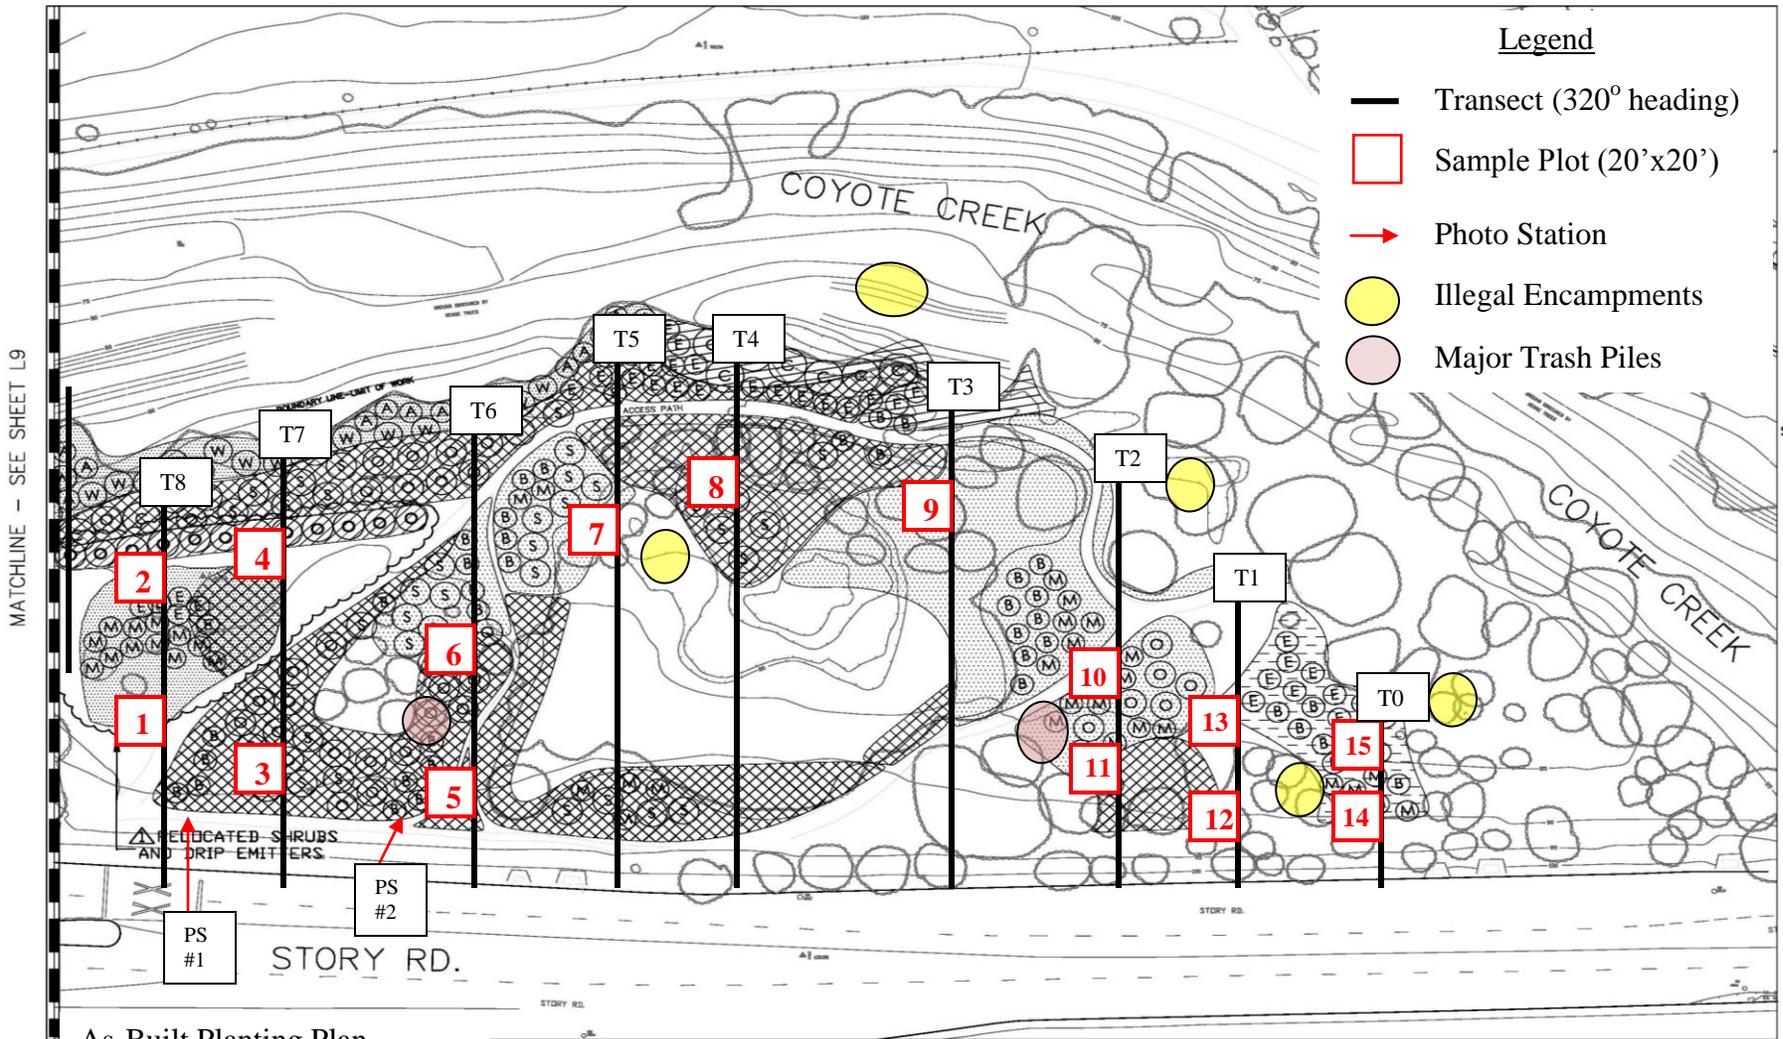
As-Built Planting Plan
 Source: Central Coast Wilds, 2005

The mitigation area was also evaluated as to site maintenance and other disturbances. Photographs documenting each the permanent sampling plots and the overall condition of the mitigation plantings were taken. Two photo stations established in 2005 were re-photographed in 2010. The location of the photo stations is depicted on Figure 2.

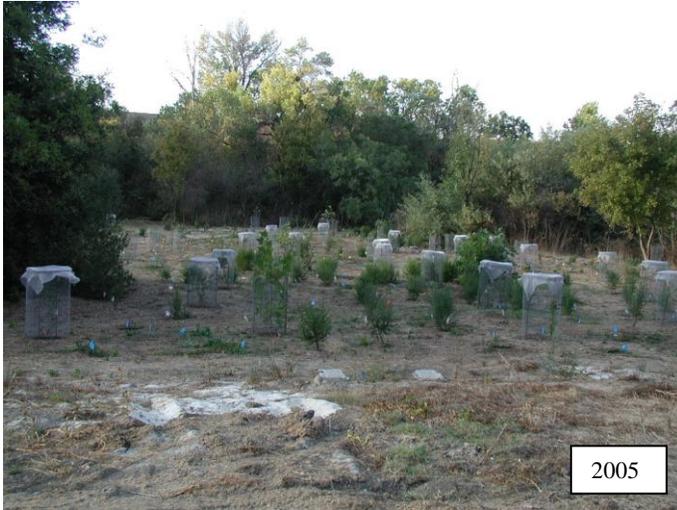
Figure 3. View of westernmost portion of riparian planting area, Year 1 - October 2005. (Photo station #1)

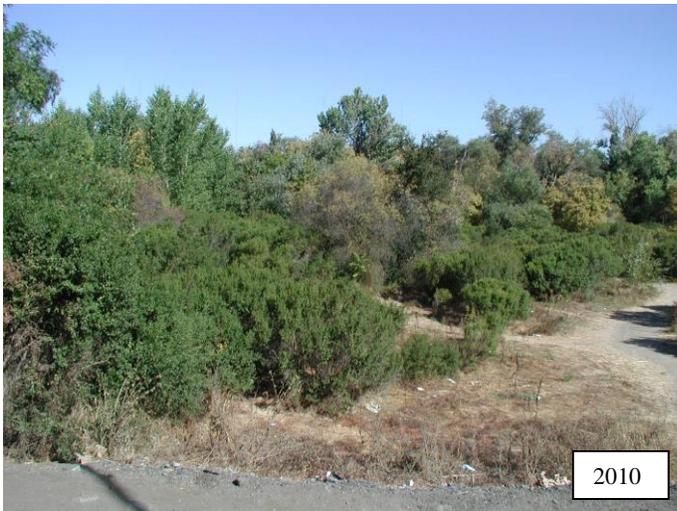
The reconnaissance inspections of the mitigation area documented the status of plant growth and maintenance activities, as well as the general progress of the revegetation efforts. Figures 3 and 4 depict the typical condition of the planting area and development of the riparian habitat between Year 1 (October 2005) and Year 6 (August 2010).

Figure 4. View of westernmost portion of riparian planting area, Year 5 - September 2010. (Photo station #1)

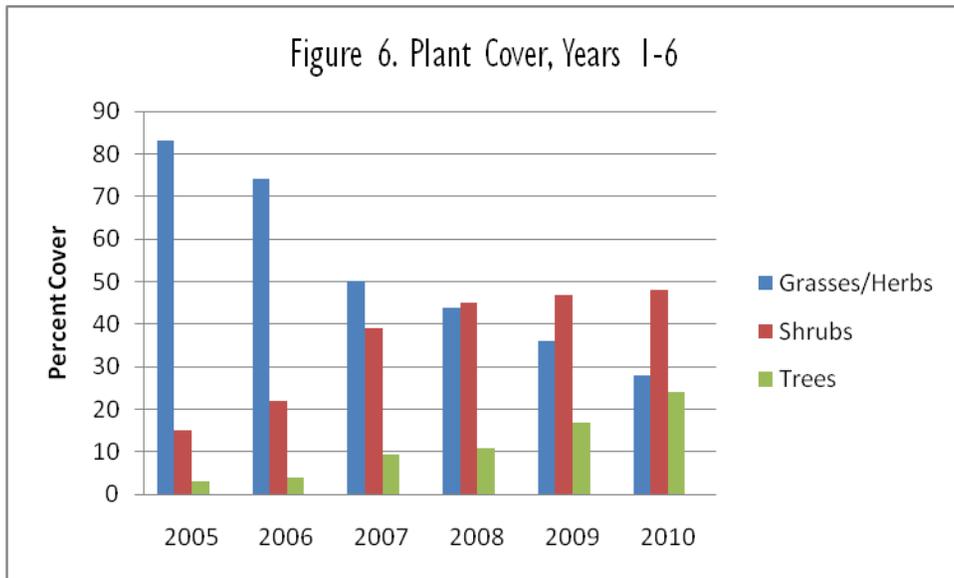
Figure 6 displays the trend in increasing shrub and tree cover since plant installation. Photographs of each sampling plot, with a comparison to the Year 1 (2005) condition, are depicted in Figures 7-21.

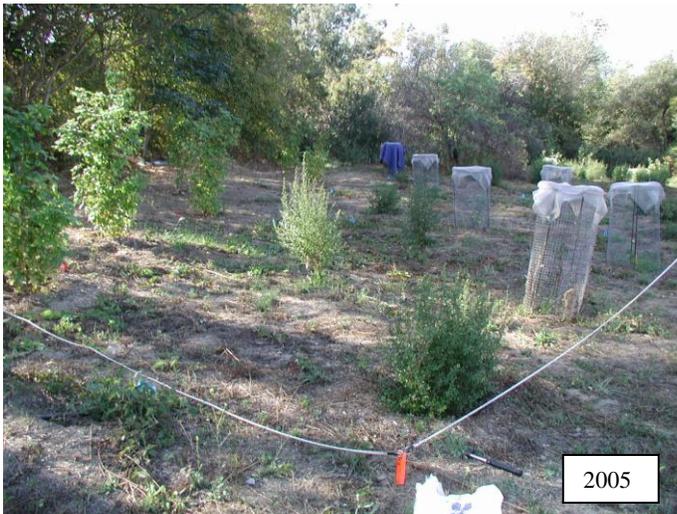
Figure 7A. View of Sample Plot 1, October 2005. Sample plot contains 7 plants; 3 coyote brush, 1 blackberry and 2 box elders. One empty planting area was noted. Herbaceous/bare cover is 80%; shrub cover is 10% and tree cover is 10%.

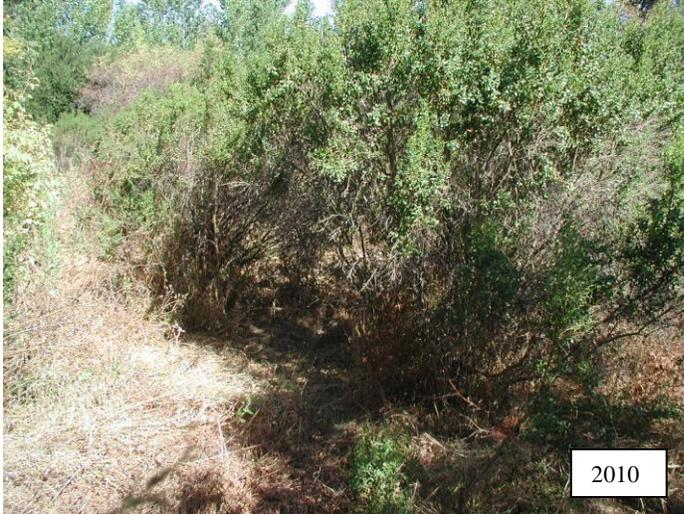
Figure 7B. View of Sample Plot 1, September 2010. Herbaceous/bare cover is 20%; shrub cover is 63% and tree cover is 50%. Natural recruitment by coyote brush and coast live oak.

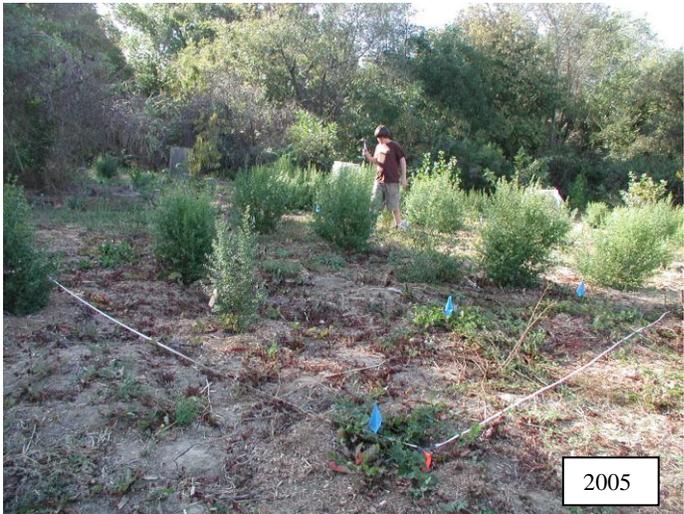
Figure 8A. View of Sample Plot 2, October 2005. Sample plot contains 14 plants consisting of 7 blackberries and 7 coyote brush. Herbaceous/bare cover is 60%; shrub cover is 40% and tree cover is 0%.

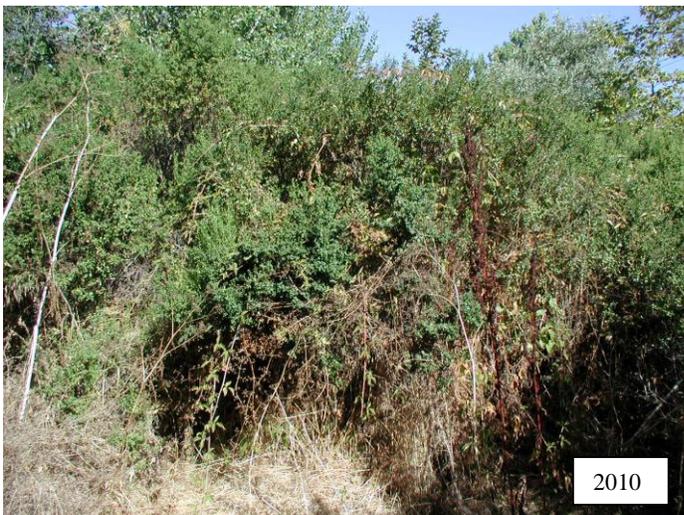
Figure 8B. View of Sample Plot 2, September 2010. Herbaceous/bare cover is 10%; shrub cover is 60% and tree cover is 30%.

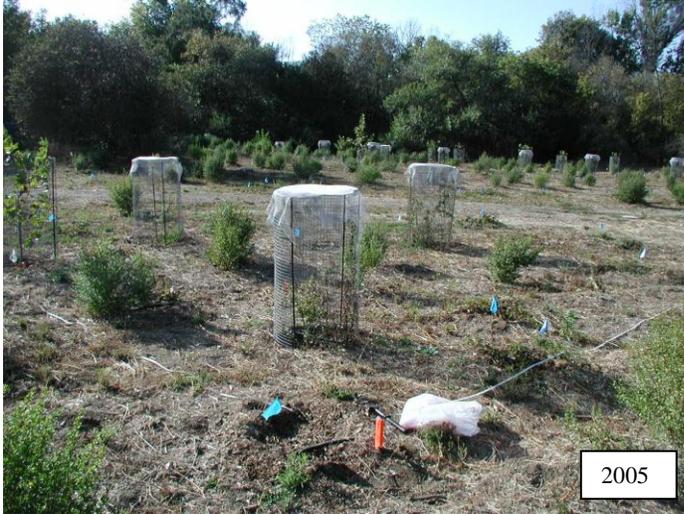
Figure 9A. View of Sample Plot 3, October 2005. Sample plot contains 10 plantings, consisting of 4 coyote brush, 2 coast live oaks, 3 blackberries and 1 sycamore. Herbaceous/bare cover is 79%; shrub cover is 20% and tree cover is 1%.

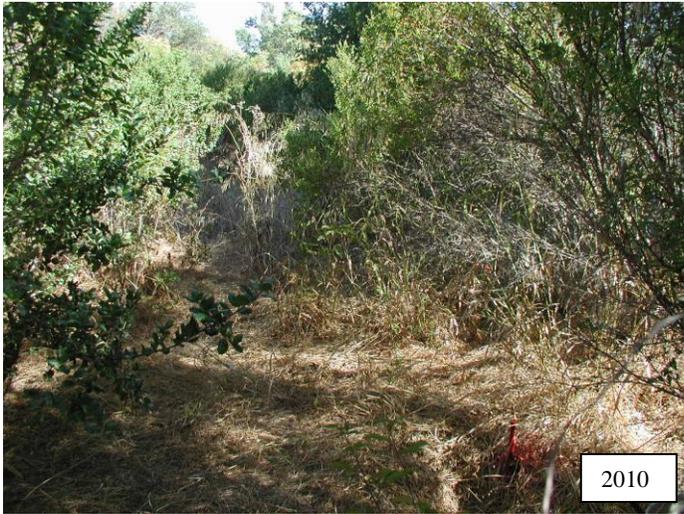
Figure 9B. View of Sample Plot 3, September 2010. Herbaceous/bare cover is 10%; shrub cover is 60% and tree cover is 30%. Natural recruitment of coast live oak.

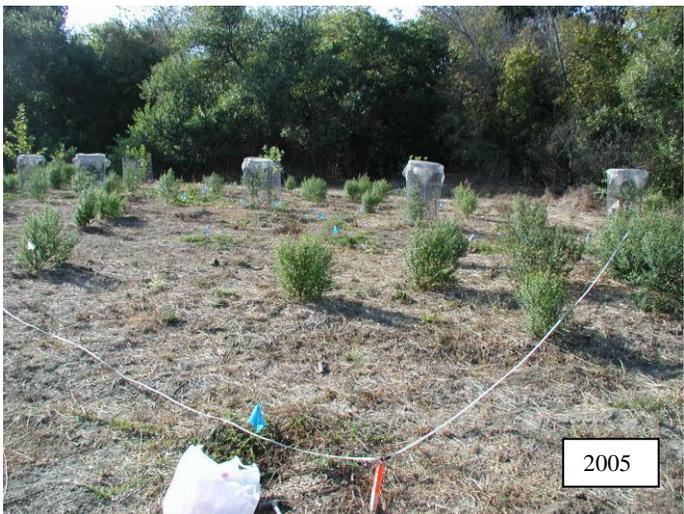
Figure 10A. View of Sample Plot 4, October 2005. Sample plot contains 7 plantings, consisting of 7 coyote brush. Herbaceous/bare cover is 60%; shrub cover is 40% and tree cover is 0%.

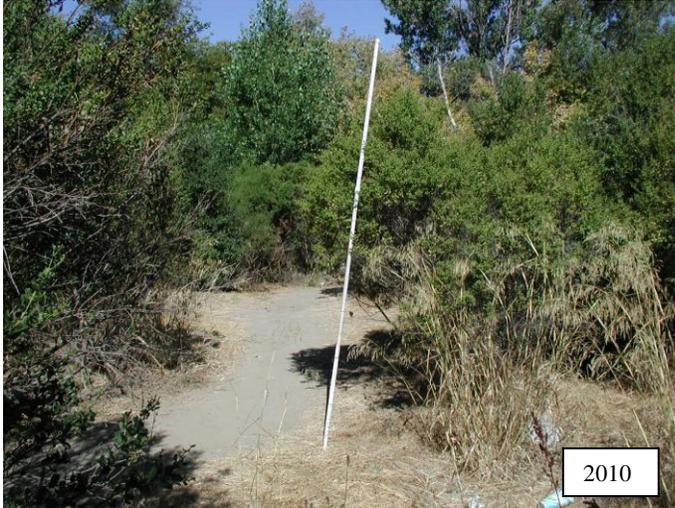
Figure 10B. View of Sample Plot 4, August 2009. Herbaceous/bare cover is 30%; shrub cover is 65% and tree cover is 5%. Natural recruitment of coyote brush. A foot trail traverses this area.

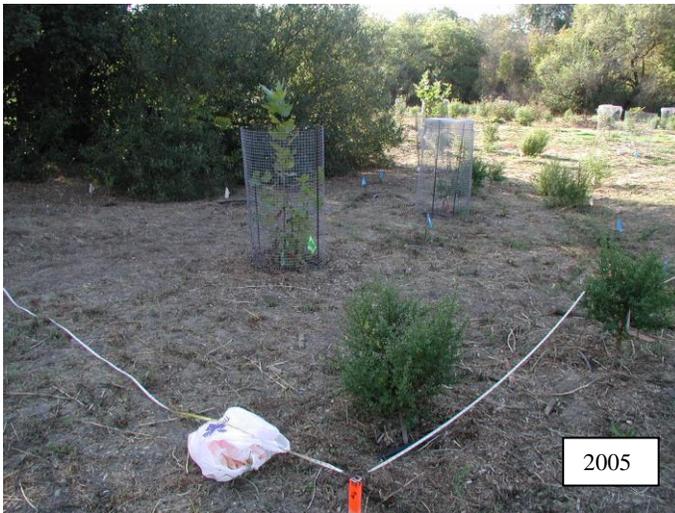
Figure 11A. View of Sample Plot 5, October 2005. Sample plot contains 5 plantings, consisting of 1 coyote brush, 1 blackberry, 1 coast live oak, 1 willow and 1 sycamore. Herbaceous/bare cover is 94%; shrub cover is 5% and tree cover is 1%.

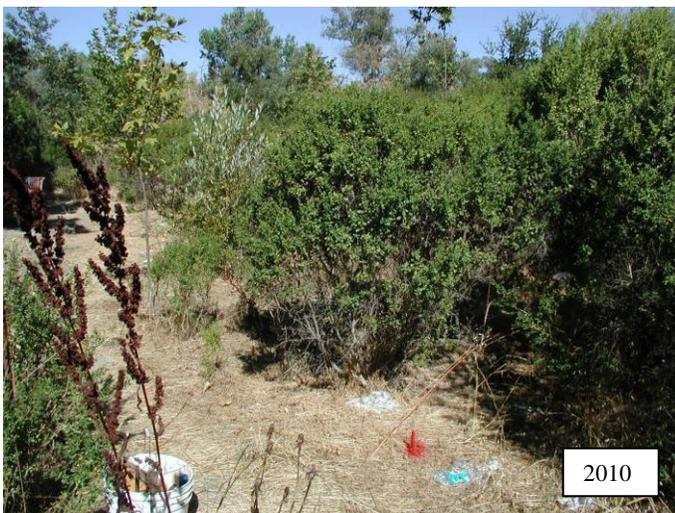
Figure 11B. View of Sample Plot 5, September 2010. Herbaceous/bare cover is 10%; shrub cover is 60%, tree cover is 30%. Natural recruitment by coyote brush and coast live oak.

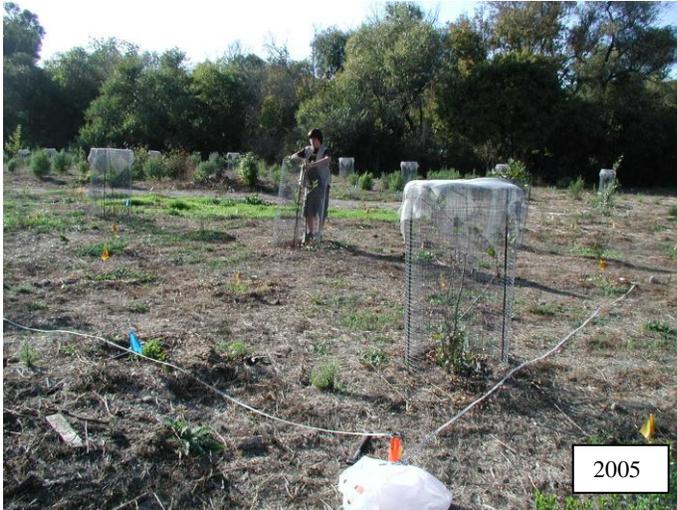
Figure 12A. View of Sample Plot 6, October 2005. Sample plot contains 10 plantings, consisting of 1 blackberry, 3 sycamore, 4 snowberry and 2 empty sites. Herbaceous/bare cover is 98%; shrub cover is 1% and tree cover is 1%.

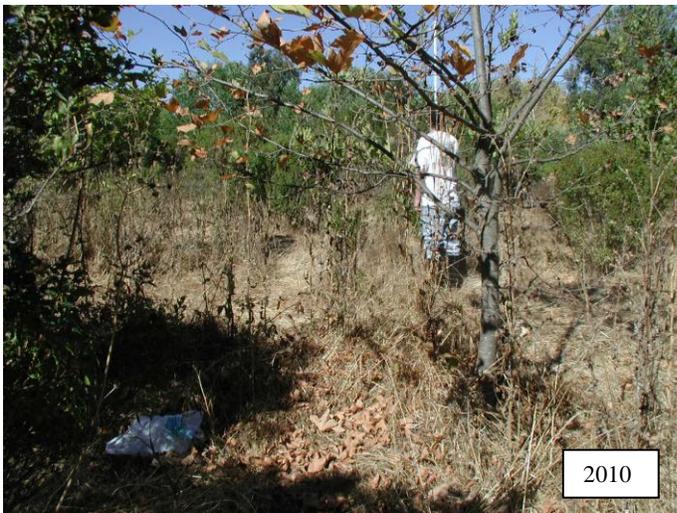
Figure 12B. View of Sample Plot 6, September 2010. Herbaceous/bare cover is 30%; shrub cover is 40% and tree cover is 30%. Natural recruitment by coast live and coyote brush.

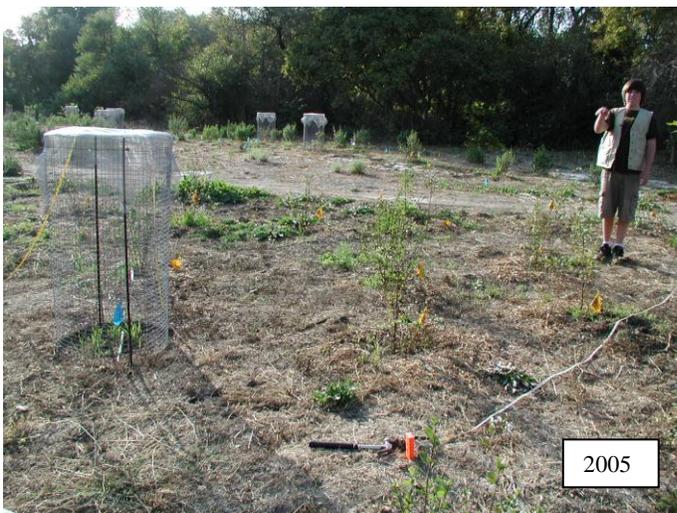
Figure 13A. View of Sample Plot 7, October 2005. Sample plot contains 9 plantings, consisting of 9 snowberries. Herbaceous/bare cover is 80%; shrub cover is 20% and tree cover is 0%.

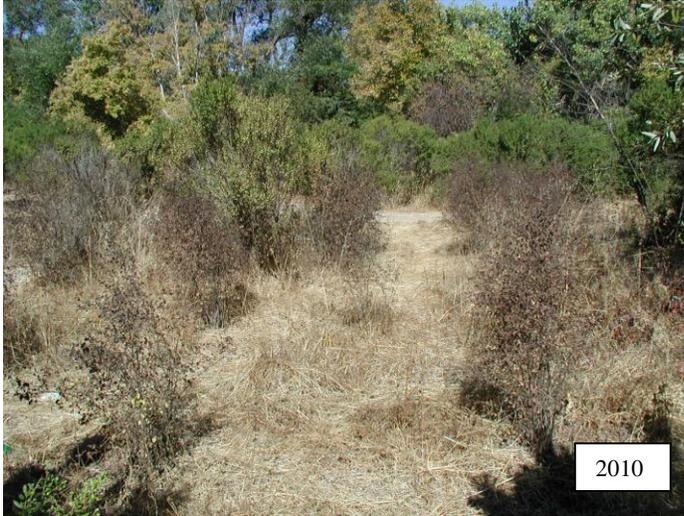
Figure 13B. View of Sample Plot 7, September 2010. Herbaceous/bare cover is 40%; shrub cover is 60% and tree cover is 0%. Snowberry affected by summer drought stress.

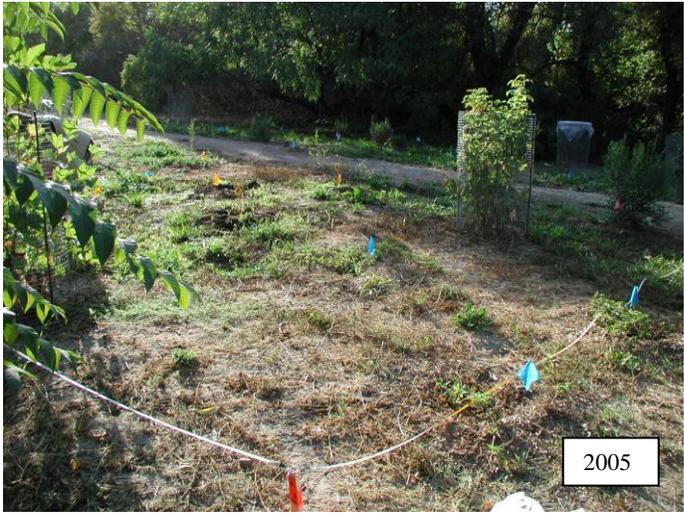
Figure 14A. View of Sample Plot 8, October 2005. Sample plot contains 5 plantings, consisting of 1 box elder, 3 snowberries and 1 sycamore. Herbaceous/bare cover is 94%; shrub cover is 1% and tree cover is 5%.

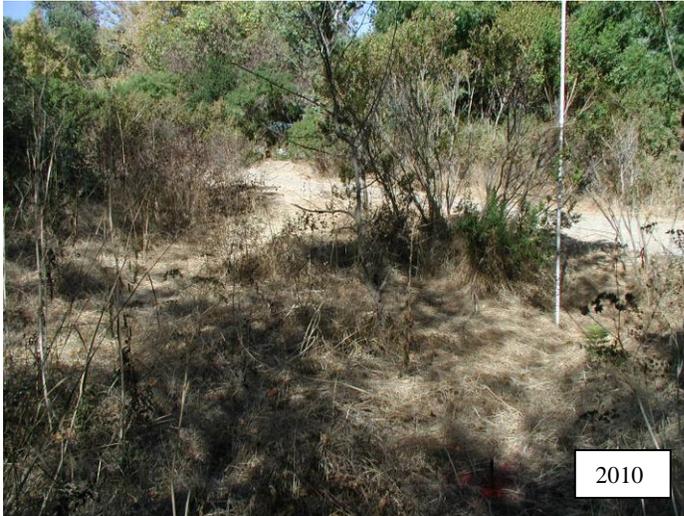
Figure 14B. View of Sample Plot 8, September 2010. Herbaceous/bare cover is 10%; shrub cover is 60% and tree cover is 30%. Natural recruitment by coyote brush.

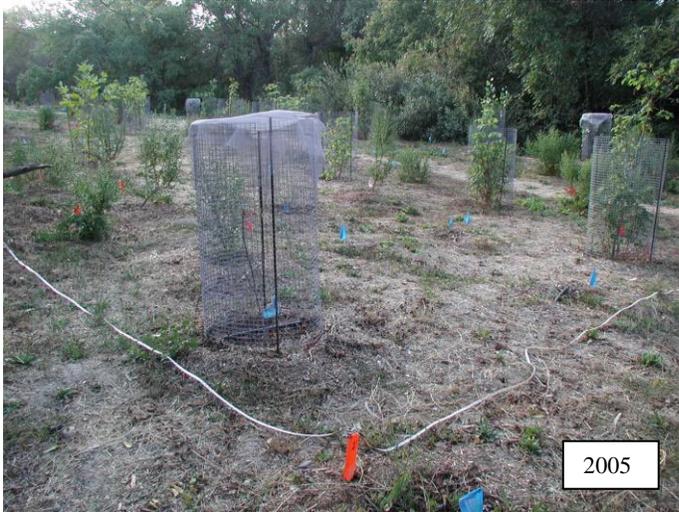
Figure 15A. View of Sample Plot 9, October 2005. Sample plot contains 10 plantings, consisting of 2 buckeyes, 2 blackberries, 1 box elder, 4 coyote brush and 1 empty site. Herbaceous/bare cover is 79%; shrub cover is 20% and tree cover is 1%.

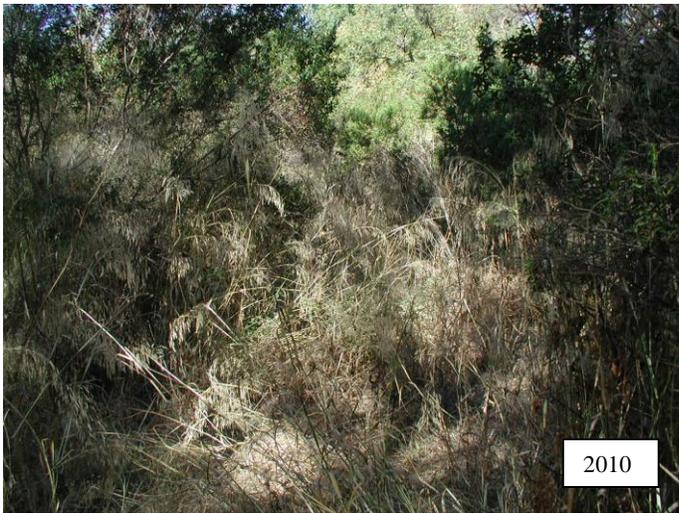
Figure 15B. View of Sample Plot 9, September 2010. Herbaceous/bare cover is 10%; shrub cover is 60% and tree cover is 30%. Grass growth has covered former pathways.

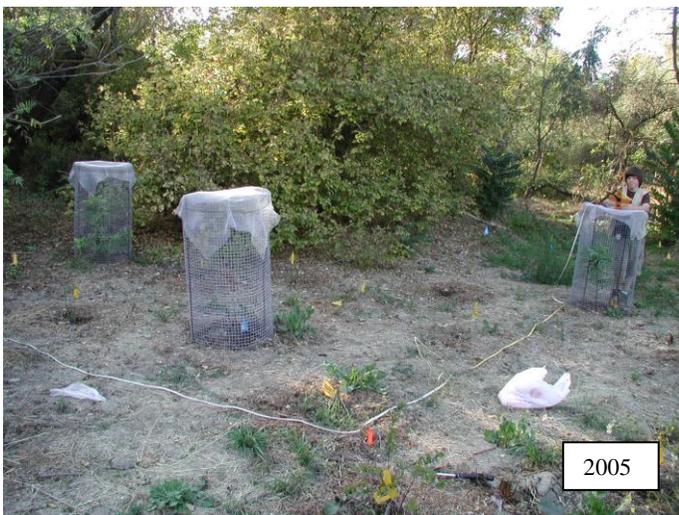
Figure 16A. View of Sample Plot 10, October 2005. Sample plot contains 11 plantings, consisting of 5 snowberry, 1 coyote brush, 1 blue elderberry, 1 buckeye and 3 empty sites. Herbaceous/bare cover is 90%; shrub cover is 5% and tree cover is 5%.

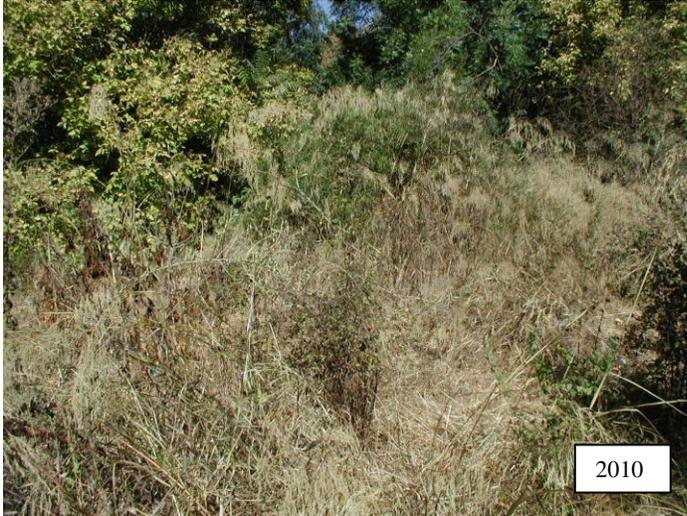
Figure 16B. View of Sample Plot 10, September 2010. Herbaceous/bare cover is 20%; shrub cover is 60% and tree cover is 20%. Natural recruitment by California blackberry and box elder.

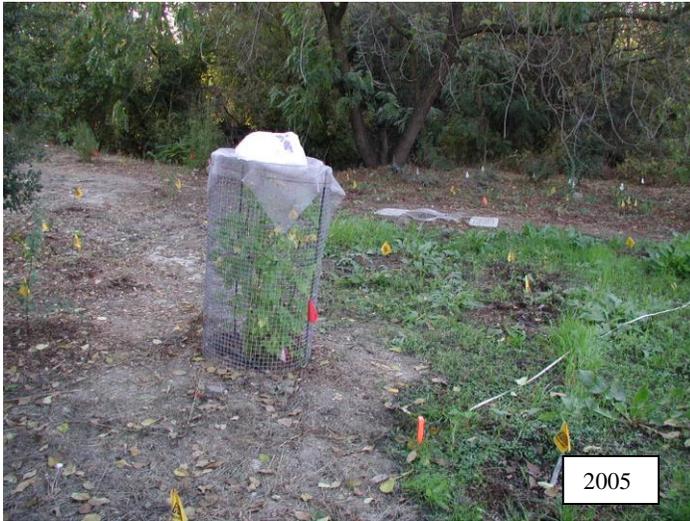
Figure 17A. View of Sample Plot 11, October 2005. Sample plot contains 8 plantings, consisting of 1 box elder, 6 snowberries and 1 empty site. Herbaceous/bare cover is 90%; shrub cover is 5%, tree cover is 5%.

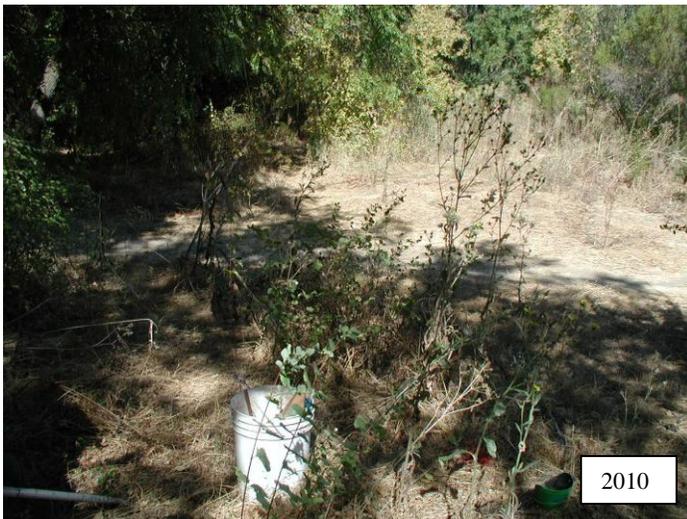
Figure 17B. View of Sample Plot 11, September 2010. Herbaceous/bare cover is 40%; shrub cover is 40%, tree cover is 20%. Natural recruitment by snowberry.

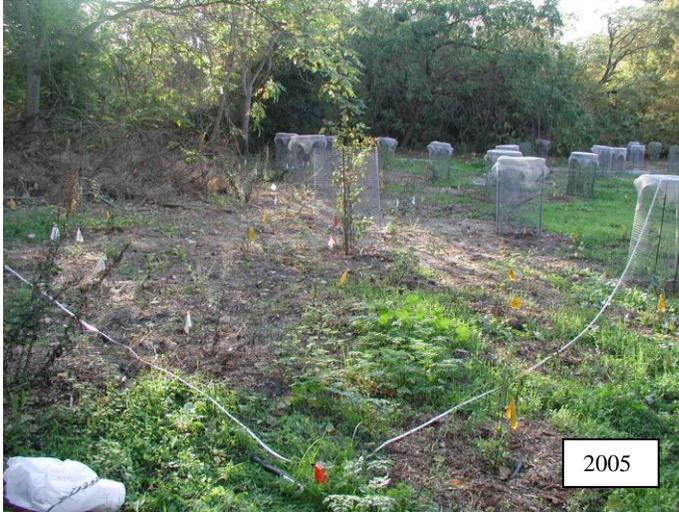
Figure 18A. View of Sample Plot 12, October 2005. Sample plot contains 12 plantings, consisting of 2 mugwort, 7 snowberries, 1 box elder, 1 buckeye and 1 empty site. Herbaceous/bare cover is 89%; shrub cover is 10%, tree cover is 1%.

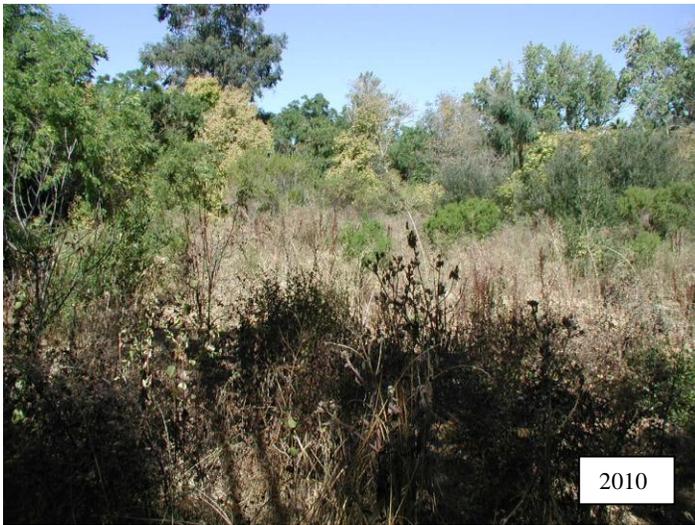
Figure 18B. View of Sample Plot 12, September 2010. Herbaceous/bare cover is 10%; shrub cover is 60%, tree cover is 30%.

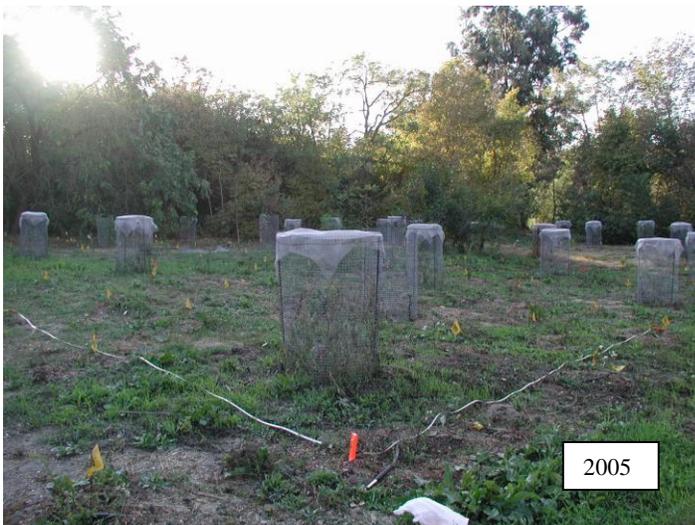
Figure 19A. View of Sample Plot 13, October 2005. Sample plot contains 10 plantings, consisting of 5 snowberries, 1 coast live oak, 1 blue elderberry, 1 box elder, 1 coyote brush and 1 empty site. Herbaceous/bare cover is 94%; shrub cover is 5%, tree cover is 1%.

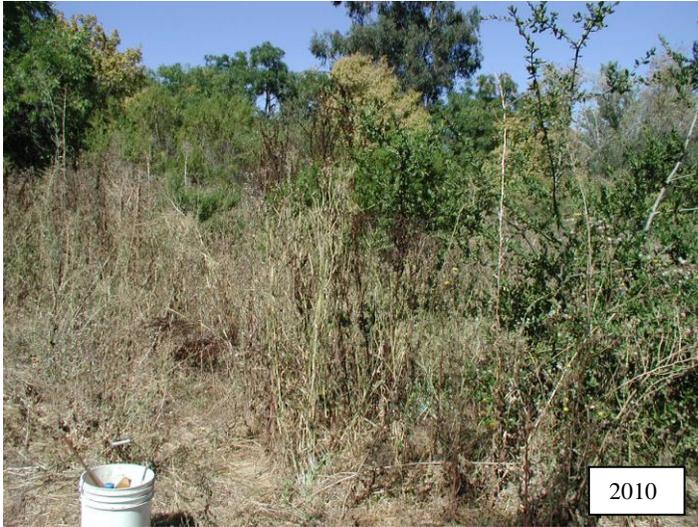
Figure 19B. View of Sample Plot 13, September 2010. Herbaceous/bare cover is 40%; shrub cover is 40%, tree cover is 20%. Natural recruitment by coyote brush.

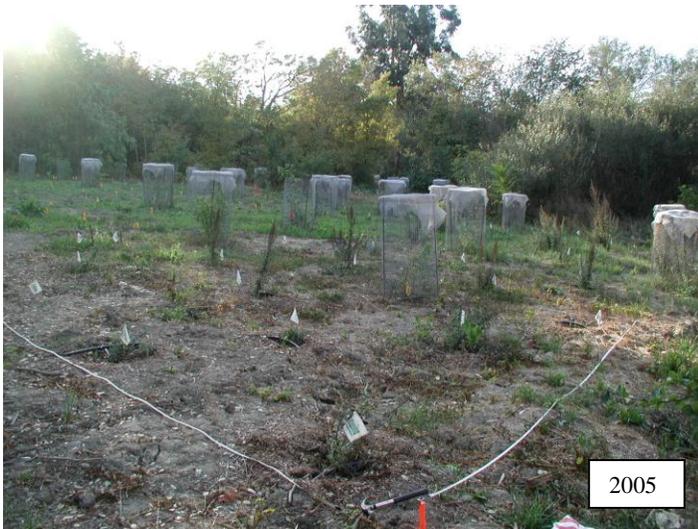
Figure 20A. View of Sample Plot 14, October 2005. Sample plot contains 10 plantings, consisting of 8 mugwort, 1 blue elderberry, and 1 empty site. Herbaceous/bare cover is 90%; shrub cover is 10%, tree cover is 0%.

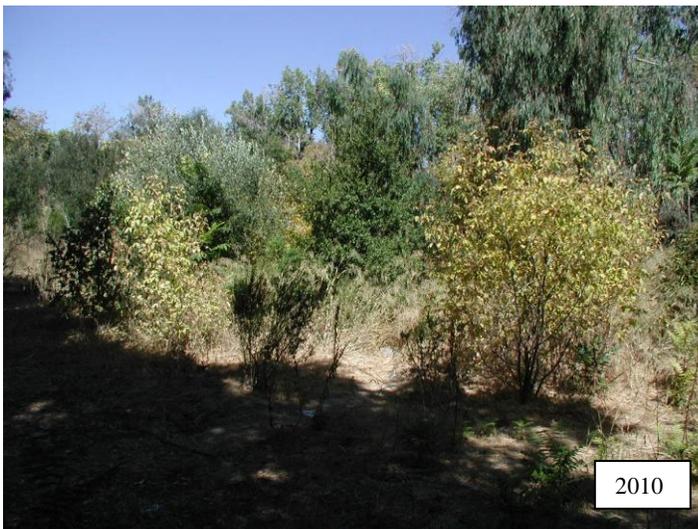
Figure 20B. View of Sample Plot 14, September 2010. Herbaceous cover and bare is 90%; shrub cover is 10%, tree cover is 0%. Weeds include tree-of-heaven seedlings.

Control of Invasive, Non-native Plant Species. The riparian mitigation area is located adjacent to stands of tree-of-heaven, an invasive plant species. Non-native thistles (such as Italian and bull thistle) also occur on and adjacent to the mitigation area. Maintenance actions are needed to remove and control occurrences of these species and other invasive, non-native plant species that establish within the mitigation area to ensure the continued survival of the riparian trees and shrubs and development of the riparian woodland, such that the site meets the Year 7-10 performance standards.

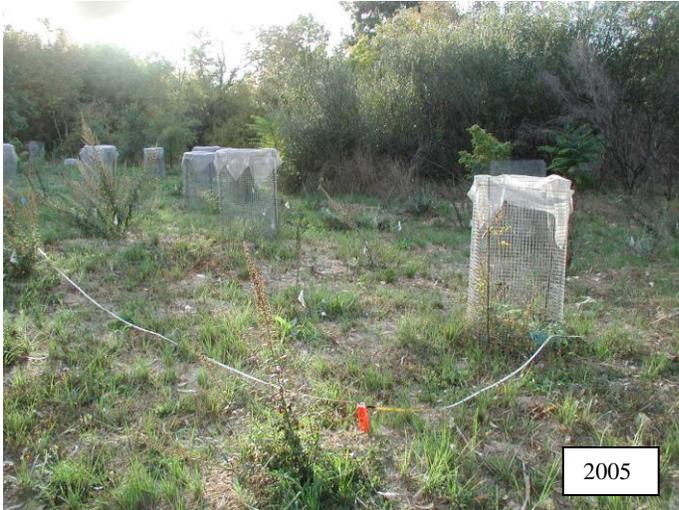
Figure 21A. View of Sample Plot 15, October 2005. Sample plot contains 8 plantings, consisting of 6 mugwort and 2 buckeyes. Herbaceous/bare cover is 60%; shrub cover is 39%, tree cover is 1%.

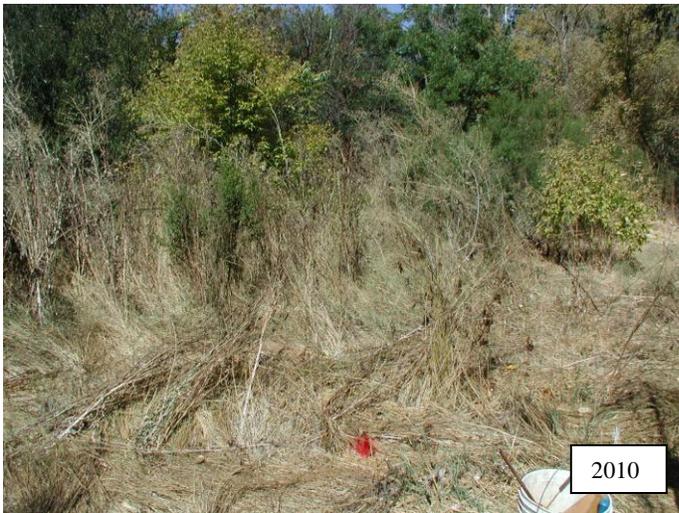
Figure 21B. View of Sample Plot 15, September 2010. Herbaceous/bare cover is 40%; shrub cover is 40%, tree cover is 20%.

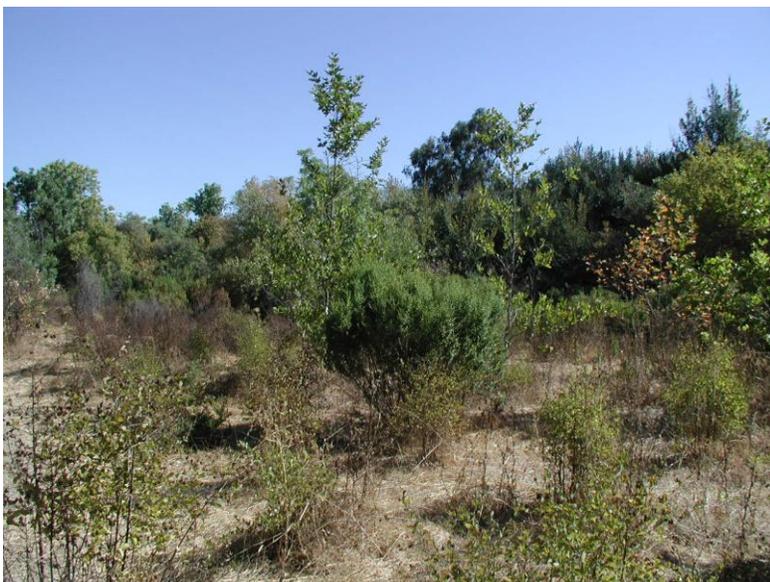
Figure 22. View of Year 6 plantings in western portion of mitigation area. Plantings include snowberry, coyote brush, coast live oaks and sycamore, September 2010.

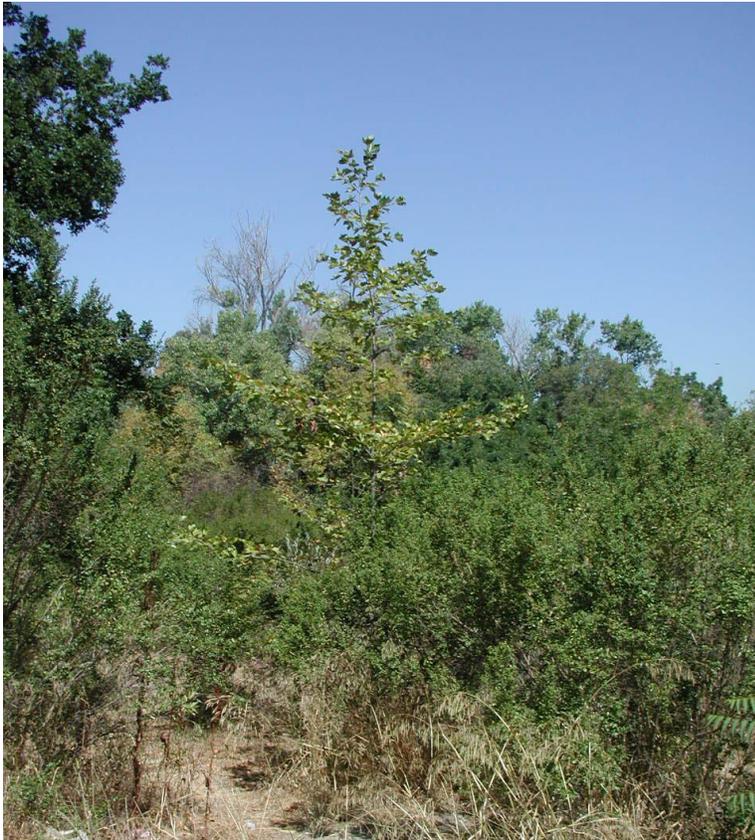
Figure 23. Six-year old sycamore trees averaging 25 feet tall, growing above coyote brush and California blackberry, September 2010.

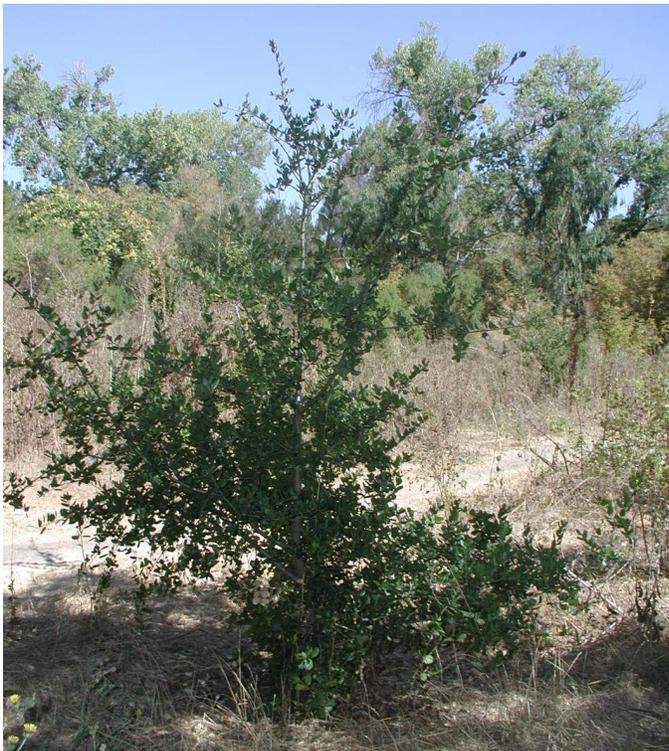
Figure 24. Six-year old coast live oak, September 2010.

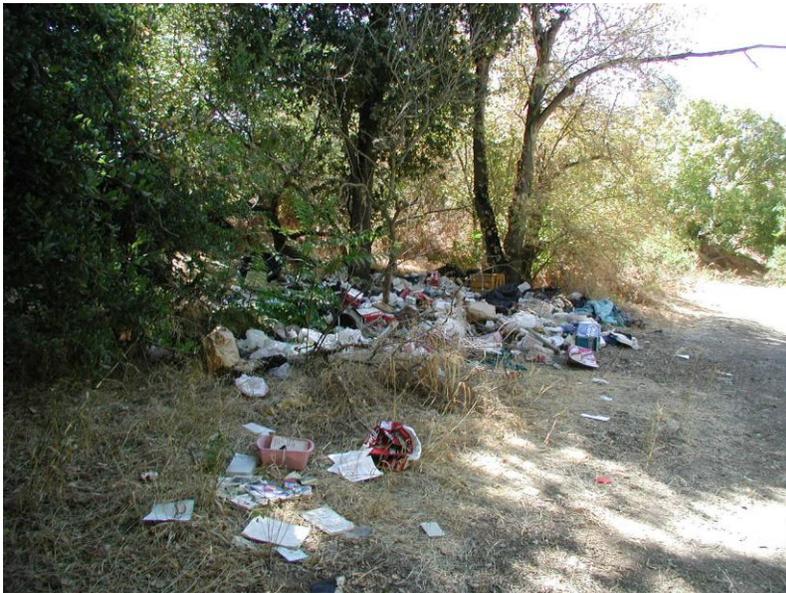
The riparian mitigation area, as well as the adjoining riparian woodland along Coyote Creek, is affected by numerous illegal encampments, trash, and human waste. As depicted in Figure 25, trash has been deposited within many areas within the mitigation area. Some trash has been deposited in large piles (as depicted in Figure 25) while human waste is littered throughout the site. In addition to compromising the integrity of the mitigation area from the creation of foot trails and trampling of vegetation, these human activities degrade the value of the riparian mitigation area and the adjacent riparian woodland for native riparian-dependent wildlife. The abundance of exposed human waste may be a health hazard, which may become a water quality problem within nearby Coyote Creek during the rainy season.

Figure 25. Trash pile deposited within mitigation area (near sample plot 11), September 2010.

- 1. Surveillance for Vandalism, Removal of Trash, and Illegal Encampments.** Periodic inspections are necessary to detect site vandalism and habitat disruption and degradation caused by transient activity and illegal encampments. As evidenced in 2010, the mitigation area supports illegal homeless encampments; these encampments are in addition to larger encampments located immediately adjacent to the mitigation site along the Coyote Creek corridor.

Due to the high level of human use within the mitigation area, quarterly maintenance visits are recommended to monitor site activities and implement habitat protection measures, such that the mitigation area continues to meet the requirements of the permits issued by regulatory agencies for the Old Oakland Road Project.
