Initial Study

6782 and 6790 San Felipe Road

(PDC11-012 and PD11-029)

Planned Development (PD) Rezoning (PDC11-012)

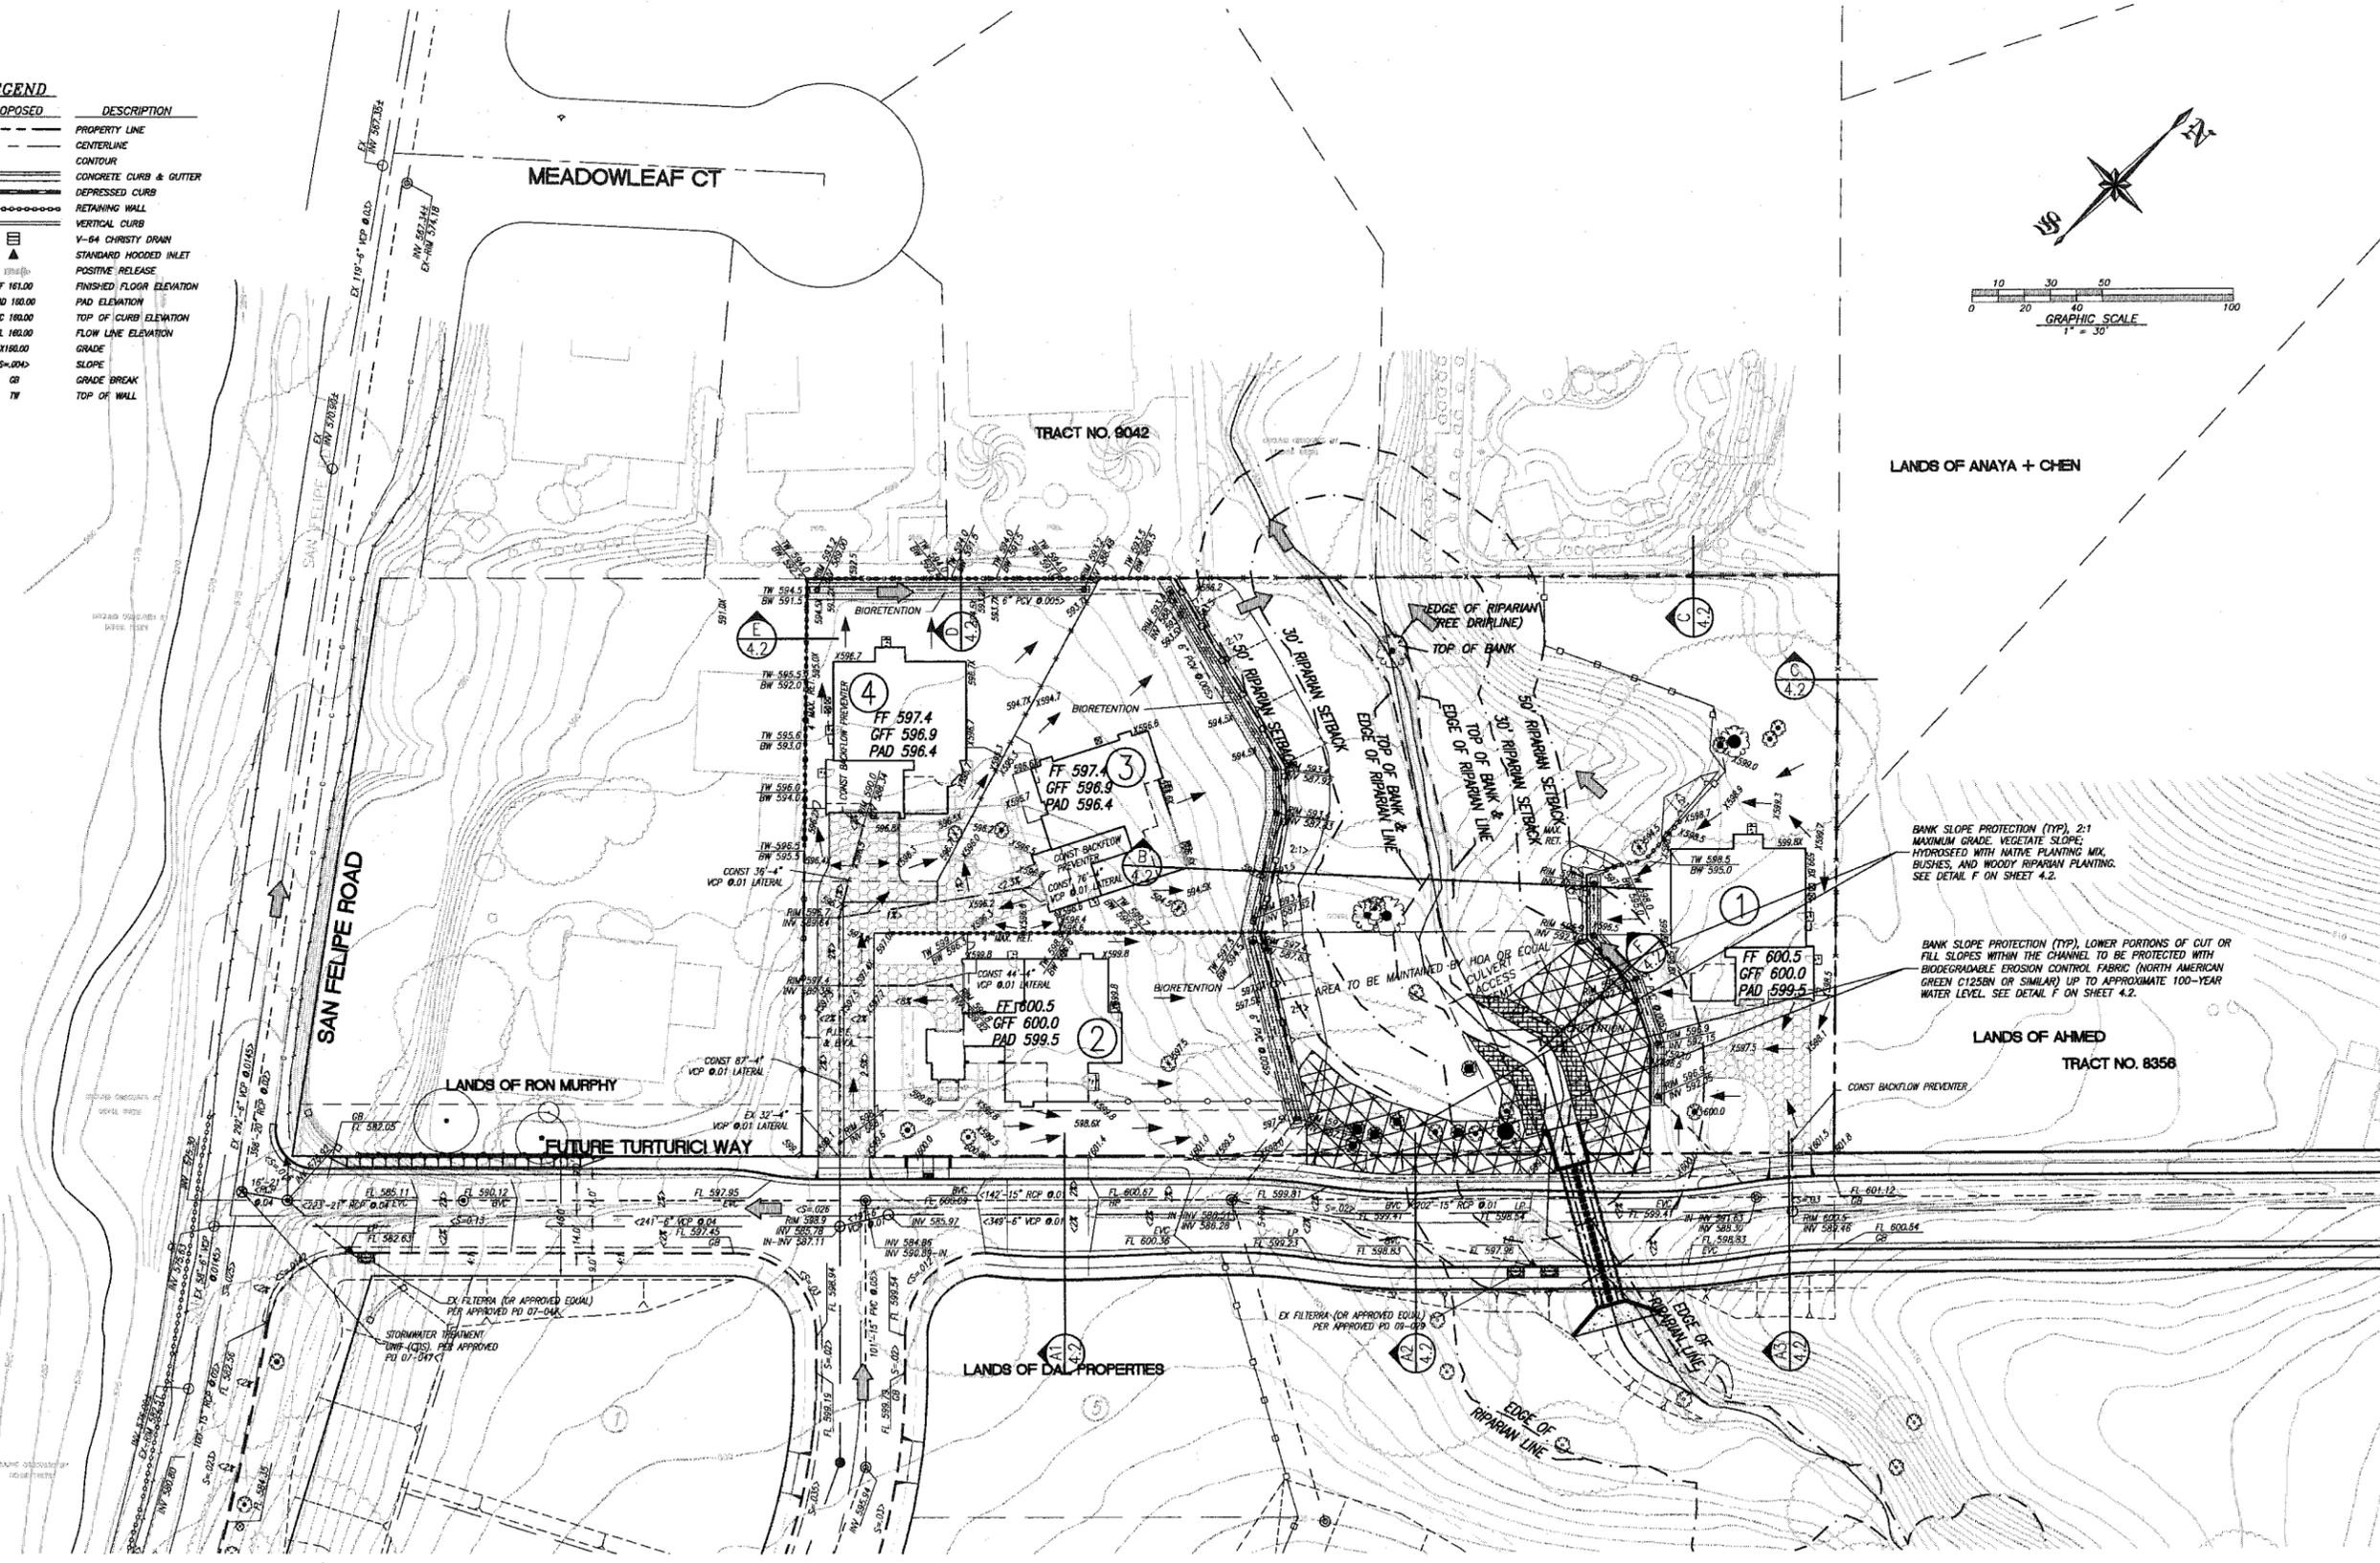
BANK SLOPE PROTECTION (TYP) 2:1 MAXIMUM GRADE. VEGETATE SLOPE; HYDROSEED WITH NATIVE PLANTING MIX, BUSHES, AND WOODY RIPARIAN PLANTING. SEE DETAIL F ON SHEET 4.2.

BANK SLOPE PROTECTION (TYP), LOWER PORTIONS OF CUT OR FILL SLOPES WITHIN THE CHANNEL TO BE PROTECTED WITH BIODEGRADABLE EROSION CONTROL FABRIC (NORTH AMERICAN GREEN C125BN OR SIMILAR) UP TO APPROXIMATE 100-YEAR WATER LEVEL. SEE DETAIL F ON SHEET 4.2.

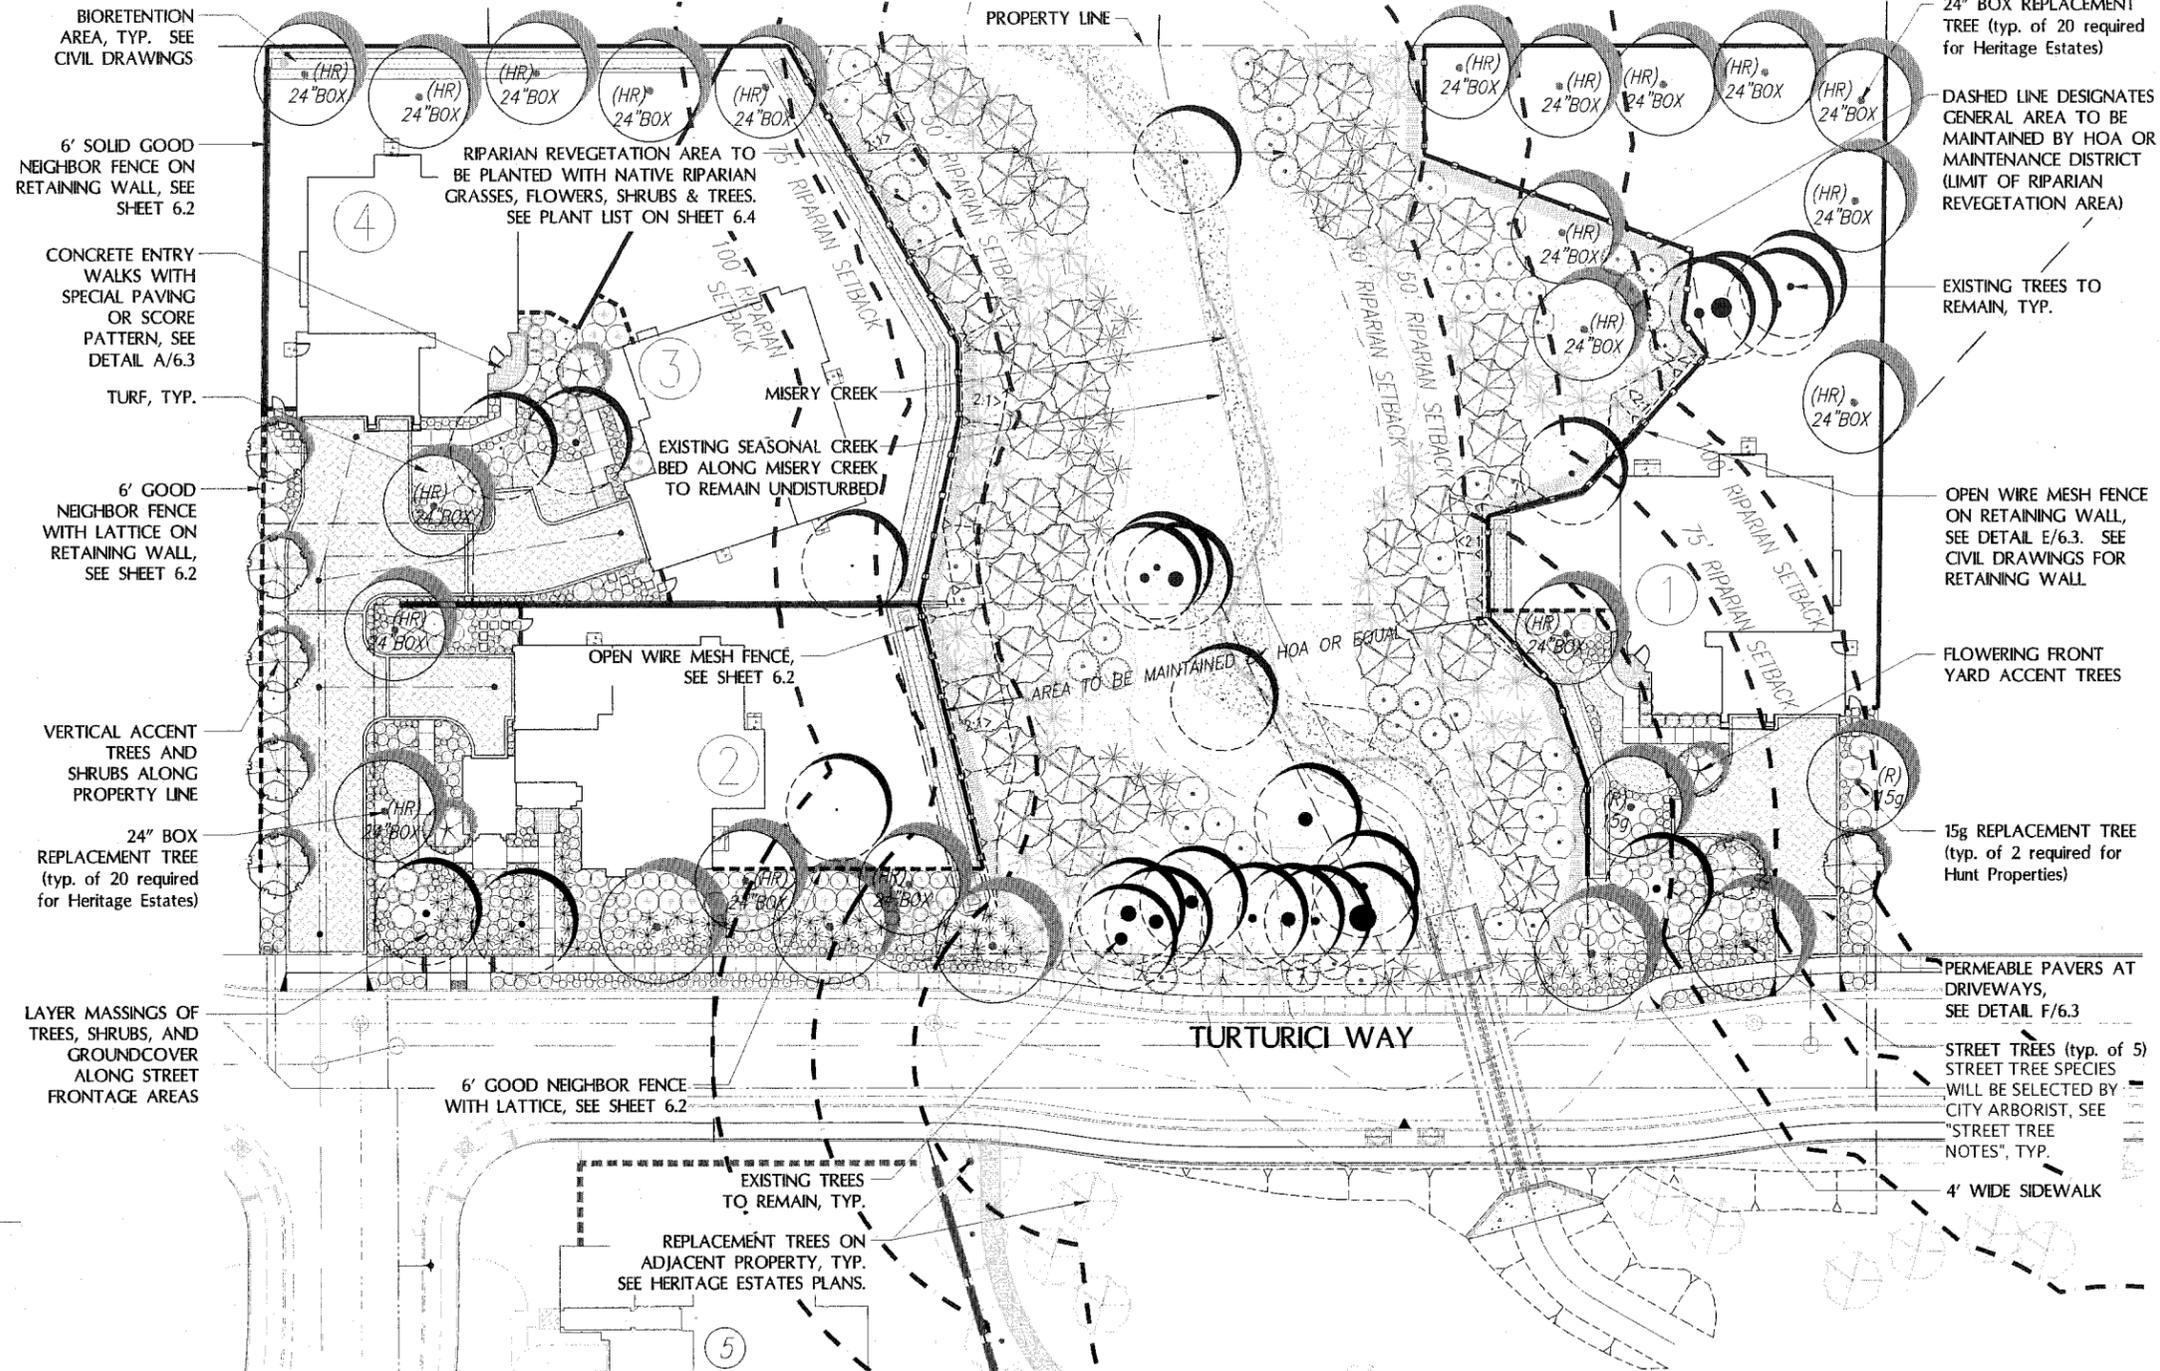
SHEET NO.:
6.1

BIORETENTION AREA, TYP. SEE CIVIL DRAWINGS

6' SOLID GOOD NEIGHBOR FENCE ON RETAINING WALL, SEE SHEET 6.2

24" BOX REPLACEMENT TREE (typ. of 20 required for Heritage Estates)

15g REPLACEMENT TREE (typ. of 2 required for Hunt Properties)

The projects Tree Removal Plan requires 2 new 15 gallon trees be planted on the site. An additional 20 new 24" box replacement trees will be located in the riparian area in order to comply with the tree replacement requirements for the adjacent property. A total of 37 new 15 gallon and 24" box trees are proposed for the site. These proposed trees exceed the tree replacement requirements. Existing trees that are to remain are shown on this sheet. See Civil Engineer's "Tree Removal Plan" for list of trees being removed.

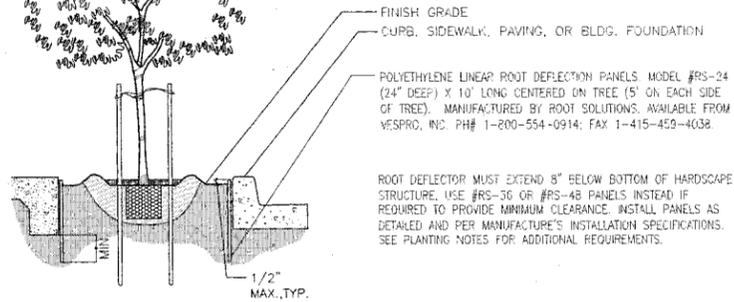
A ROOT DEFLECTOR
NTS

- NOTES:
1. ROOT DEFLECTORS MAY BE REQUIRED UNDER CERTAIN CONDITIONS. SEE PLANTING NOTES FOR SPECIFIC CONDITIONS WHERE ROOT DEFLECTORS ARE REQUIRED.
 2. INSTALL ROOT DEFLECTOR AGAINST STRUCTURE OR AS CLOSE TO STRUCTURE AS POSSIBLE. THE TOP OF ROOT DEFLECTOR SHALL BE SET ABOVE GRADE AS NOTED (NEVER BELOW GRADE). THE RAISED ROOT DEFLECTORS SHALL FACE TOWARDS TREE.
 3. SEE TREE PLANTING DETAIL FOR TREE INSTALLATION.

- ALL TREES CLOSER THAN 5'-0" FROM CURBS, FOUNDATIONS, SIDEWALKS, OR OTHER HARDSCAPE ITEMS SHALL BE INSTALLED WITH ROOT DEFLECTORS. SEE SHEET 6.4.

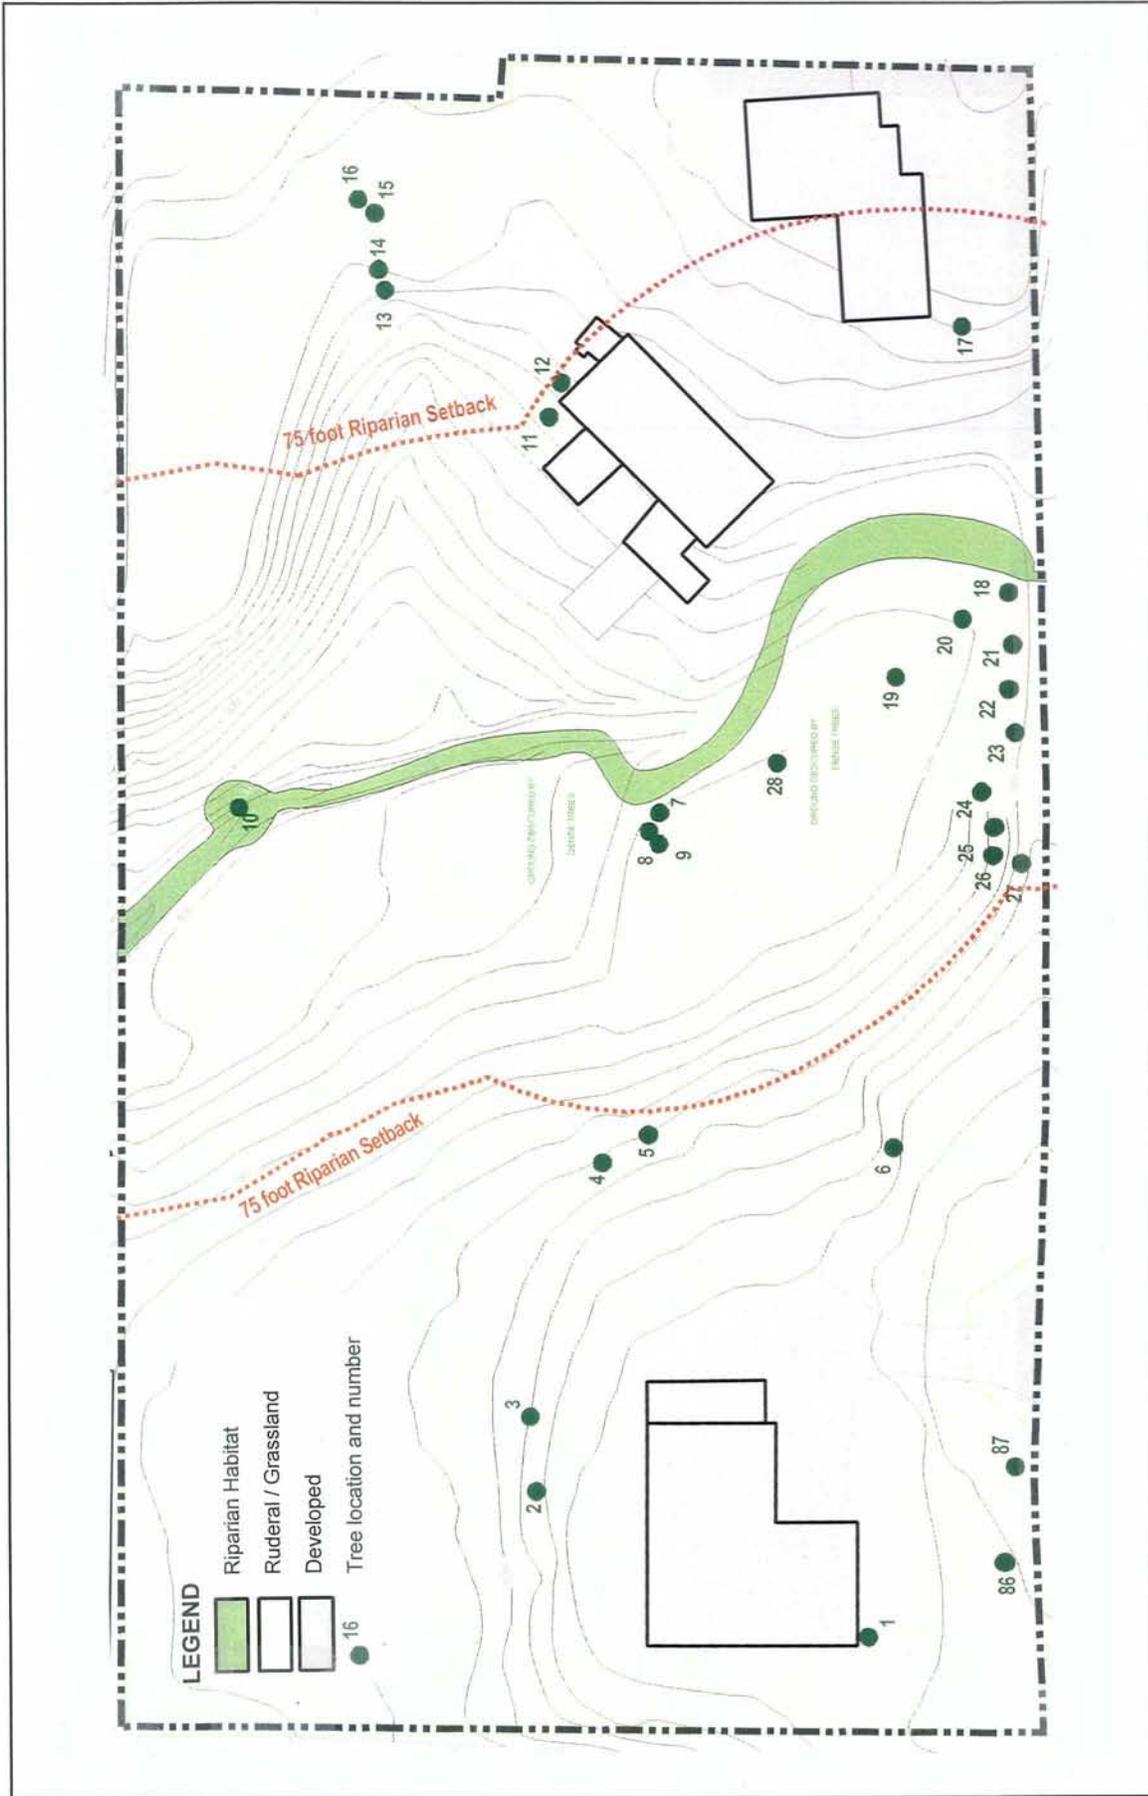
Habitat Areas
Figure 17

A riparian corridor associated with Misery Creek is located through the project site. The riparian woodland vegetation near Misery Creek running through the project site consists of a dense canopy of mature eucalyptus trees on the southern edge of the site in varying condition. Only one tree, a red willow, occurs within the riparian corridor, although the dense eucalyptus

near the creek offer a modest canopy over much of the creek channel. The understory of the riparian woodland is relatively sparse, consisting mainly of the same non-native ruderal grasses that are present in the upland habitat, with dead Italian thistles closer to the creek. In addition, coast live oak and blue oak seedlings were observed in the southern portion of the riparian corridor.

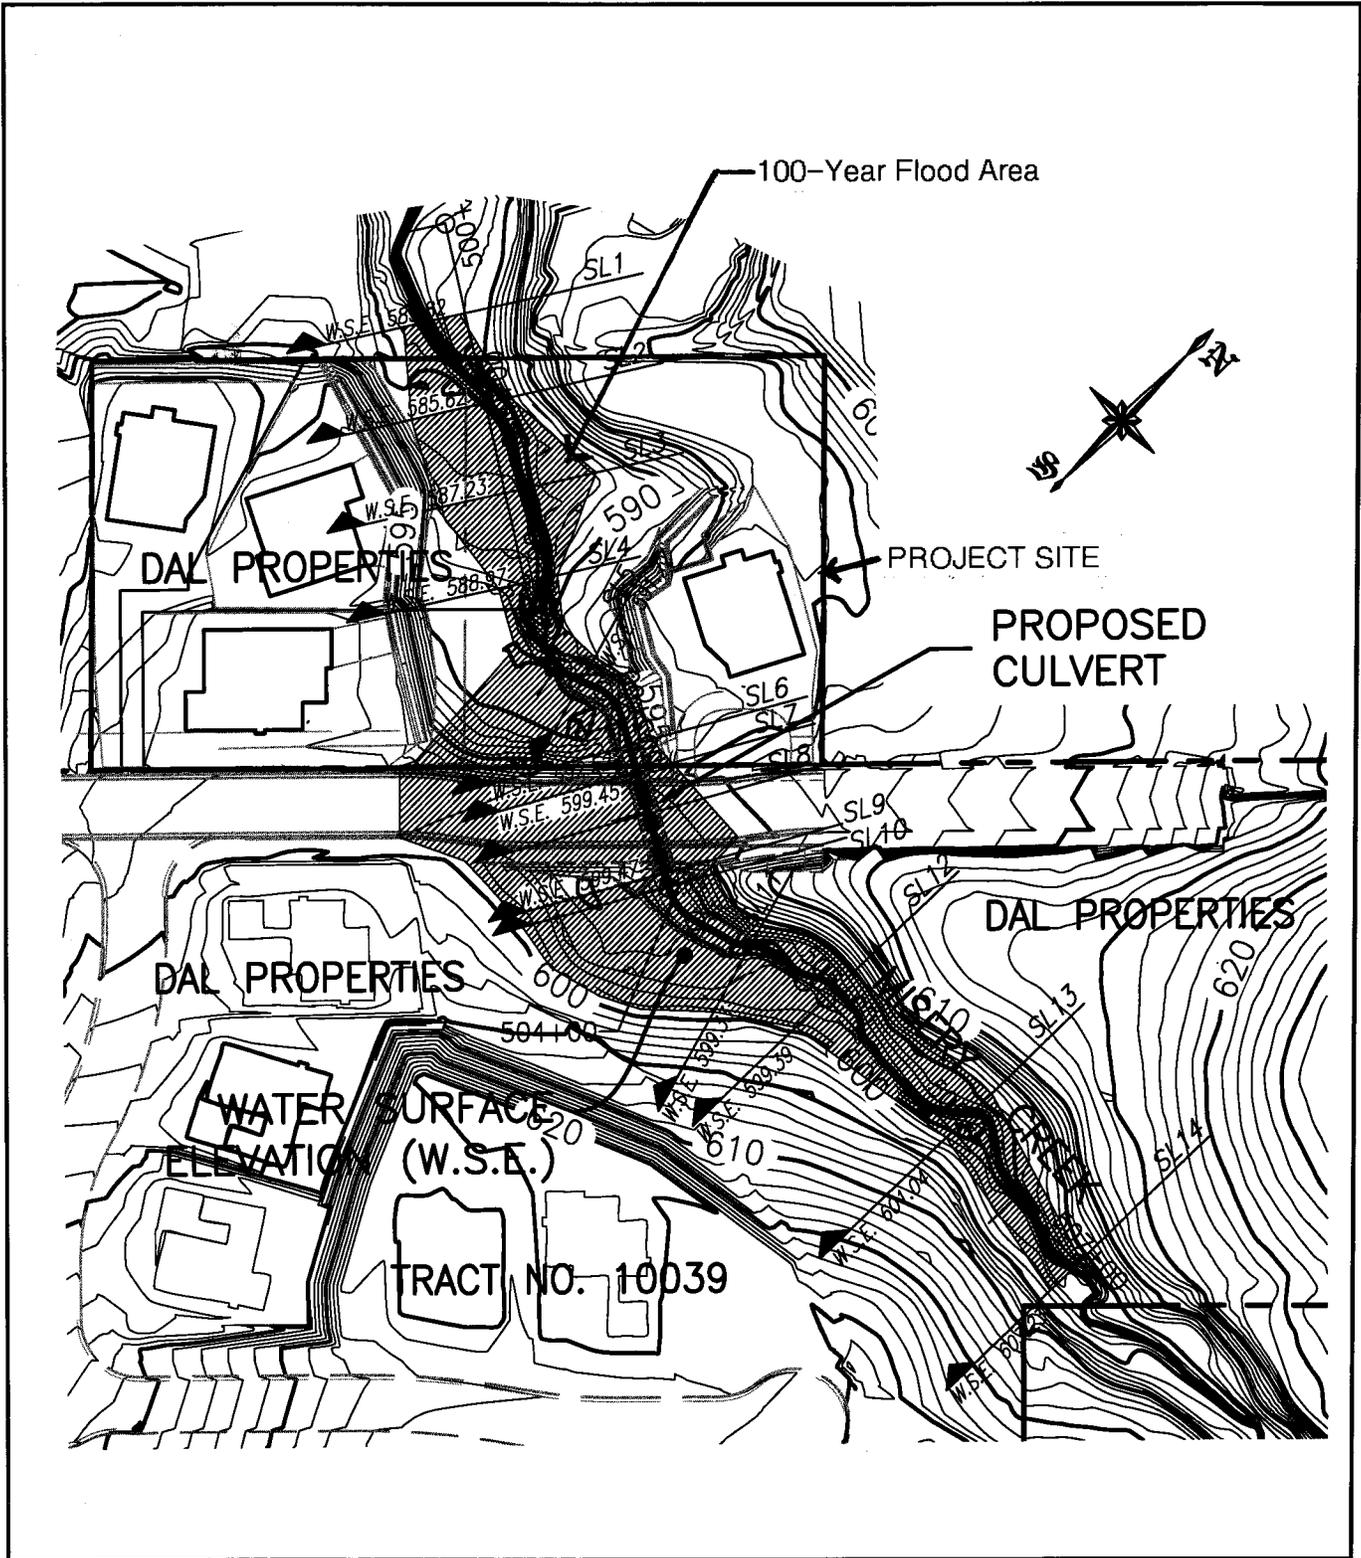
Figure 20

Potential Flooding

The proposed project is in conformance with the flood protection requirements of the Evergreen Development Policy / Evergreen–East Hills Development Policy.

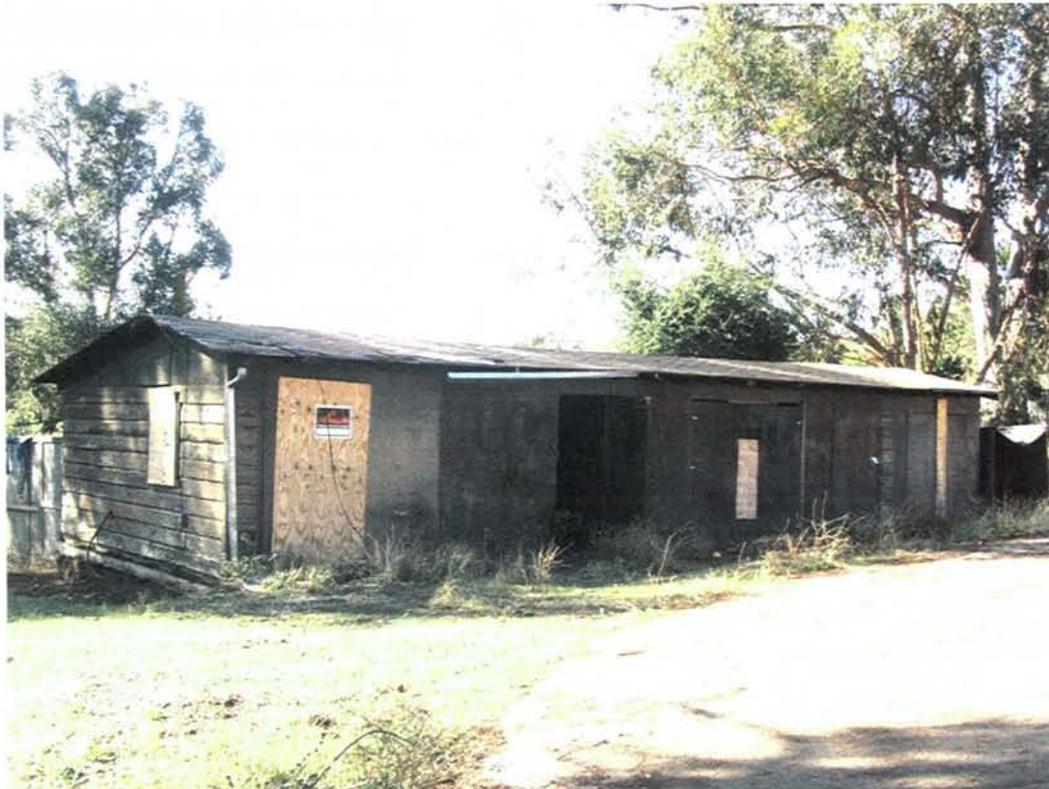
The single-story, pitched-roof building appears to have been mostly open on the front façade, but over time plywood has been added to create sections of wall with plywood hinged doors. The rear has “pens” attached where openings have been cut into the wall. This is where a boiler was located as part of the jelly making process. Sections of siding are missing from this façade. The building does not exhibit vernacular architectural distinction and the uses were ancillary to the maintenance of the property.

6790 San Felipe Road, Storage shed- front façade facing the house.

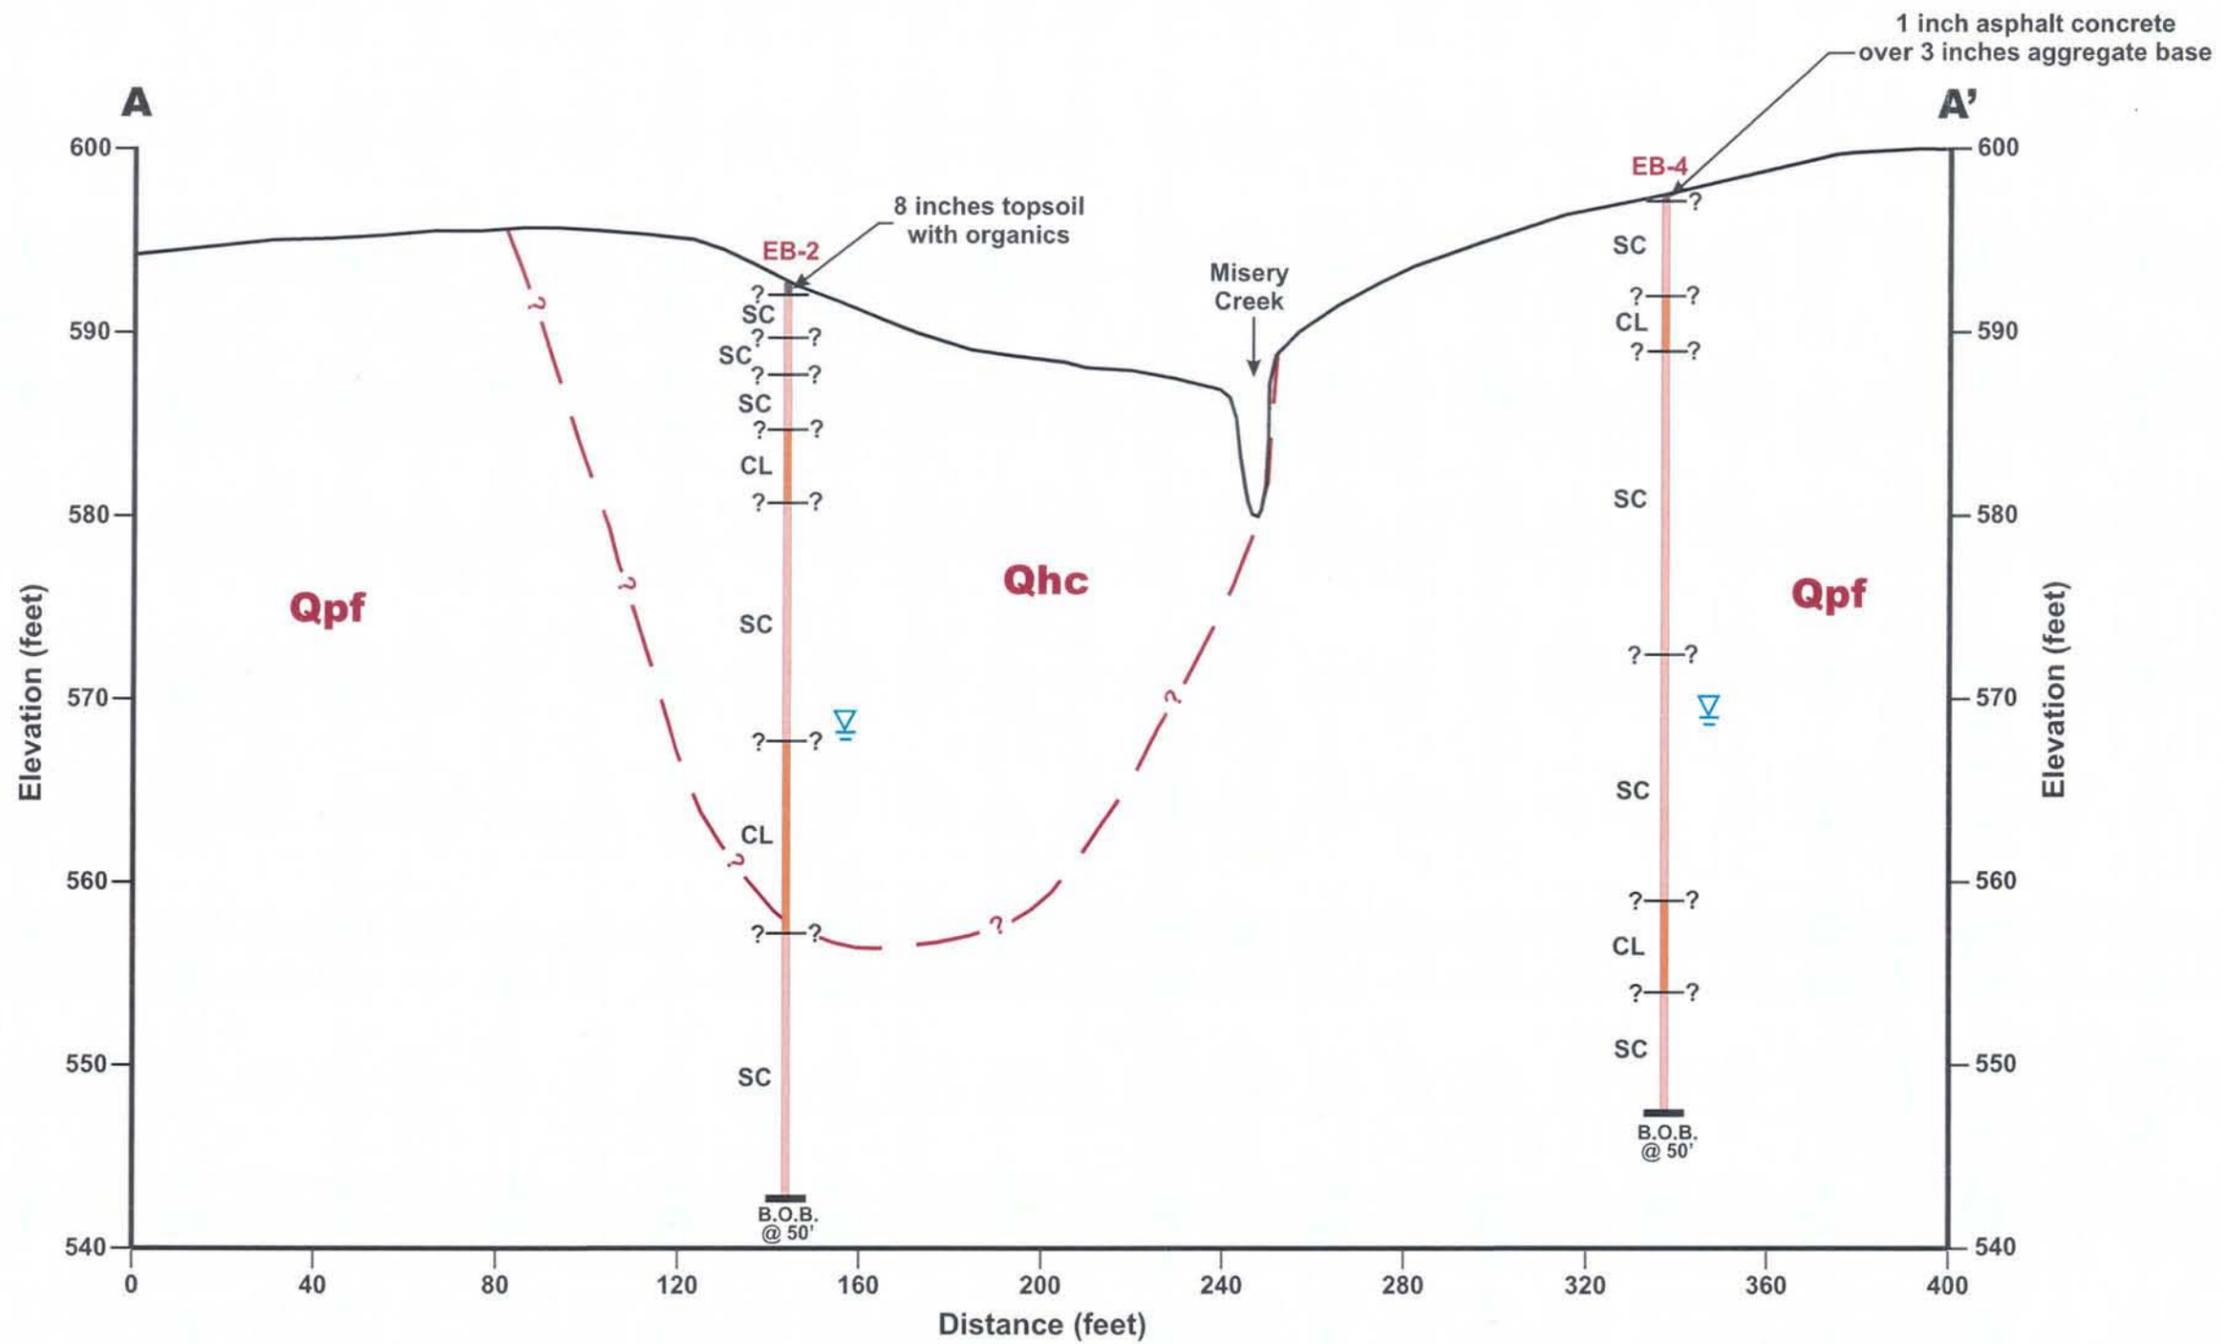
Project Number 336-2-3	Figure Number Figure 3	Date September 2011	Drawn By RRN
Cross-Section A-A' San Felipe Road Residential San Jose, CA

Section A-A'
 (View Looking Northwest)
 1"=10' Horizontal
 1"=40' Vertical

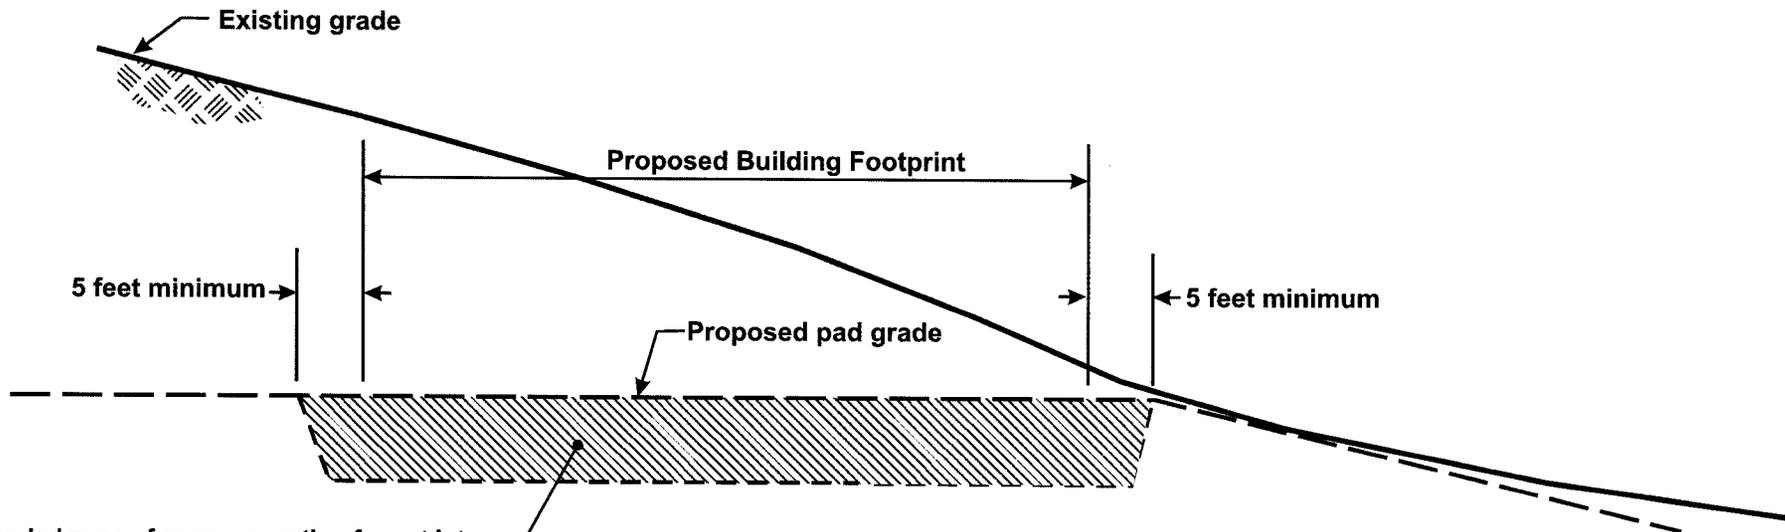
Conceptual Cut Lot Over-Excavation

Recommended zone of over-excitation for cut lots. Depth of over-excitation below pad grade should be 2 feet minimum. The depth of over-excitation should be reviewed by Geotechnical Engineer during construction and if needed, adjusted accordingly.

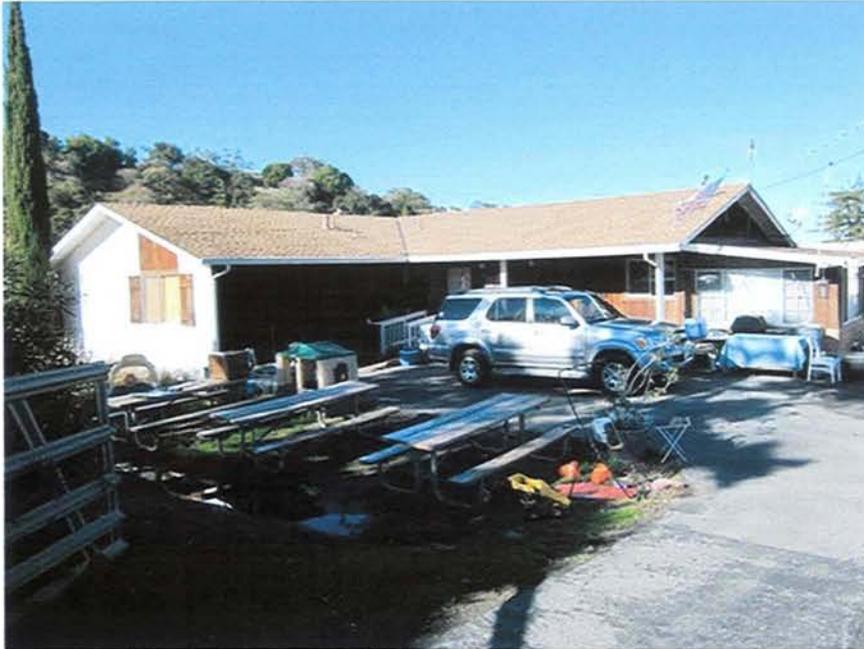
Photograph 1. Residence at 6782 San Felipe Road.
