Subject: Phase I Environmental Site Assessment
San Jose Parcels
34, 66, and 80 East Rosemary Street and 1290 North 1st Street
San Jose, California 95112
Versar Project No. 105071.5071.107

Phase I Environmental Site Assessment

**SAN JOSE PARCELS
34, 66, AND 80 EAST ROSEMARY STREET
1290 NORTH 1ST STREET
SAN JOSE, CALIFORNIA**

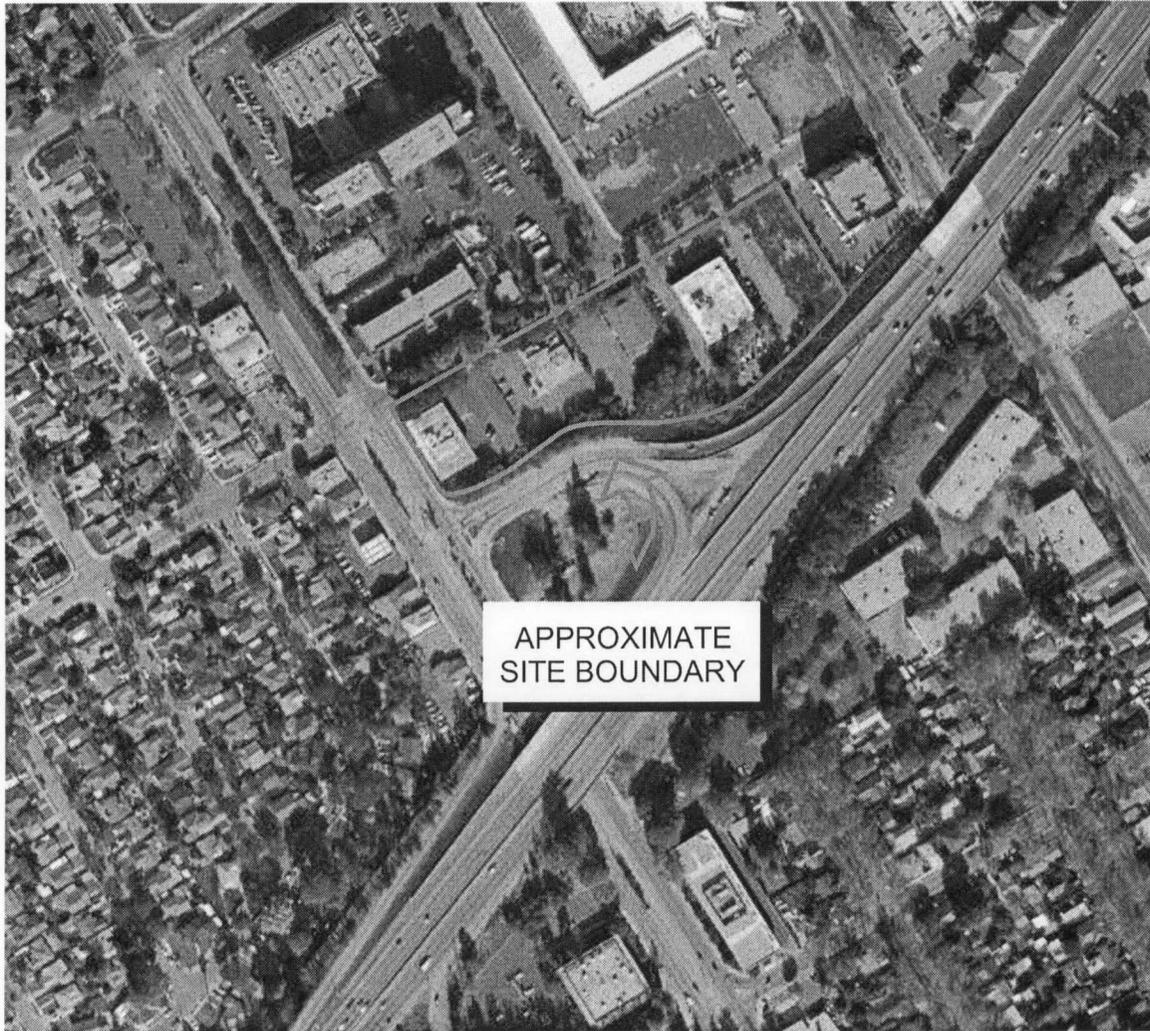
Dr. By: JI	Versar ^{INC} 7844 Madison Avenue Suite 167 Fair Oaks, CA 95628 (916) 962-1612	SITE AERIAL PHOTOGRAPH San Jose Parcels 34, 66, and 80 East Rosemary Street 1290 North 1st Street San Jose, California	Figure 2
Date: 05/23/06			
Versar Project No.:5071.107

The location of the Site is shown in Figure 1, *Site Location Map*, Figure 2, *Site Aerial Photograph*, and Figure 3, *Site Layout Map*. Photographic documentation is presented in Appendix A. Site improvements are discussed in Section 4.1 of this report.

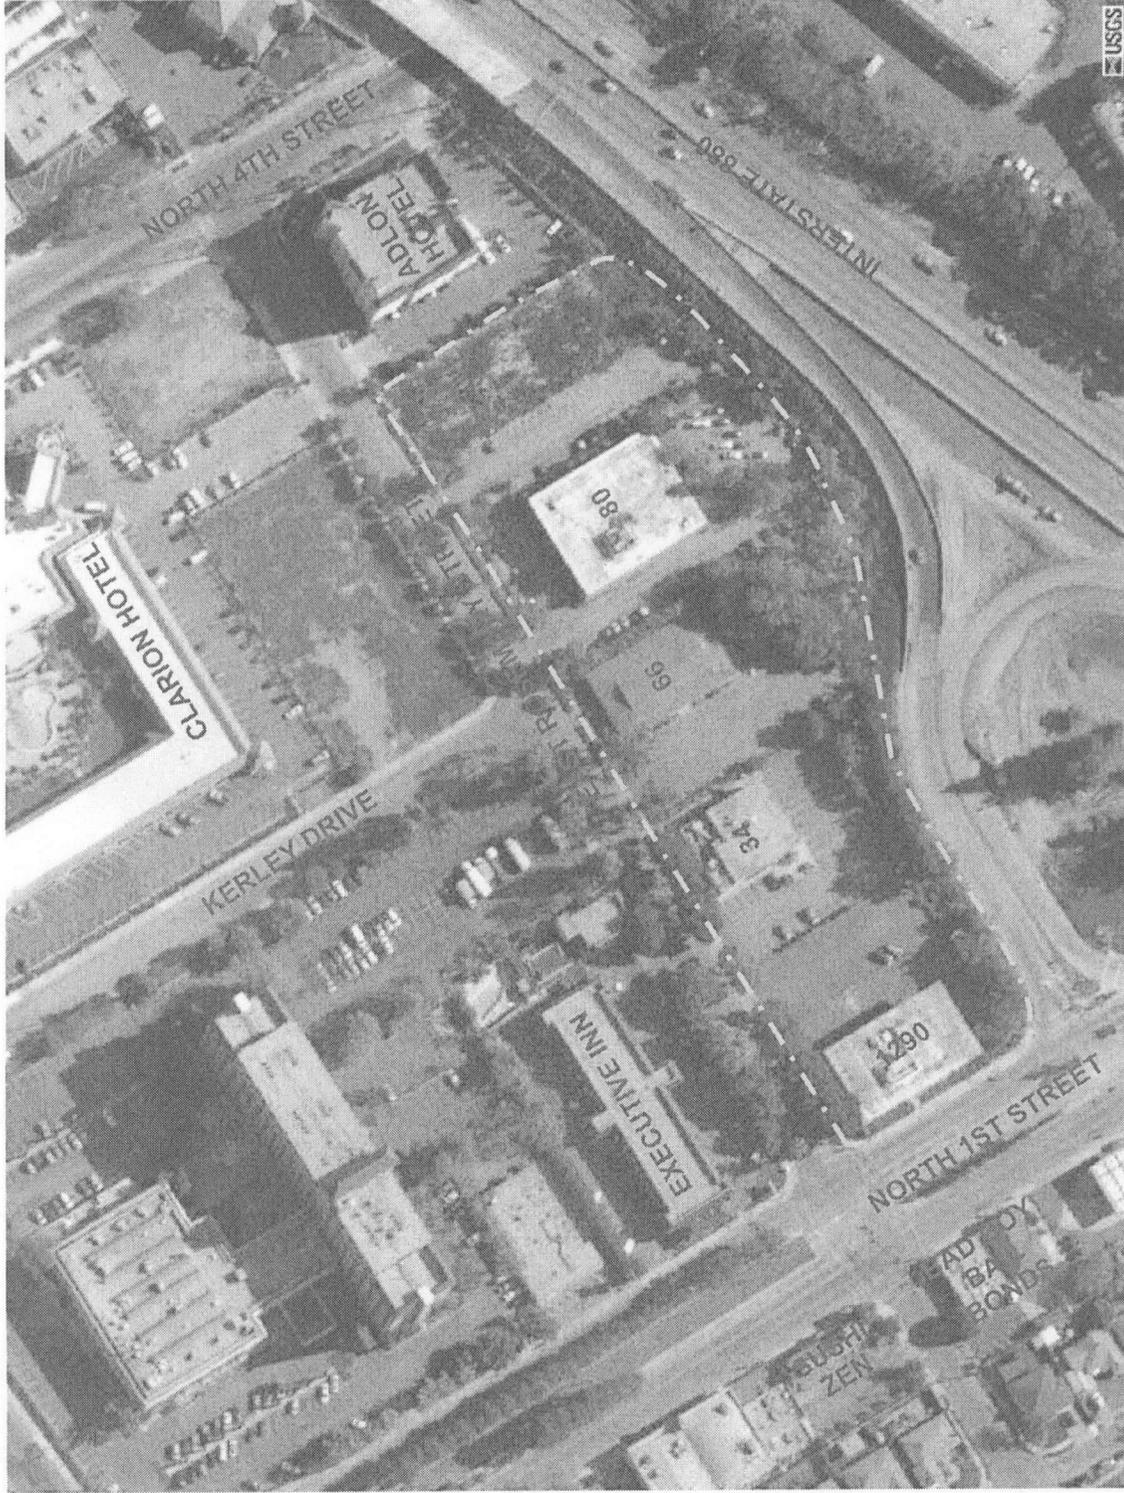
The Site consists of five parcels of land improved with four commercial buildings. The Site is located in an area developed primarily with commercial properties. The surrounding property uses were noted and shown in Figure 3:
