Los Lagos Golf Course  
Environmental Mitigation Monitoring  
Year 7 (2008) Monitoring Report

## Los Lagos Golf Course Environmental Mitigation Monitoring Year 7 (2008) Monitoring Report

Biotic Resources Group  
Kathleen Lyons, Plant Ecologist

November 14, 2008

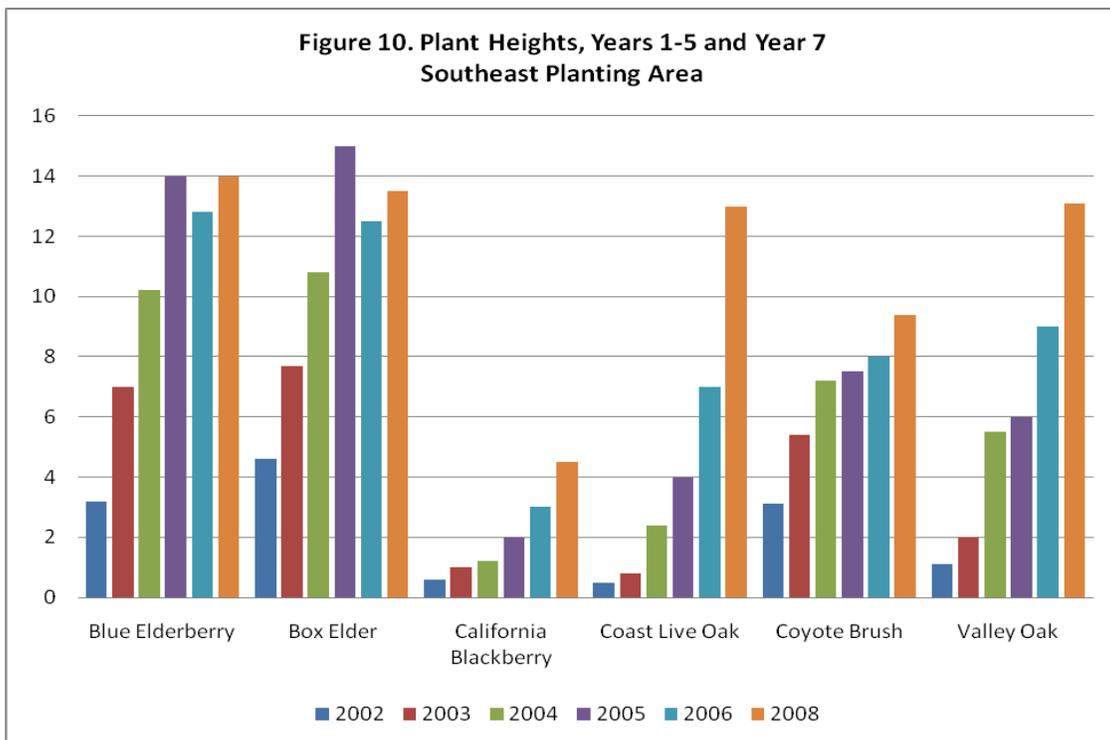
Figure 9 depicts the condition of the planting area. Figure 10 shows the trend of tree and shrub heights between 2002 (Year 1) and 2008 (Year 7).

Figure 9. View of southeast planting area, September 2008.

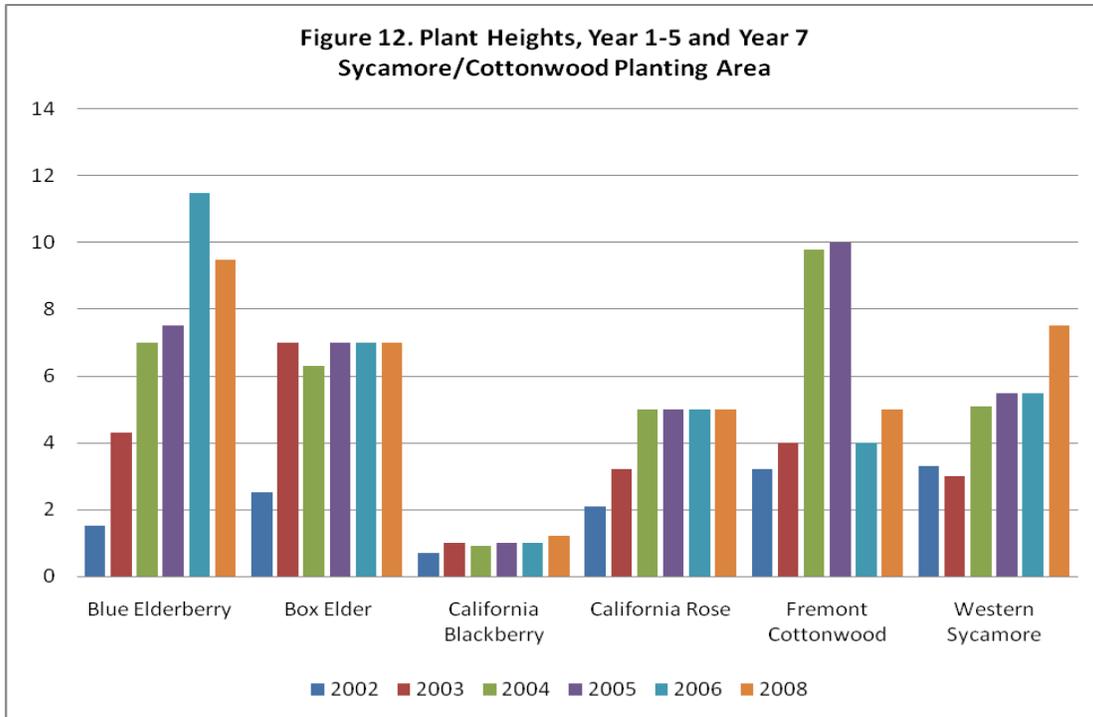
The sample plot data documented that most plants exhibited excellent health and vigor (Table 6). Blue elderberries are the tallest plants, averaging 9.5 feet, a decrease from 11.5 feet in Year 5; stem dieback was noticed on two plantings that account for the decline in average height. Sycamores average 7.5 feet tall. A two foot increase from Year 5. Shrubs of California rose average 5 feet, which is similar to previous sampling years. The 2008 monitoring documented that most plants exhibited good to excellent health and vigor (Table 6), although one cottonwood had died. Figure 11 shows this planting area vegetation. Figure 12 shows the trend of tree and shrub heights between 2002 (Year 1) and 2008 (Year 7).

Figure 11. View of portion of sycamore cottonwood planting area, October 2008.
