# FOURTH ANNUAL MONITORING REPORT

QUAIL HOLLOW BRIDGE REPLACEMENT PROJECT  
ALUM ROCK PARK, SAN JOSE, CALIFORNIA

LSA Project No. SJO0607B

December 3, 2009

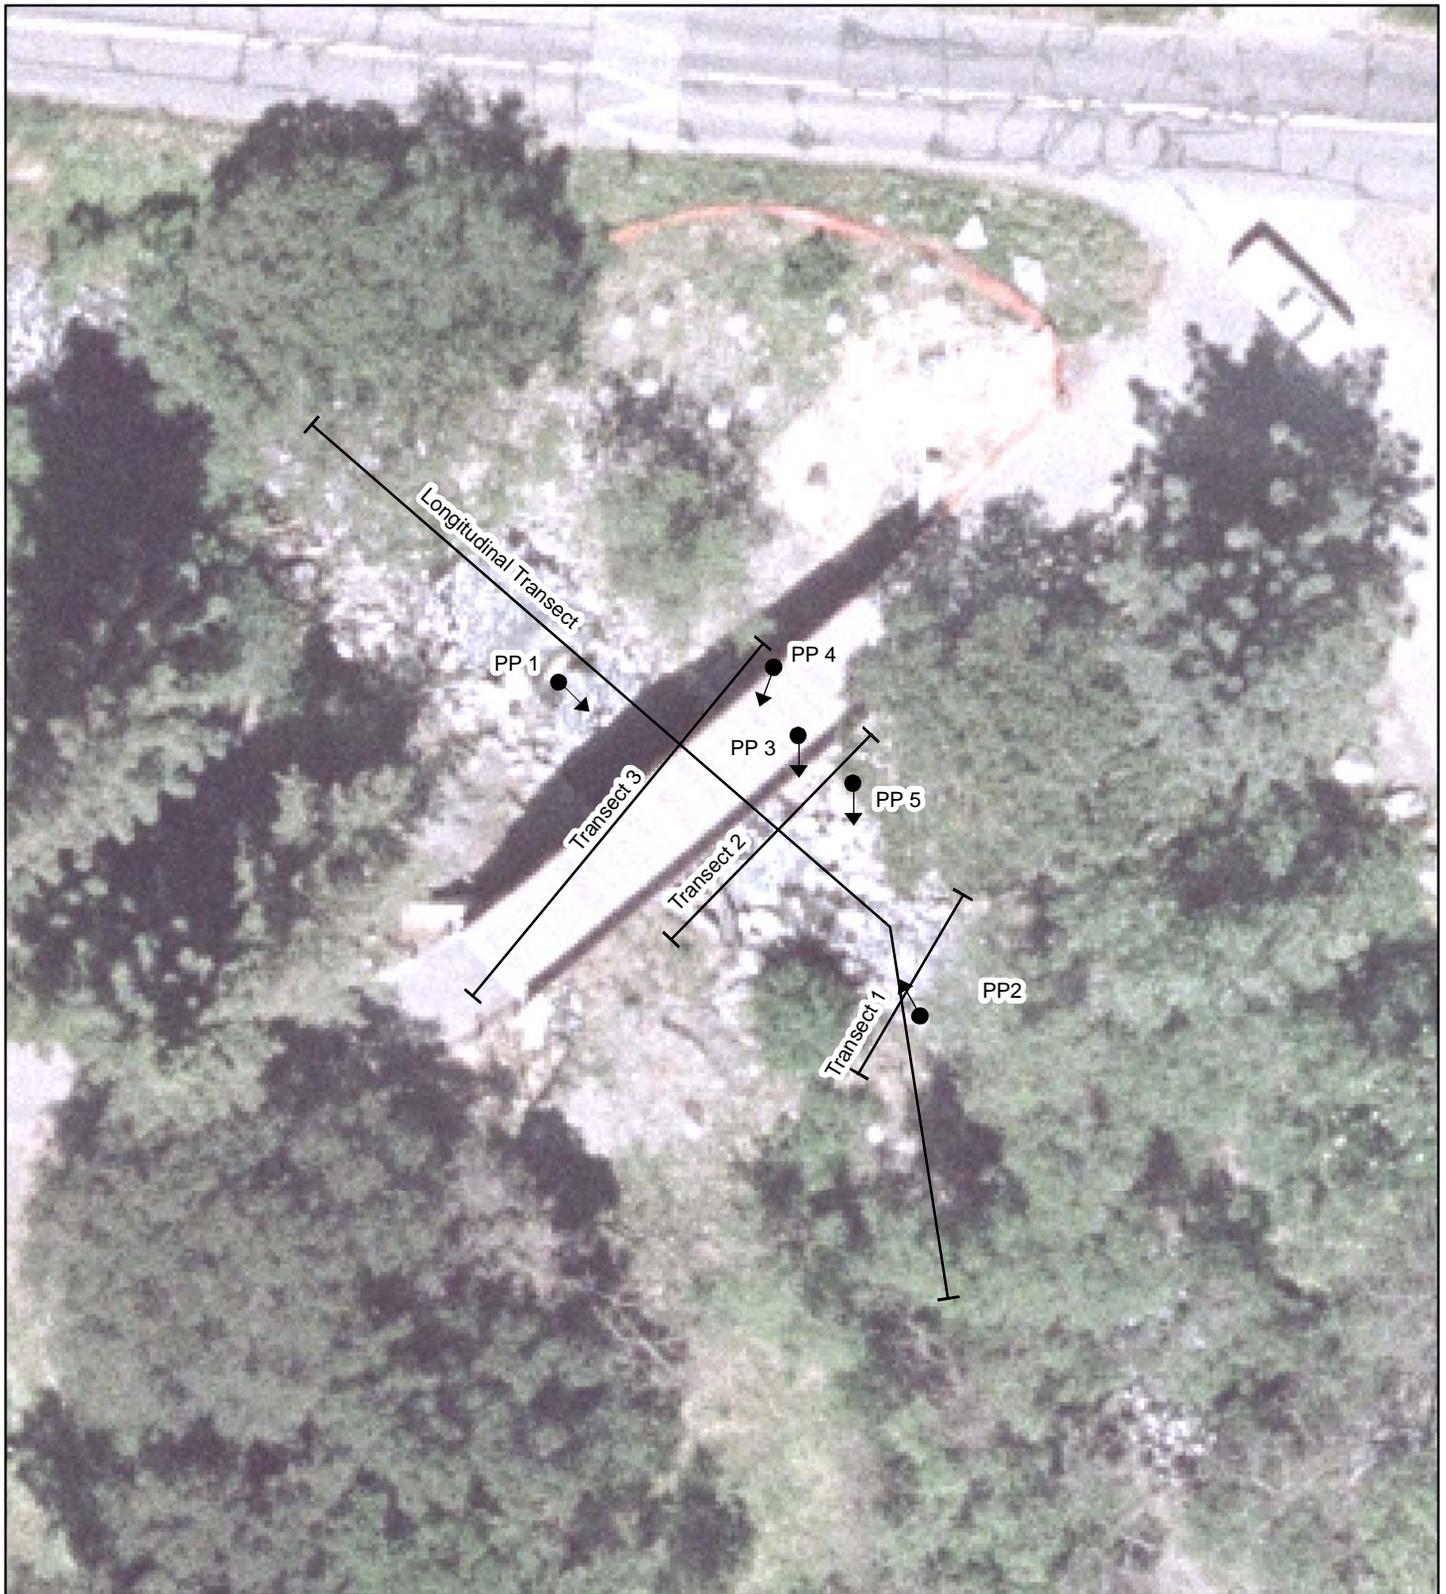
FIGURE 3

**Performance Measure 6: Geomorphic Stability of Channel.** Based on a visual evaluation of the site during the year 4 geomorphic monitoring, the project is performing well and meeting the design criteria. There was no excessive erosion or sedimentation in the project area. The rock weirs appear to be stable, function well through the winter flows, and provide fish passage. The depth of the step pools continues to perform well and provides aquatic habitat. During the June 2, 2009 geomorphology monitoring, juvenile steelhead and western toad (*Bufo boreas*) larvae were observed within the large pools in the project area. LSA established a permanent longitudinal profile and three permanent cross sections in the project area on June 2, 2009 (Figure 3, Appendix A and Longitudinal Profile and Cross Section Graphs, Appendix D).
