APPENDIX G

HAZARDOUS MATERIALS

**Phase I Environmental
Site Assessment**
San Jose Flea Market
San Jose, California

March 30, 2005
Project No. 2121-1

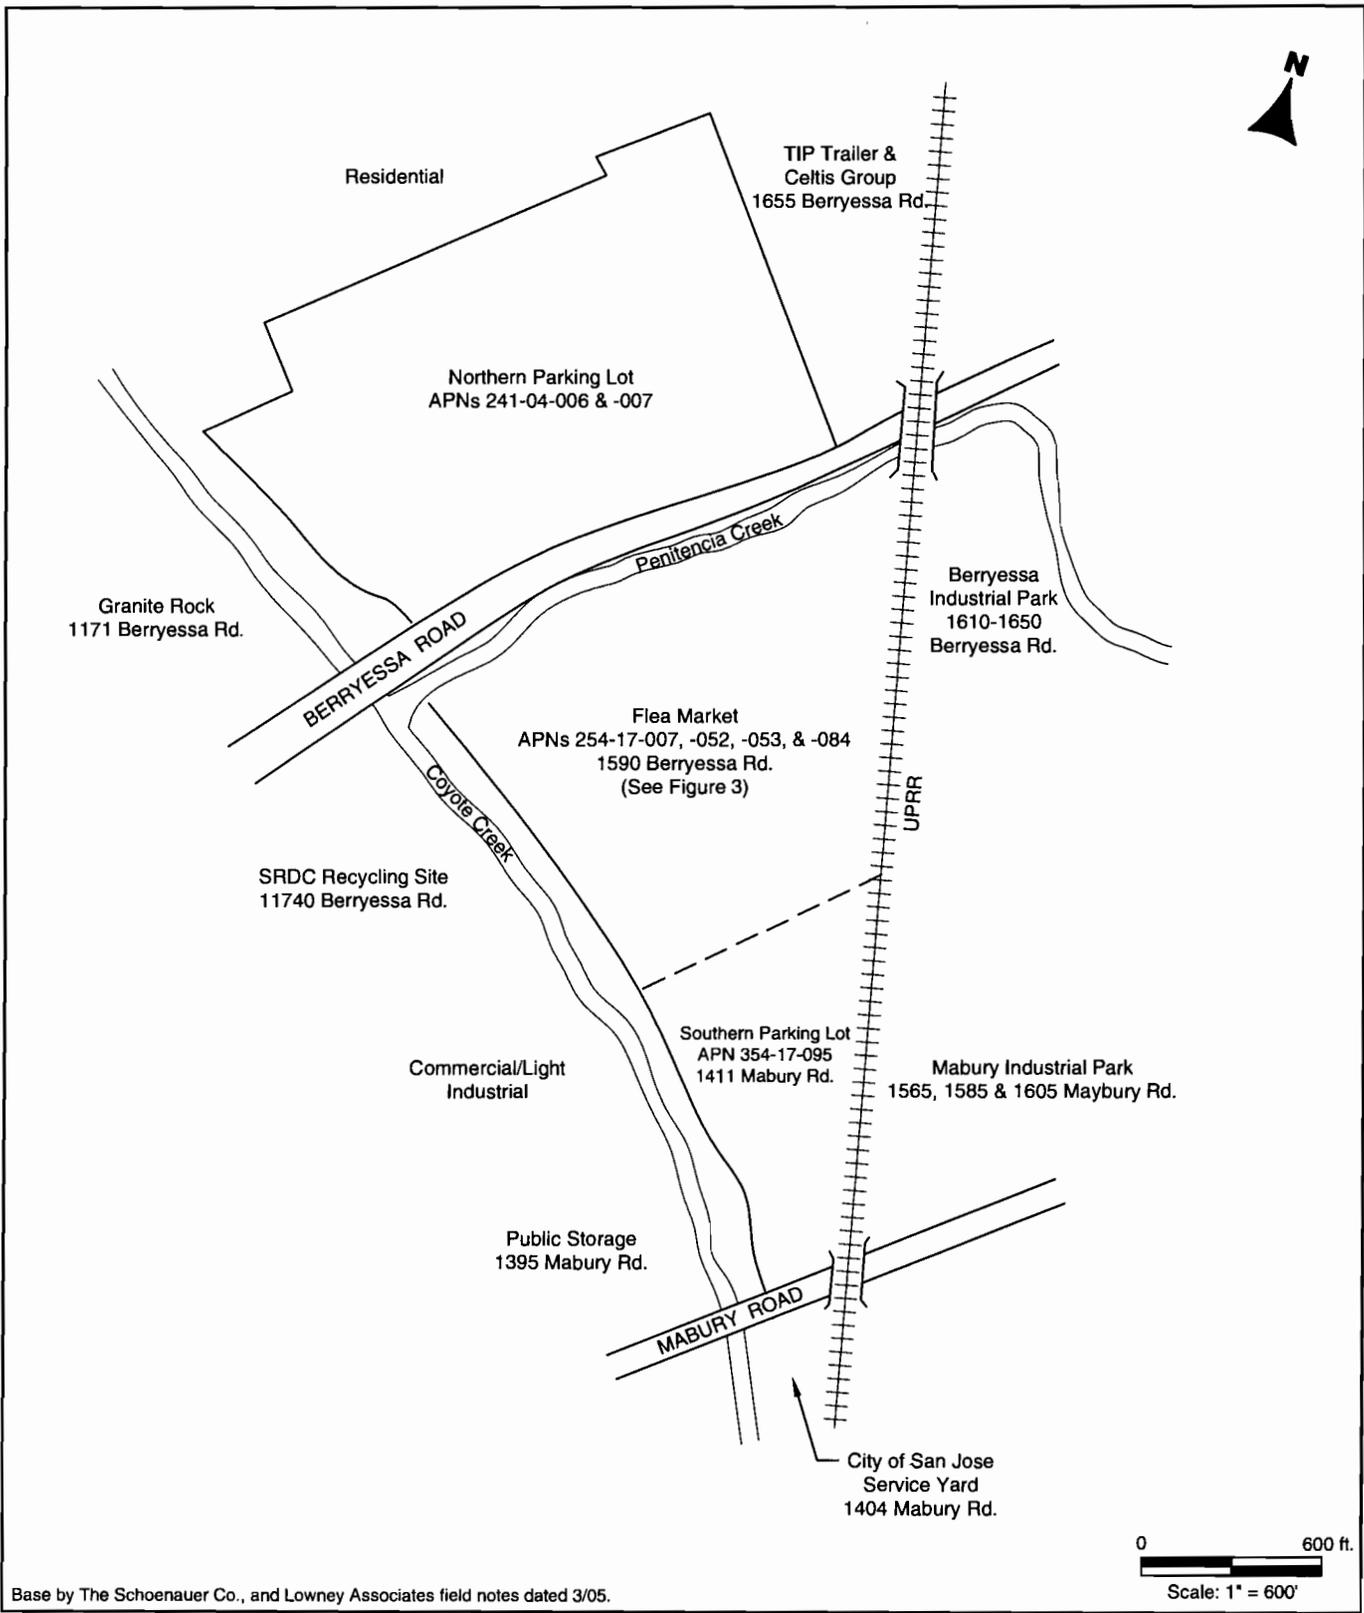
SITE PLAN

SAN JOSE FLEA MARKET
San Jose, California

The approximately 120-acre site is located at 1590 Berryessa Road in San Jose, California, and is occupied by the San Jose Flea Market and parking lots (Figure 1 and Figure 2).

In June 2005, two borings (EB-13 and EB-14) were completed to approximate depths of 11 feet and 12 feet, respectively, at randomly selected locations near the estimated location of the former feed lot/meat packing facility (see Figure 2). Approximately ½ foot of apparent fill material was observed beneath surface asphalt and baserock within boring EB-13. Approximately 6 feet of fill was observed beneath the baserock in boring EB-14. Ground water was encountered at approximately 9½ feet deep in boring EB-13 and approximately 8¼ feet in boring EB-14.

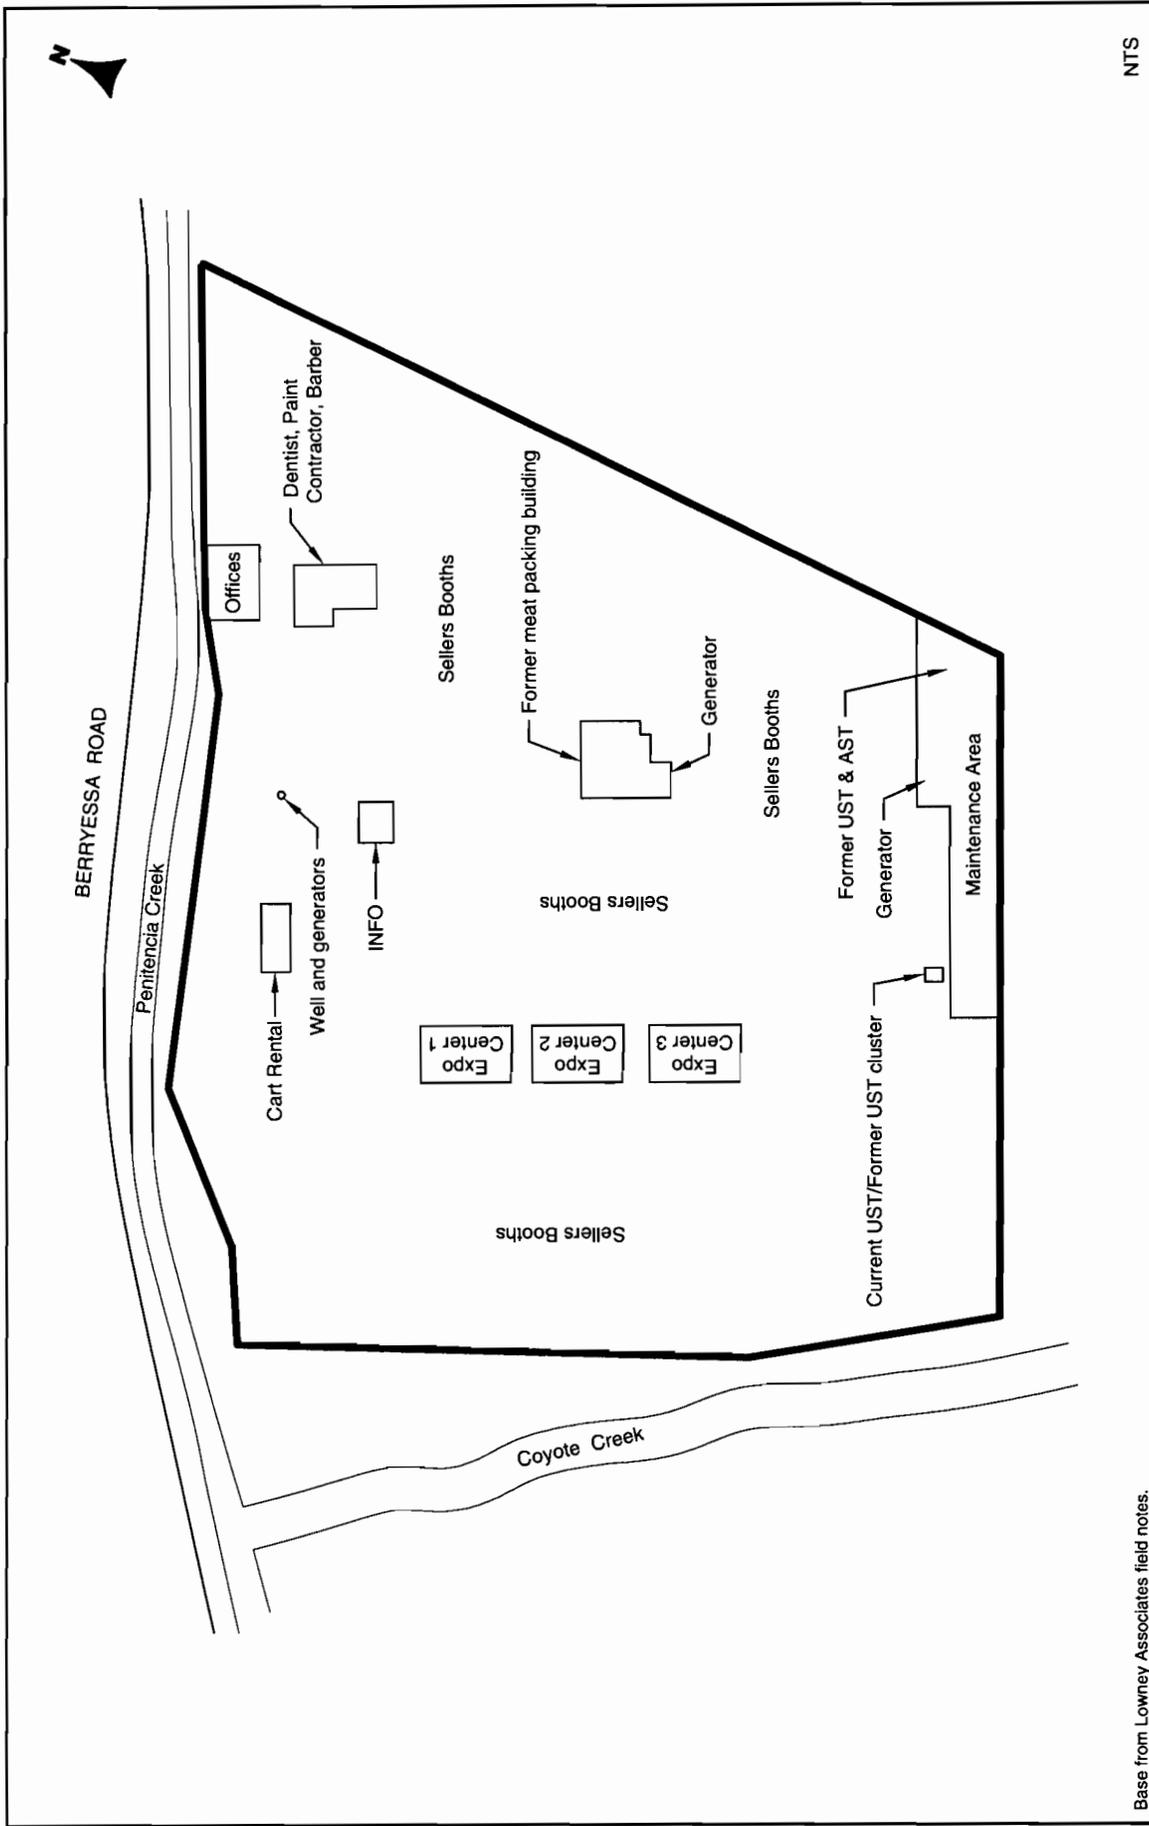
FLEA MARKET PLAN
SAN JOSE FLEA MARKET
 San Jose, California

Base from Lowney Associates field notes.
3/05*EB

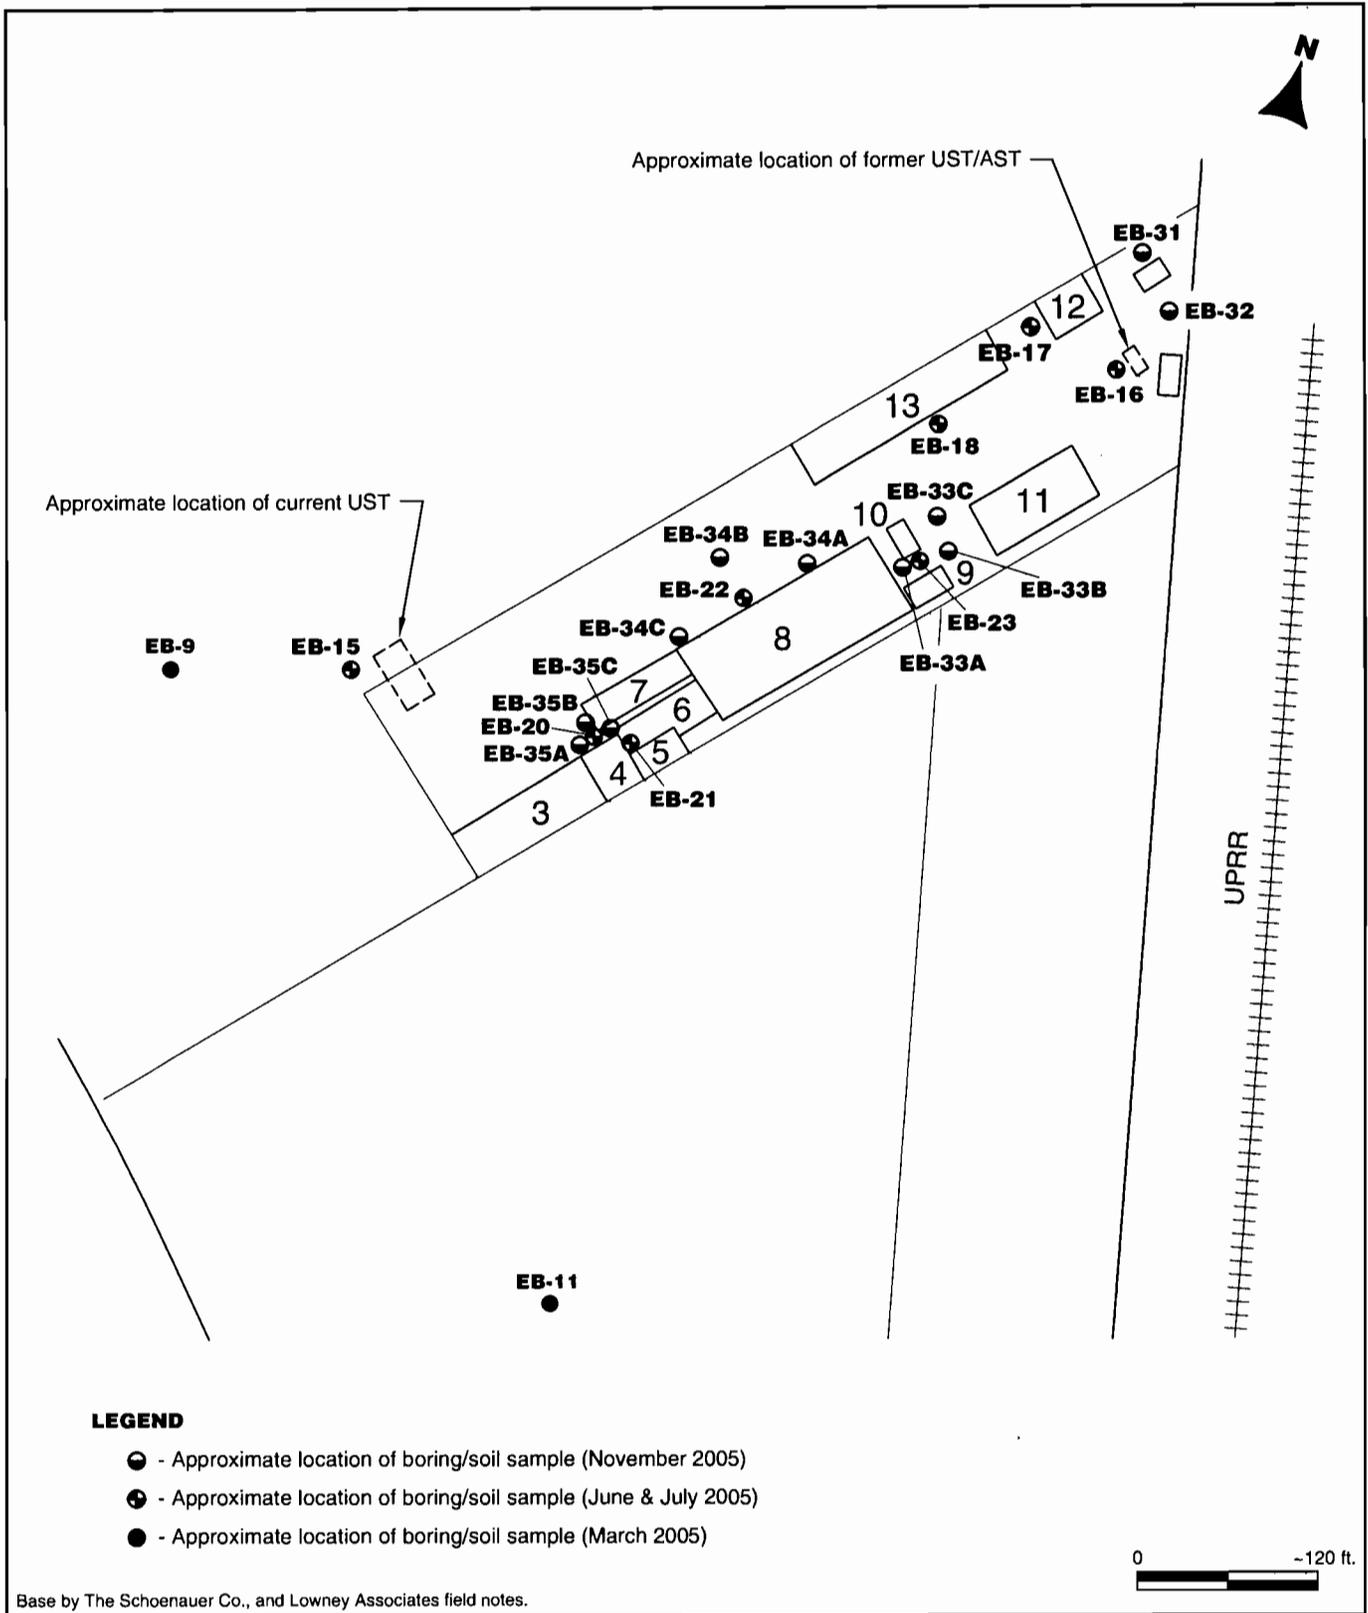
CORORATE YARD SITE PLAN

7/05'EB

One 8,000-gallon split UST (4,000 gallons of gasoline and 4,000 gallons of diesel) was observed on-site during the 2005 Phase I. The UST is currently operational and is located near the southwestern corner of the Corporate Yard (see Figure 3).

In June 2005, one boring (EB-15) was completed to an approximate depth of 16 feet and was located approximately 10 feet west and in the anticipated down-gradient direction (in terms of ground water flow) of the current UST location. Thin layers of dark, cohesive, granular material with a petroleum odor were observed at approximately 5 feet and 9 feet in boring EB-15. Fill material at that location extends to at least a depth of approximately 12 feet. Ground water was encountered at approximately 12 feet deep in boring EB-15.

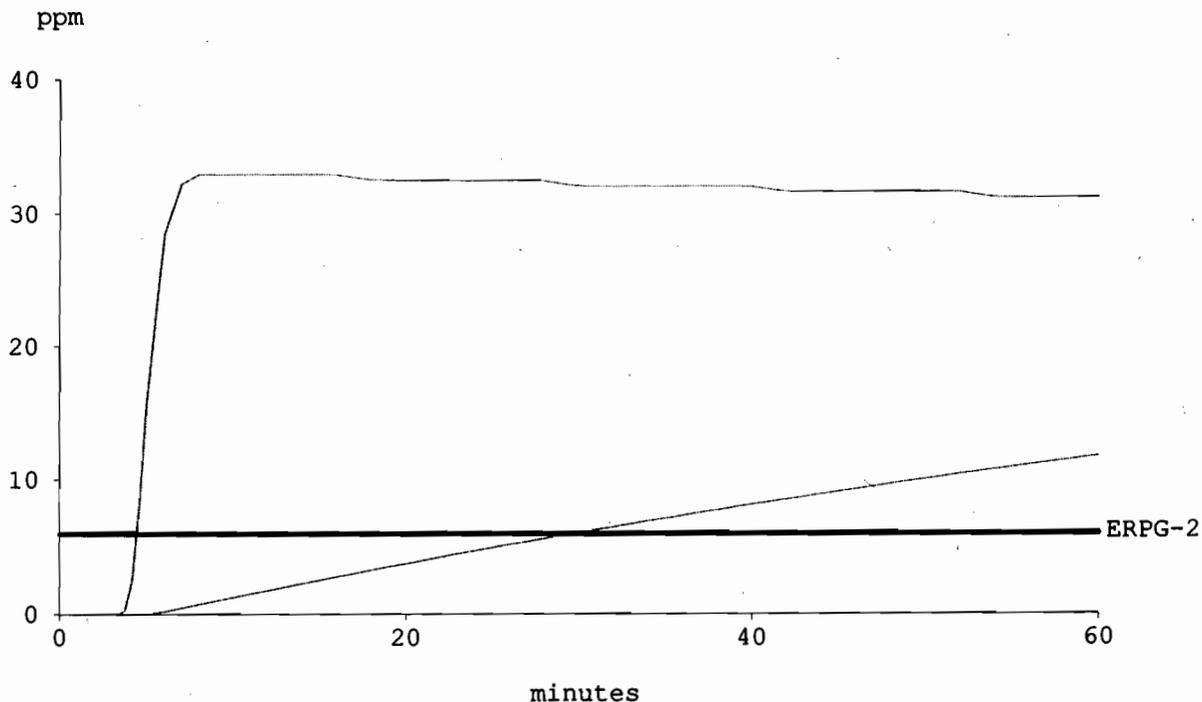
Model Run: Heavy Gas
Concentration Estimates at the point:
Downwind: .25 miles Off Centerline: 0 miles
Max Concentration:
Outdoor: 32.9 ppm
Indoor: 11.7 ppm

— Outdoor Concentration
- - Indoor Concentration

At Point: Downwind: .25 miles Off Centerline: 0 miles

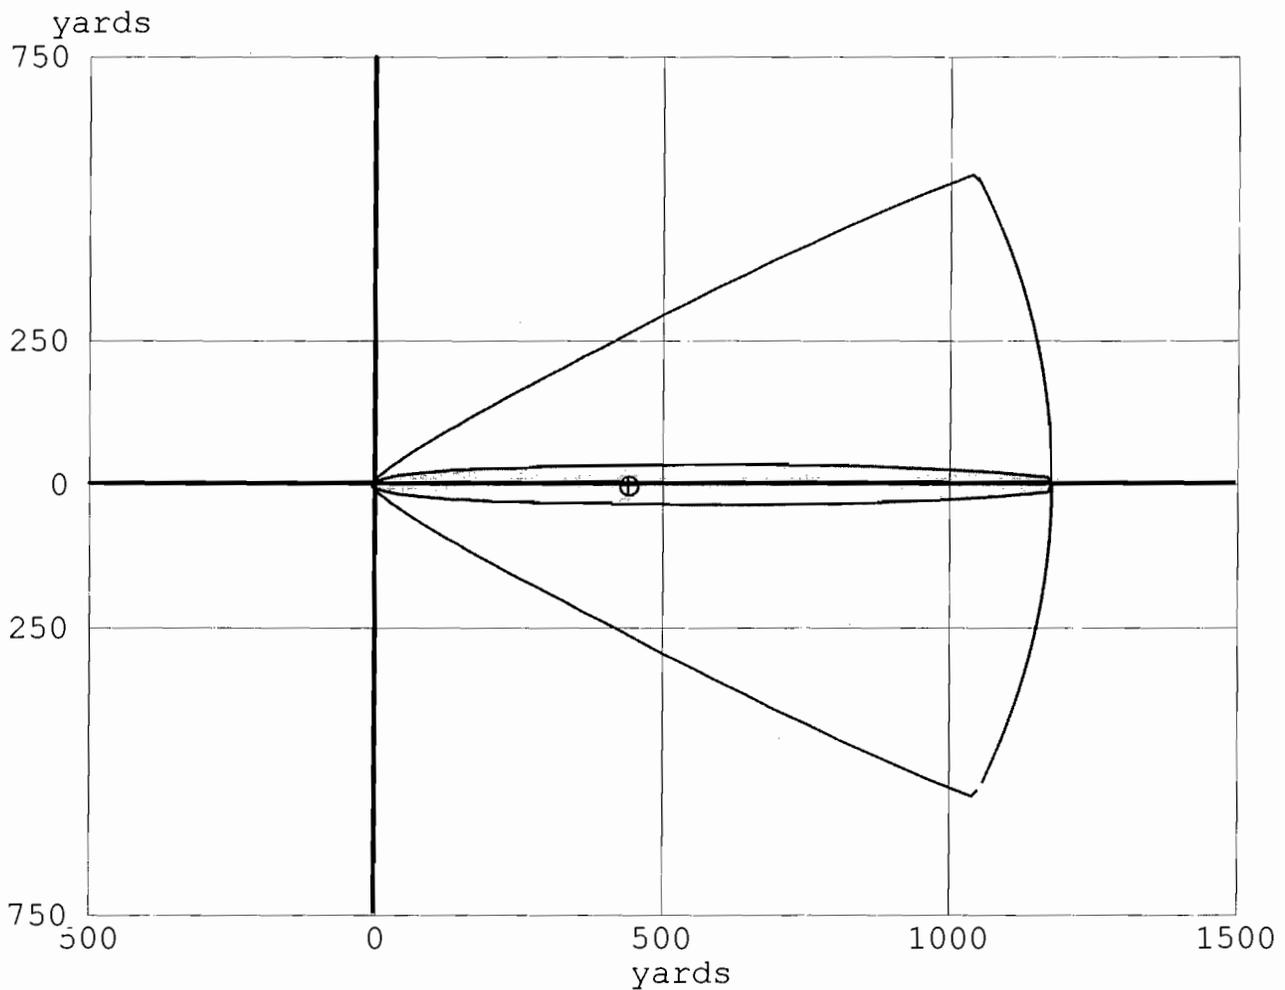
Model Run: Heavy Gas

Red : 1180 yards --- (6 ppm = ERPG-2)

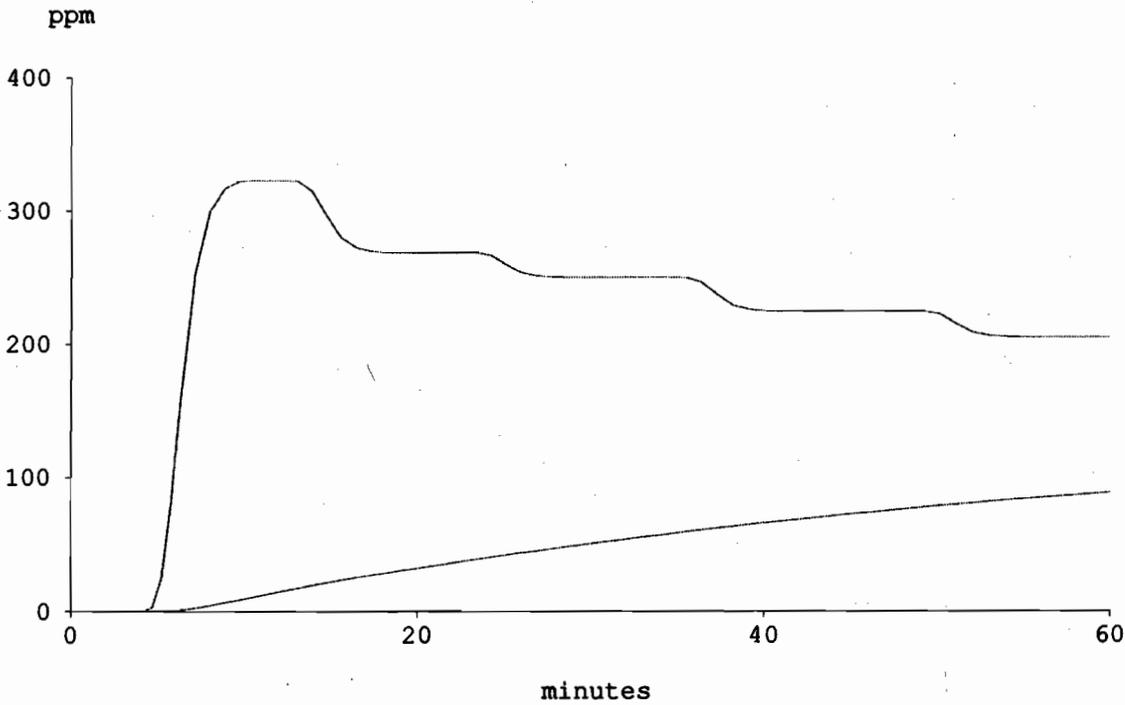
THREAT AT POINT:
Model Run: Heavy Gas
Concentration Estimates at the point:
Downwind: .25 miles Off Centerline: 0 miles
Max Concentration:
Outdoor: 323 ppm
Indoor: 88.6 ppm

— Outdoor Concentration
— Indoor Concentration

At Point: Downwind: .25 miles Off Centerline: 0 miles

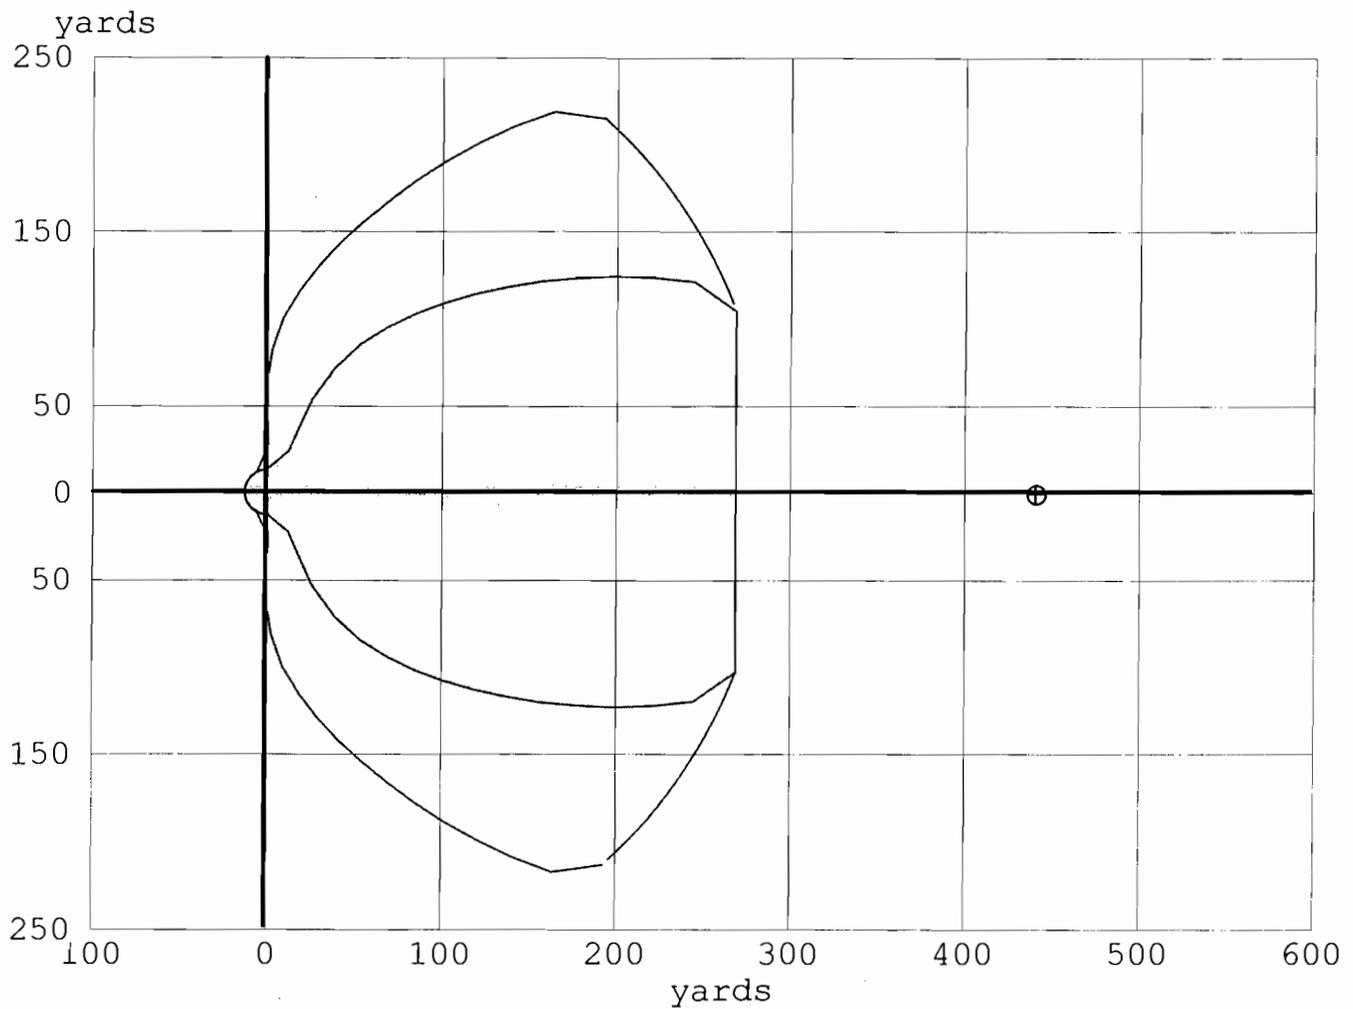
Model Run: Heavy Gas

Red : 270 yards --- (750 ppm = ERPG-2)

≥ 750 ppm = ERPG-2

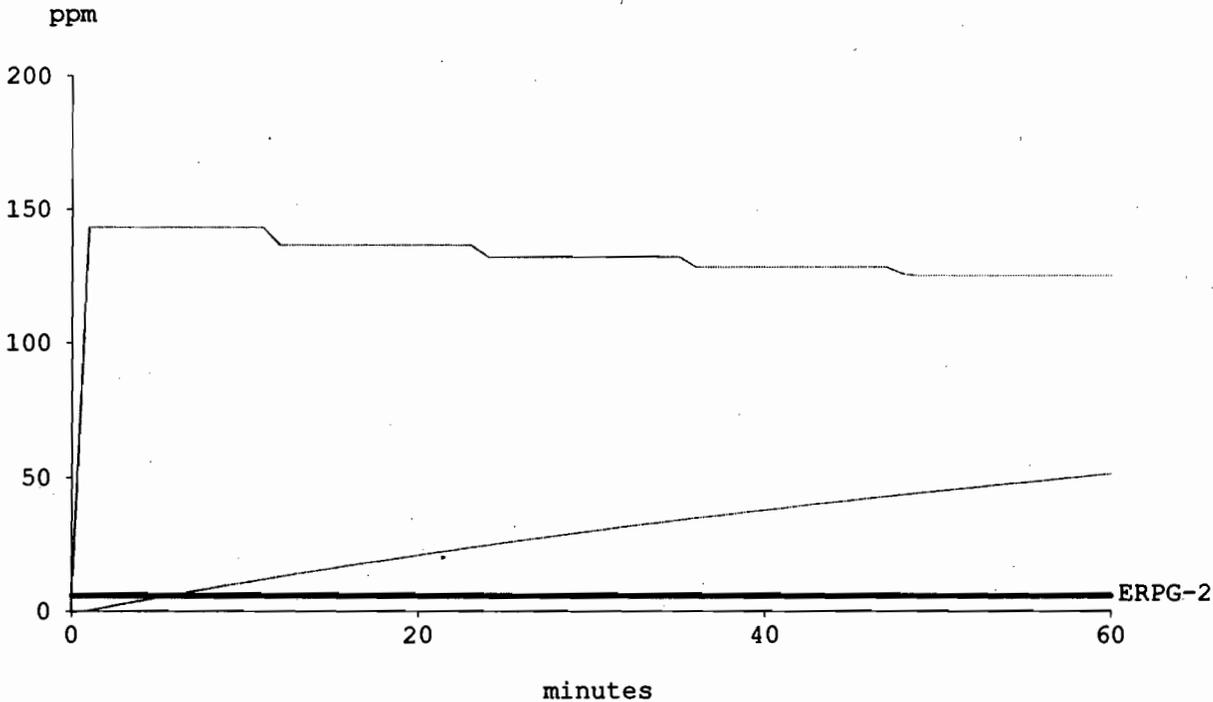
Max Concentration:

Outdoor: 143 ppm

— Outdoor Concentration

- - - Indoor Concentration

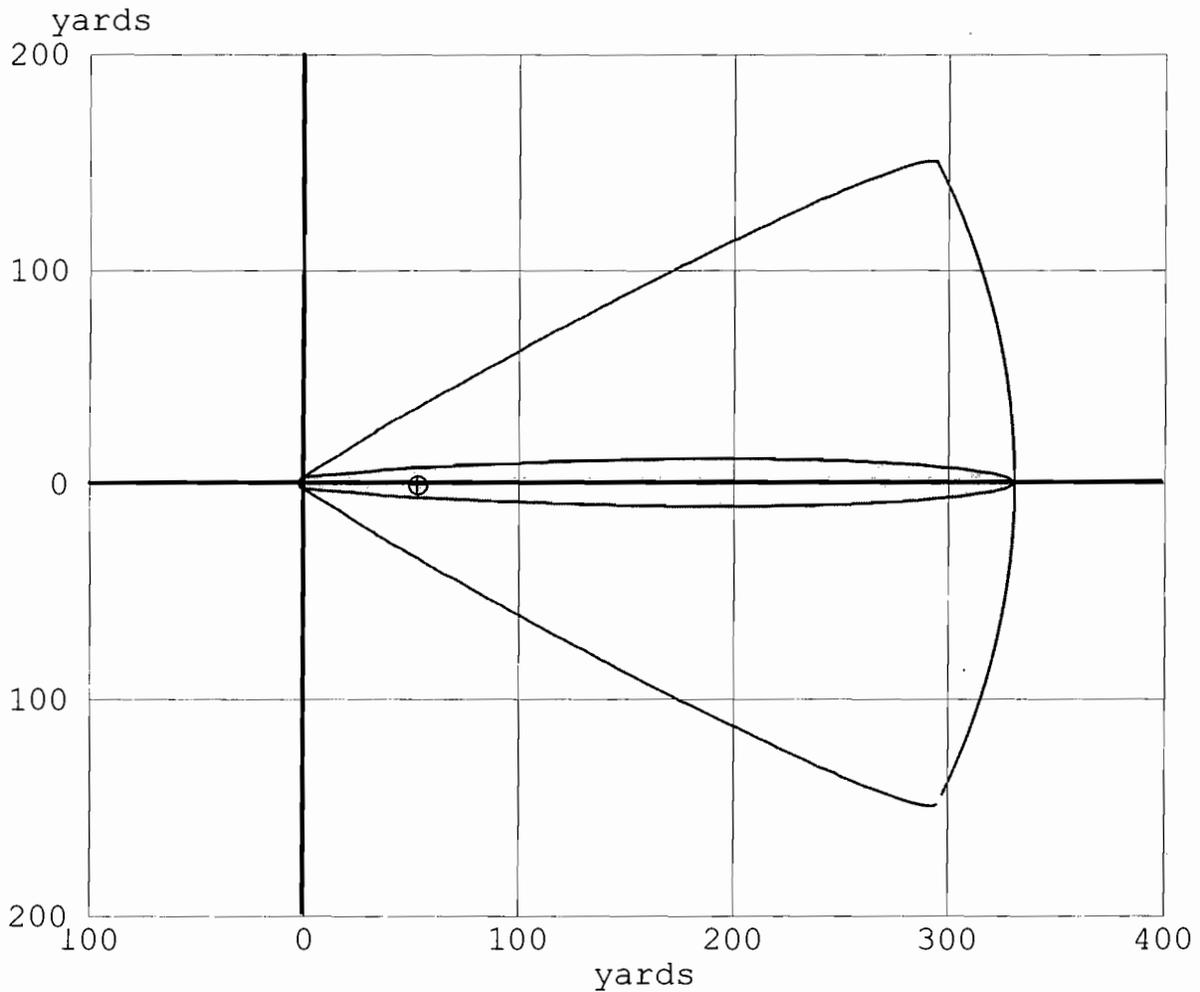
Model Run: Gaussian
Red : 331 yards --- (6 ppm = ERPG-2)

≥ 6 ppm = ERPG-2

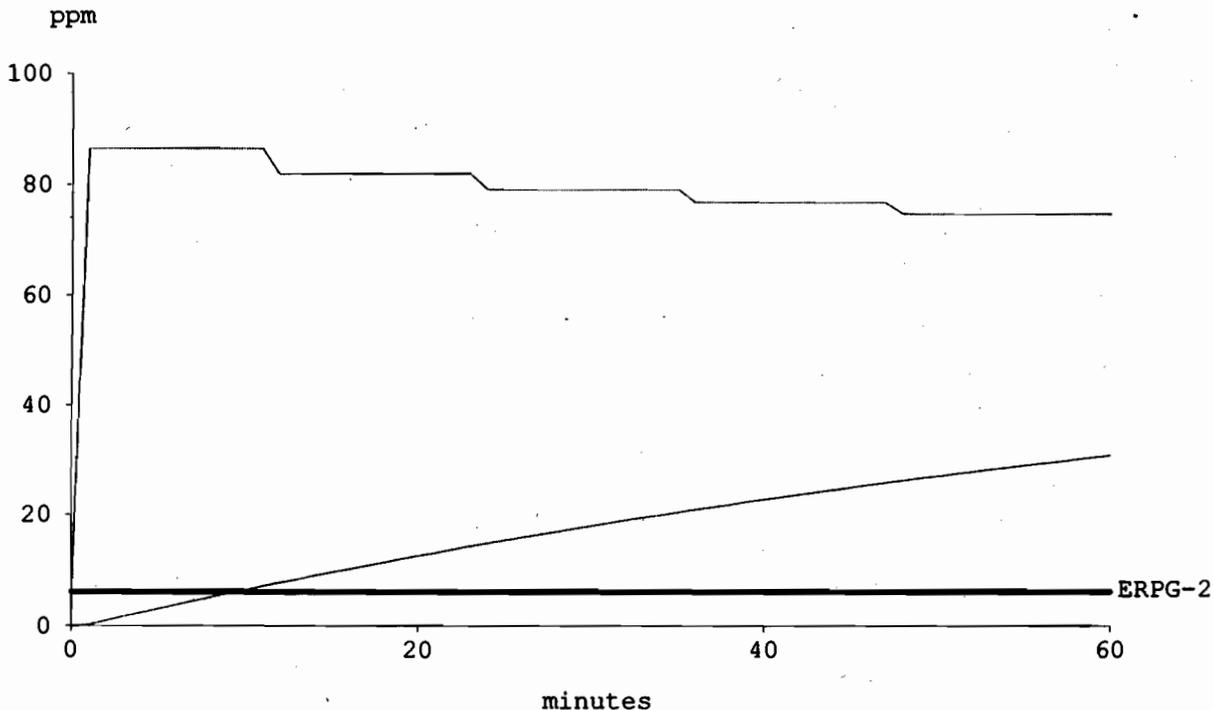
Model Run: Gaussian
Concentration Estimates at the point:
Downwind: 0.03 miles Off Centerline: 0 miles
Max Concentration:
Outdoor: 86.6 ppm

— Outdoor Concentration
- - Indoor Concentration

At Point: Downwind: 0.03 miles Off Centerline: 0 miles

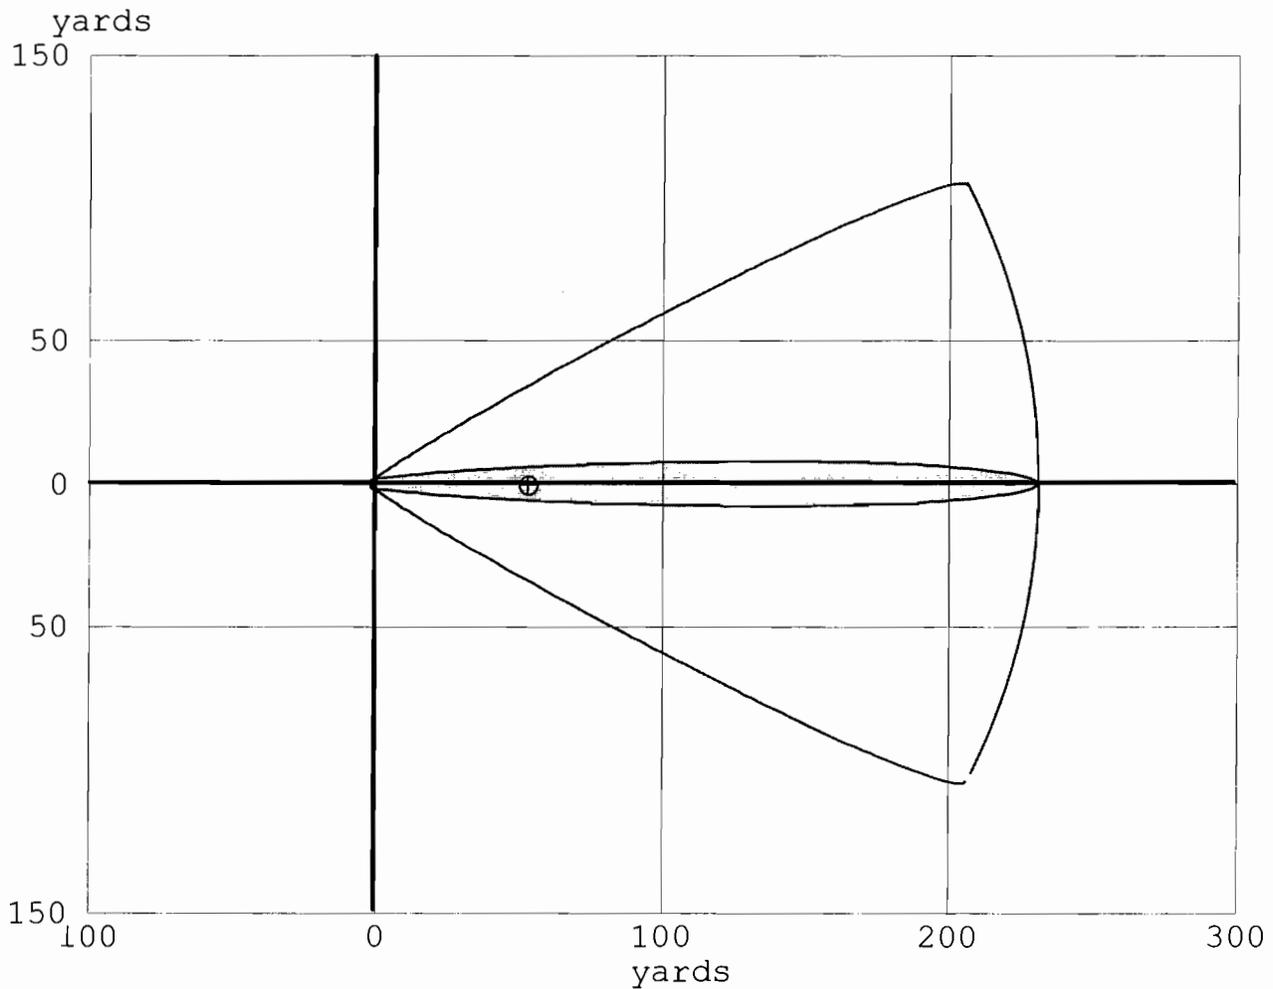
THREAT ZONE:
Model Run: Gaussian
Red : 231 yards --- (6 ppm = ERPG-2)

≥ 6 ppm = ERPG-2

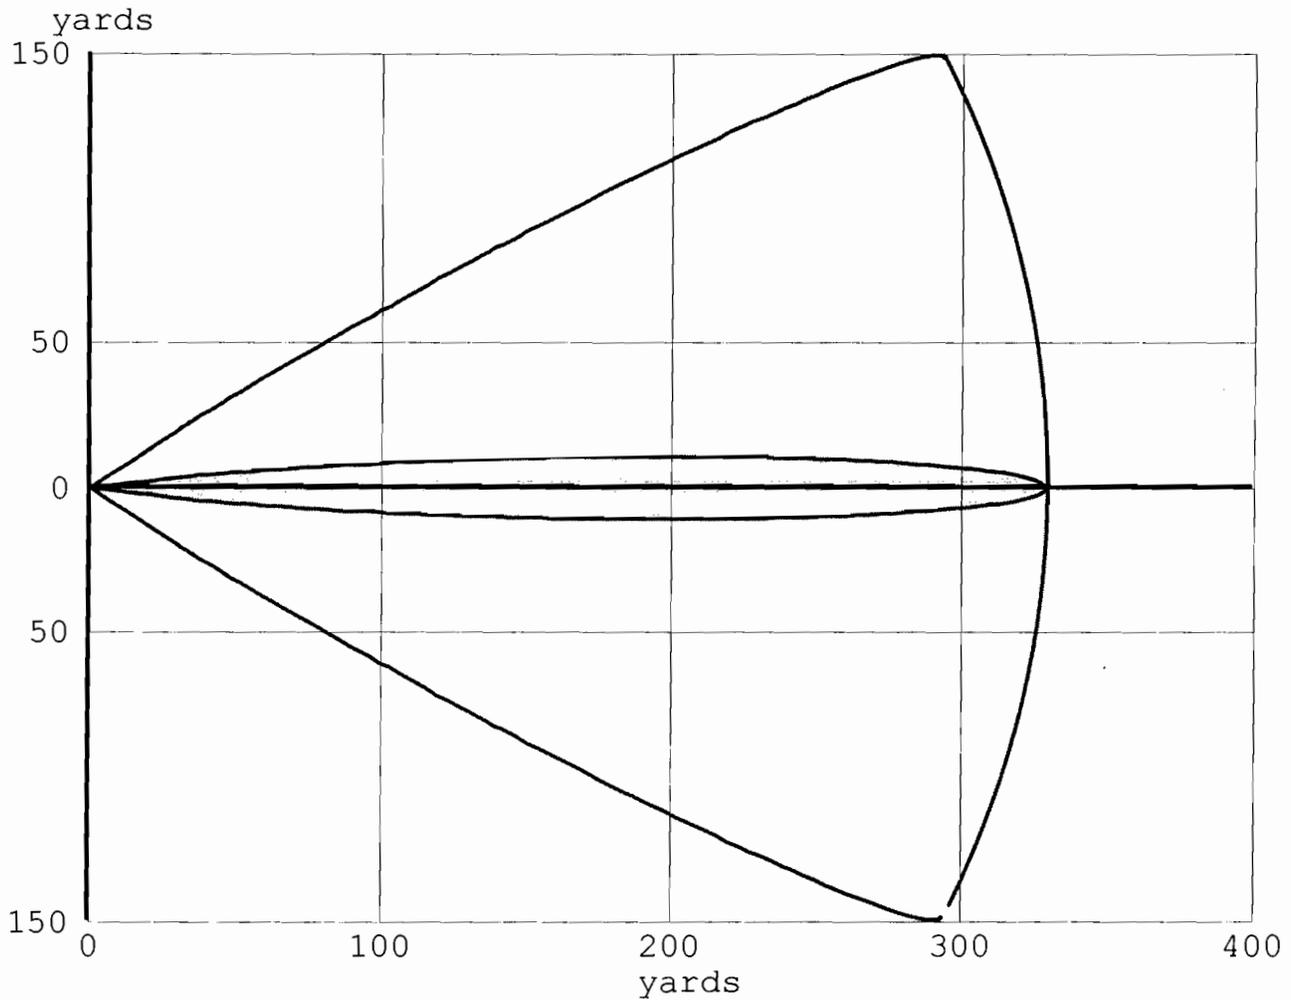
Model Run: Gaussian

Red : 329 yards --- (20 ppm)

- ≥ 20 ppm
- Confidence Lines

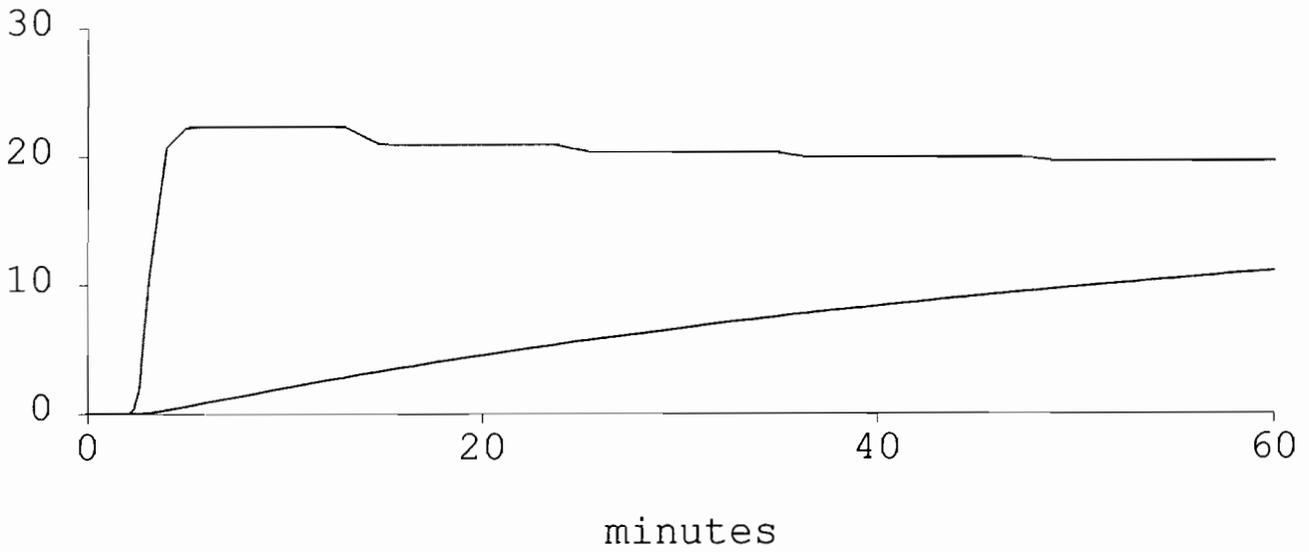
Time: May 25, 2006 1303 hours PDT (using computer's clock)
Chemical Name: CHLOROFORM
Warning: Potential or confirmed human carcinogen.
Building Air Exchanges Per Hour: 0.828 (user specified)
TIME DEPENDENT INFORMATION:
Model Run: Heavy Gas
Concentration Estimates at the point:
Downwind: 625 feet
Off Centerline: 0 feet
Max Concentration:
Outdoor: 22.2 ppm
Indoor: 11 ppm
Note: Indoor graph is shown with a dotted line.

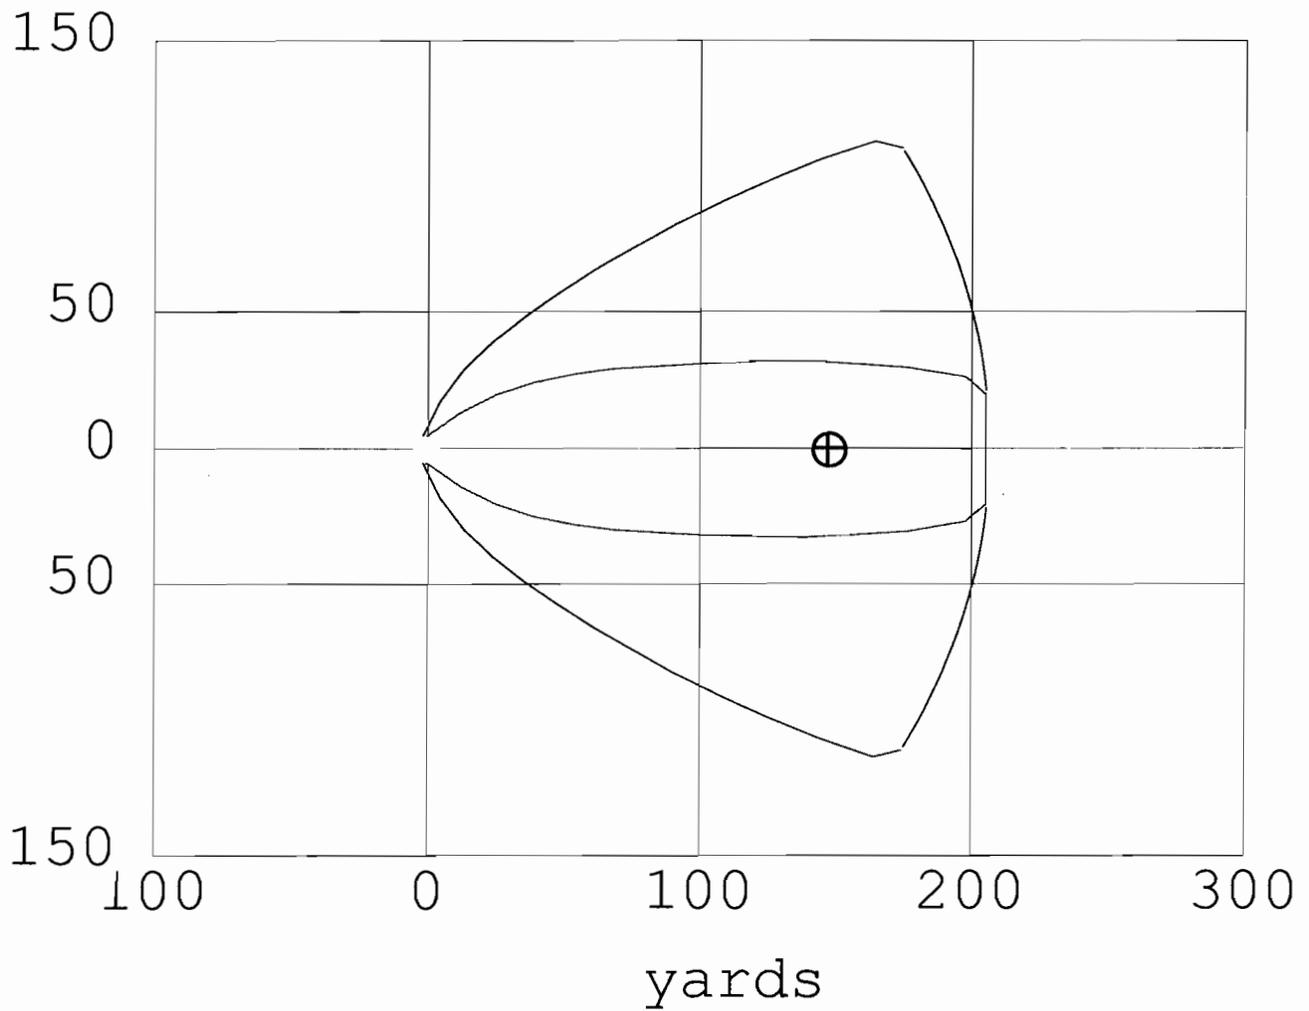
Max Threat Zone for LOC: 206 yards

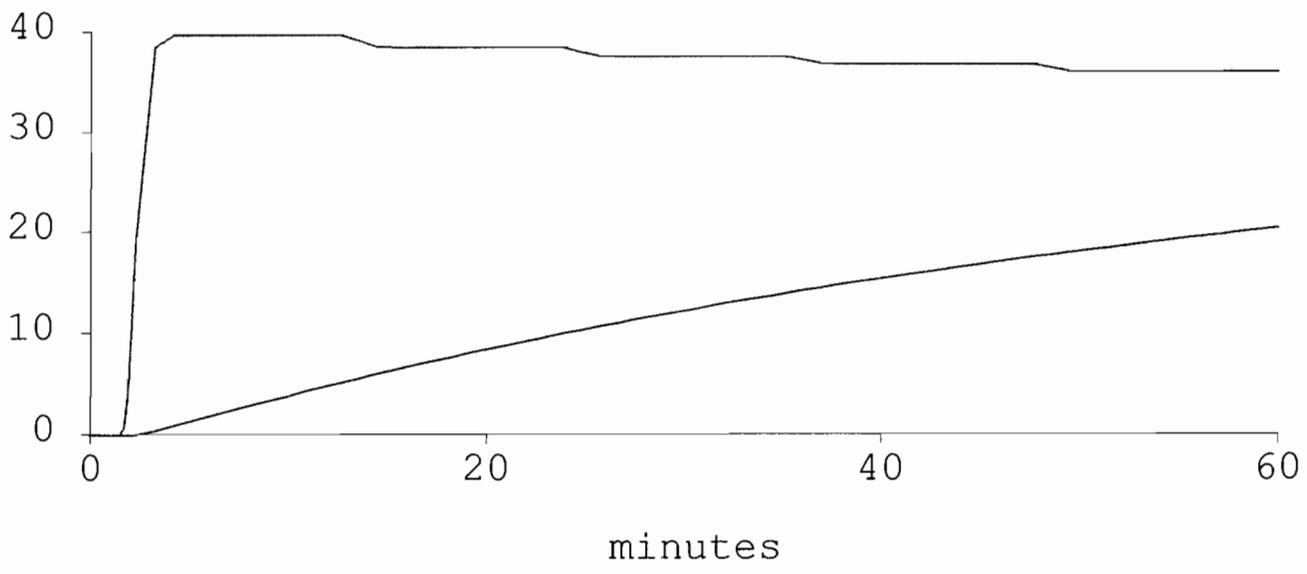
Time: May 25, 2006 1358 hours PDT (using computer's clock)
Chemical Name: HEXANE
Building Air Exchanges Per Hour: 0.828 (user specified)
TIME DEPENDENT INFORMATION:
Model Run: Heavy Gas
Concentration Estimates at the point:
Downwind: 440 feet
Off Centerline: 0 feet
Max Concentration:
Outdoor: 39.6 ppm
Indoor: 20.5 ppm
Note: Indoor graph is shown with a dotted line.

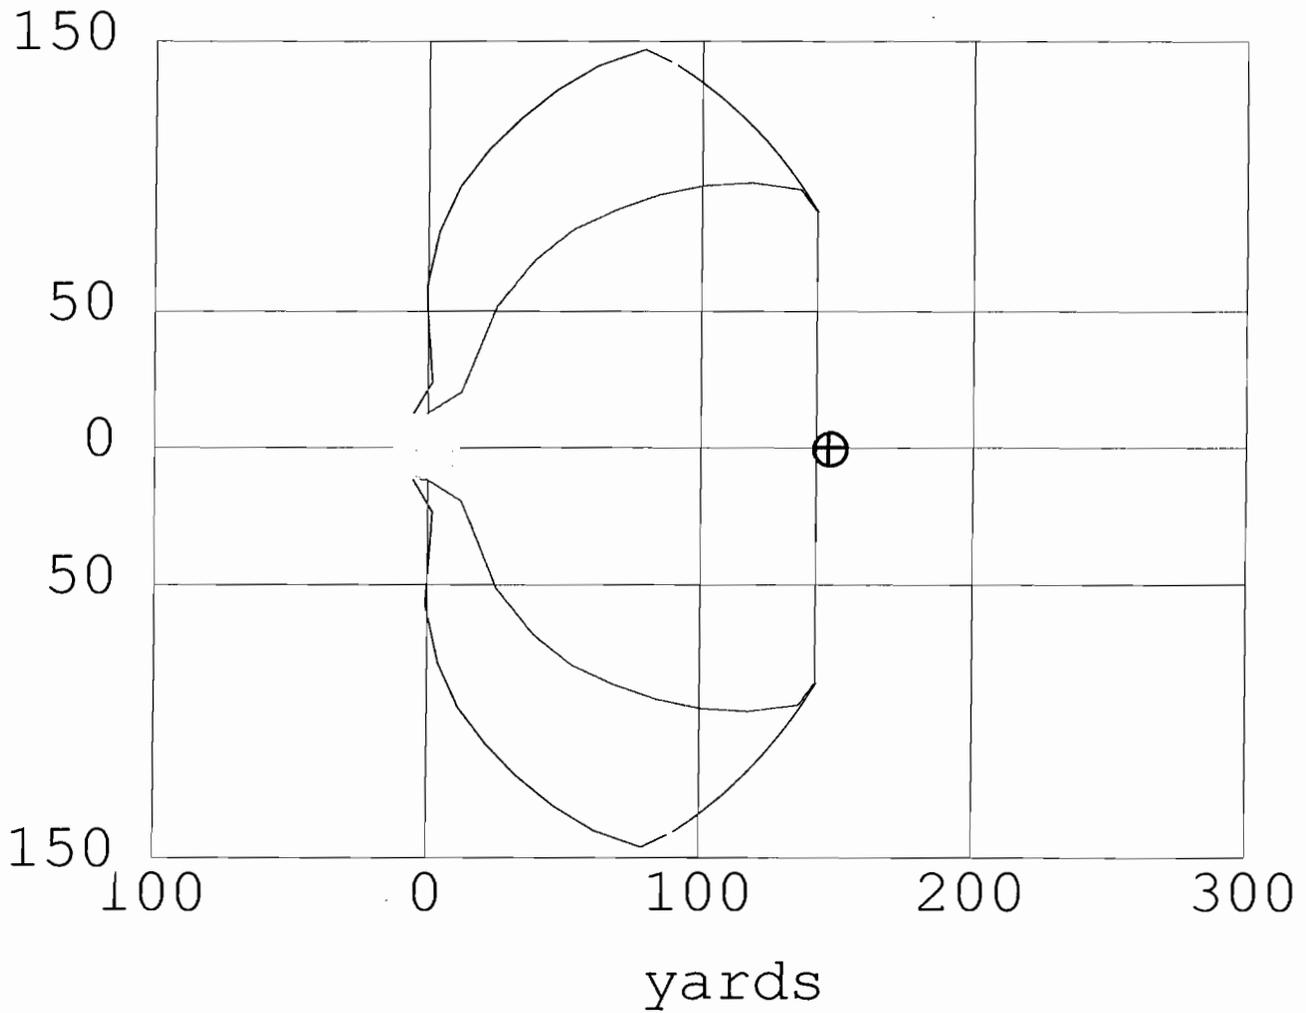
Time: May 25, 2006 1358 hours PDT (using computer's clock)
Chemical Name: DICHLOROMETHANE
Warning: Potential or confirmed human carcinogen.
Wind: 1.5 meters/sec from 0° true at 3 meters
FOOTPRINT INFORMATION:
Model Run: Heavy Gas
User-specified LOC: equals IDLH (2300 ppm)
Max Threat Zone for LOC: 144 yards

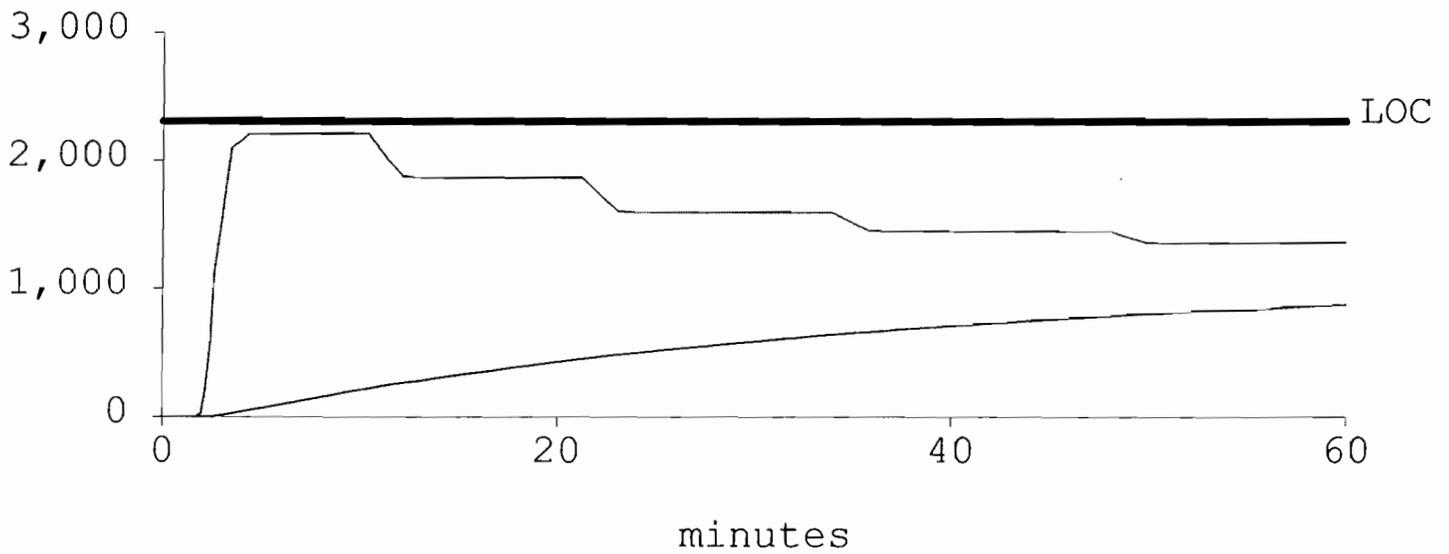
Time: May 25, 2006 1358 hours PDT (using computer's clock)
Chemical Name: DICHLOROMETHANE
Warning: Potential or confirmed human carcinogen.
Building Air Exchanges Per Hour: 0.828 (user specified)
TIME DEPENDENT INFORMATION:
Model Run: Heavy Gas
Concentration Estimates at the point:
Downwind: 440 feet
Off Centerline: 0 feet
Max Concentration:
Outdoor: 2,210 ppm
Indoor: 873 ppm
Note: Indoor graph is shown with a dotted line.
