APPENDIX G

HAZARDOUS MATERIALS

**Phase I Environmental
Site Assessment**
San Jose Flea Market
San Jose, California

March 30, 2005
Project No. 2121-1

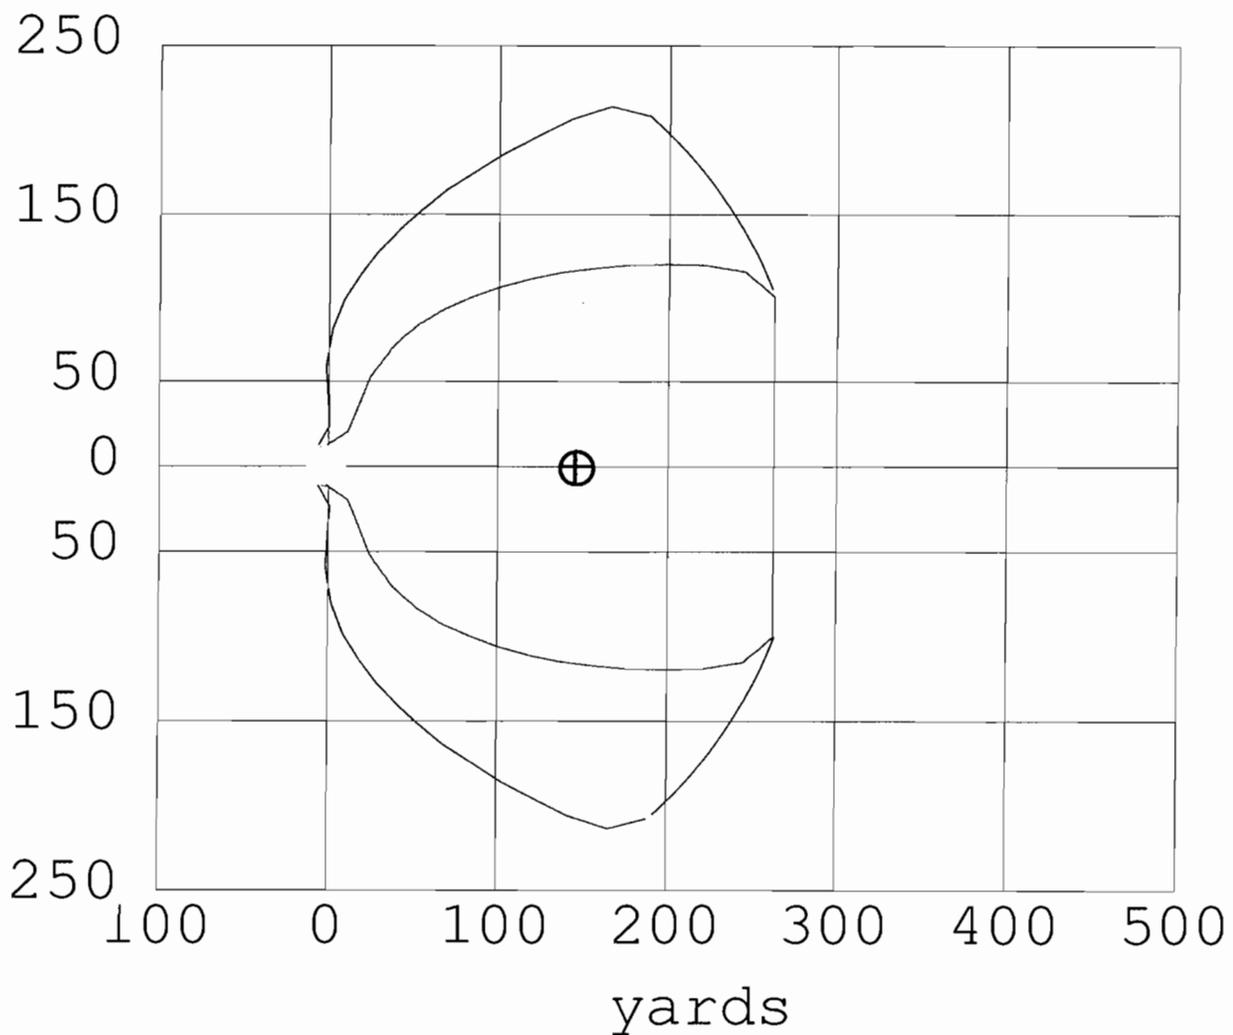
Time: May 25, 2006 1358 hours PDT (using computer's clock)
Chemical Name: DICHLOROMETHANE
Warning: Potential or confirmed human carcinogen.
Wind: 1.5 meters/sec from 0° true at 3 meters
FOOTPRINT INFORMATION:
Model Run: Heavy Gas
User-specified LOC: 750 ppm
Max Threat Zone for LOC: 263 yards
