# **Habitat Mitigation and Monitoring Plan Alum Rock Park Bank Repair and Stream Restoration Projects**

**July 2011**

Appendix A – Figures  
Appendix B – Project Plans  
Appendix C – Project Photographs  
Appendix D – OHMM Delineation Report

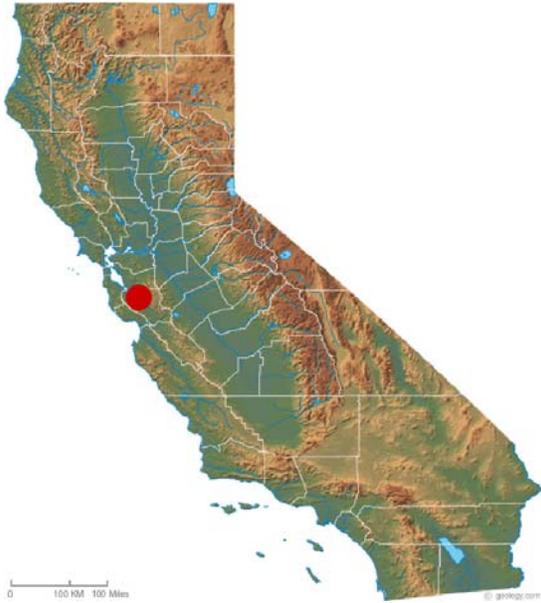
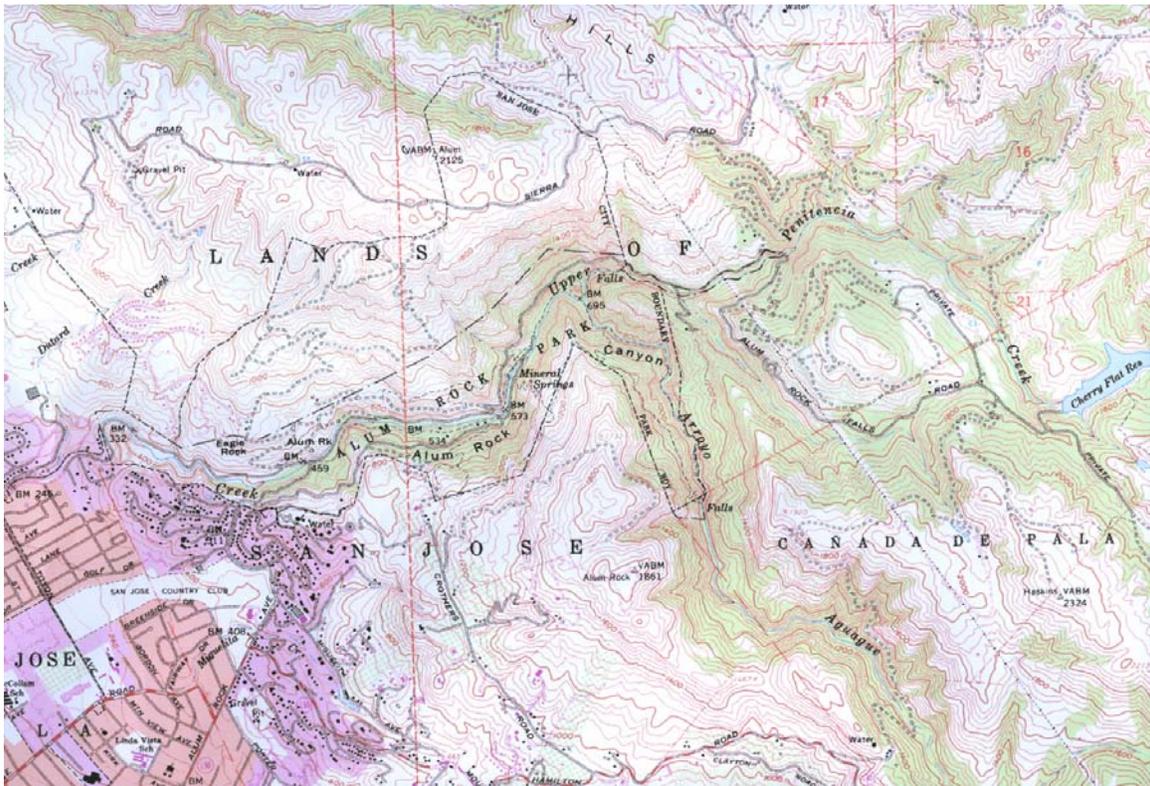
**Figure 1.** Location and Vicinity Maps

Source: California State Geological Survey

Source: USGS Calaveras Reservoir topographic quadrangle.

The project site is located along Upper Penitencia Creek within the 720-acre Alum Rock Park, in the foothills of the Diablo Range just east of San José (Appendix A - Figure 1, Vicinity Map). APN No. 595-07-015, 599-25-001, 612-46-001.

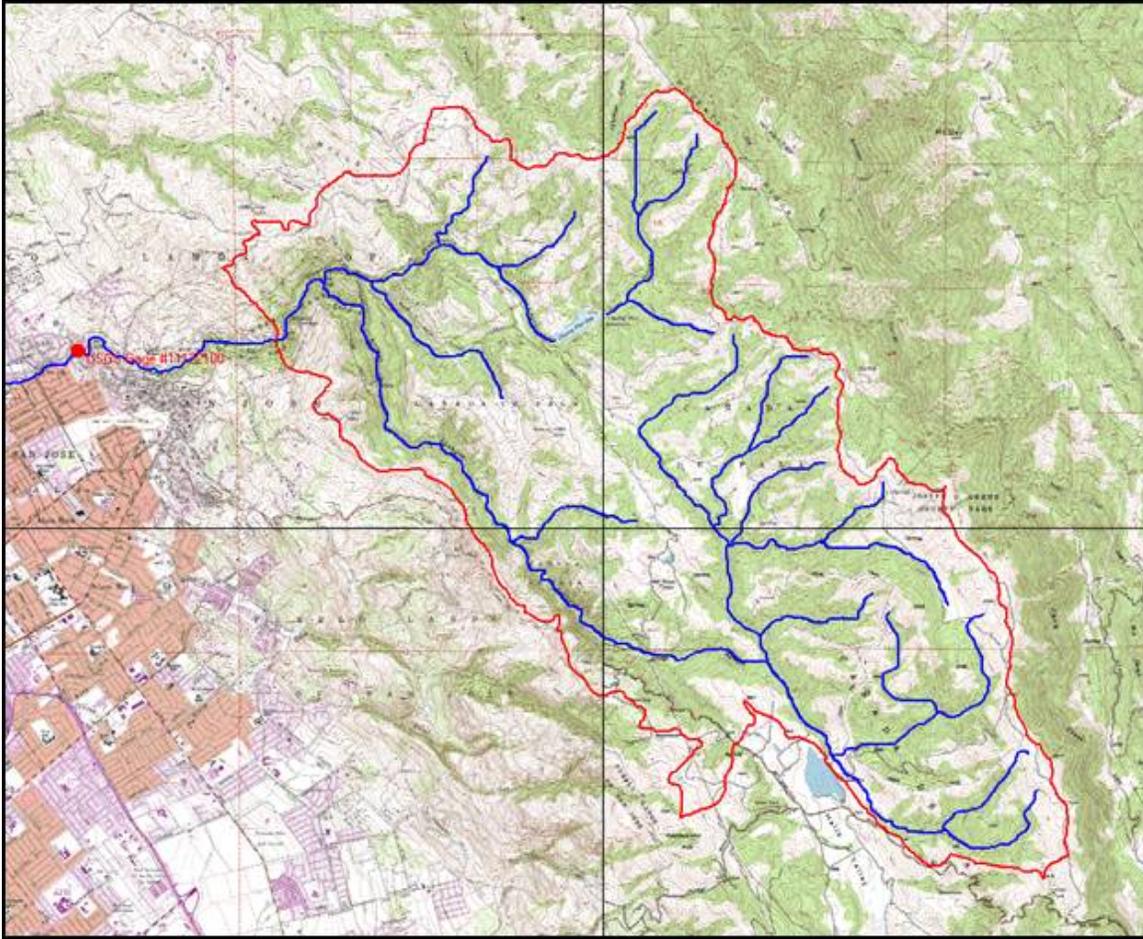
**Figure 2.** Watershed Map, showing the Upper Penitencia Creek drainage above the project site.

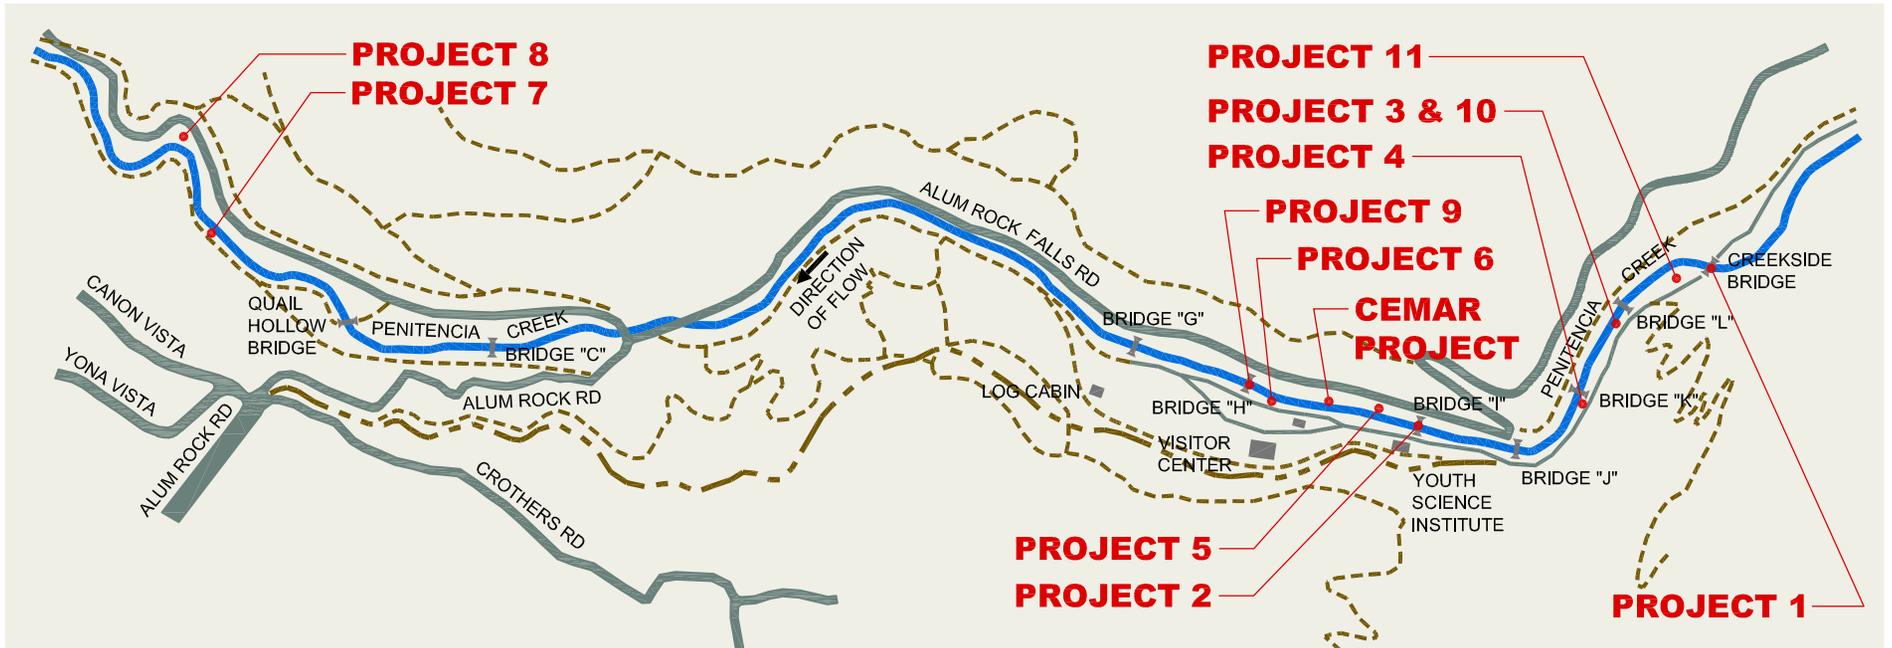
**PROJECT 1**

Creekside bridge repair: retaining wall, new concrete apron, revetment slope, grading.

Youth Science Institute bridge repair: retaining wall, new asphalt concrete pavement, revetment slope, grading.

Repair of rock wall (Project 3) and expansion of floodplain on east bank immediately downstream of historic foot bridge "L" (Project 10).

Repair of undercut section of rock wall on east bank immediately downstream of historic foot bridge "K".

Repair of eroded rill at end of north bank vertical rock wall directly adjacent to grade control structure.

Repair of failed bank protection project adjacent to Visitors Center. This project was originally constructed as part of the Phase II projects in 2001 (RMP, "Site #18").

Repair/protect failing south bank along trail downstream of Quail Hollow Bridge.

Repair of failing north bank sack concrete wall at sharp bend in top of bank road.

Repair/protection of the abutments/footings, repair of the rock railing, and bank repair at the Visitors Center Bridge (Bridge "H").

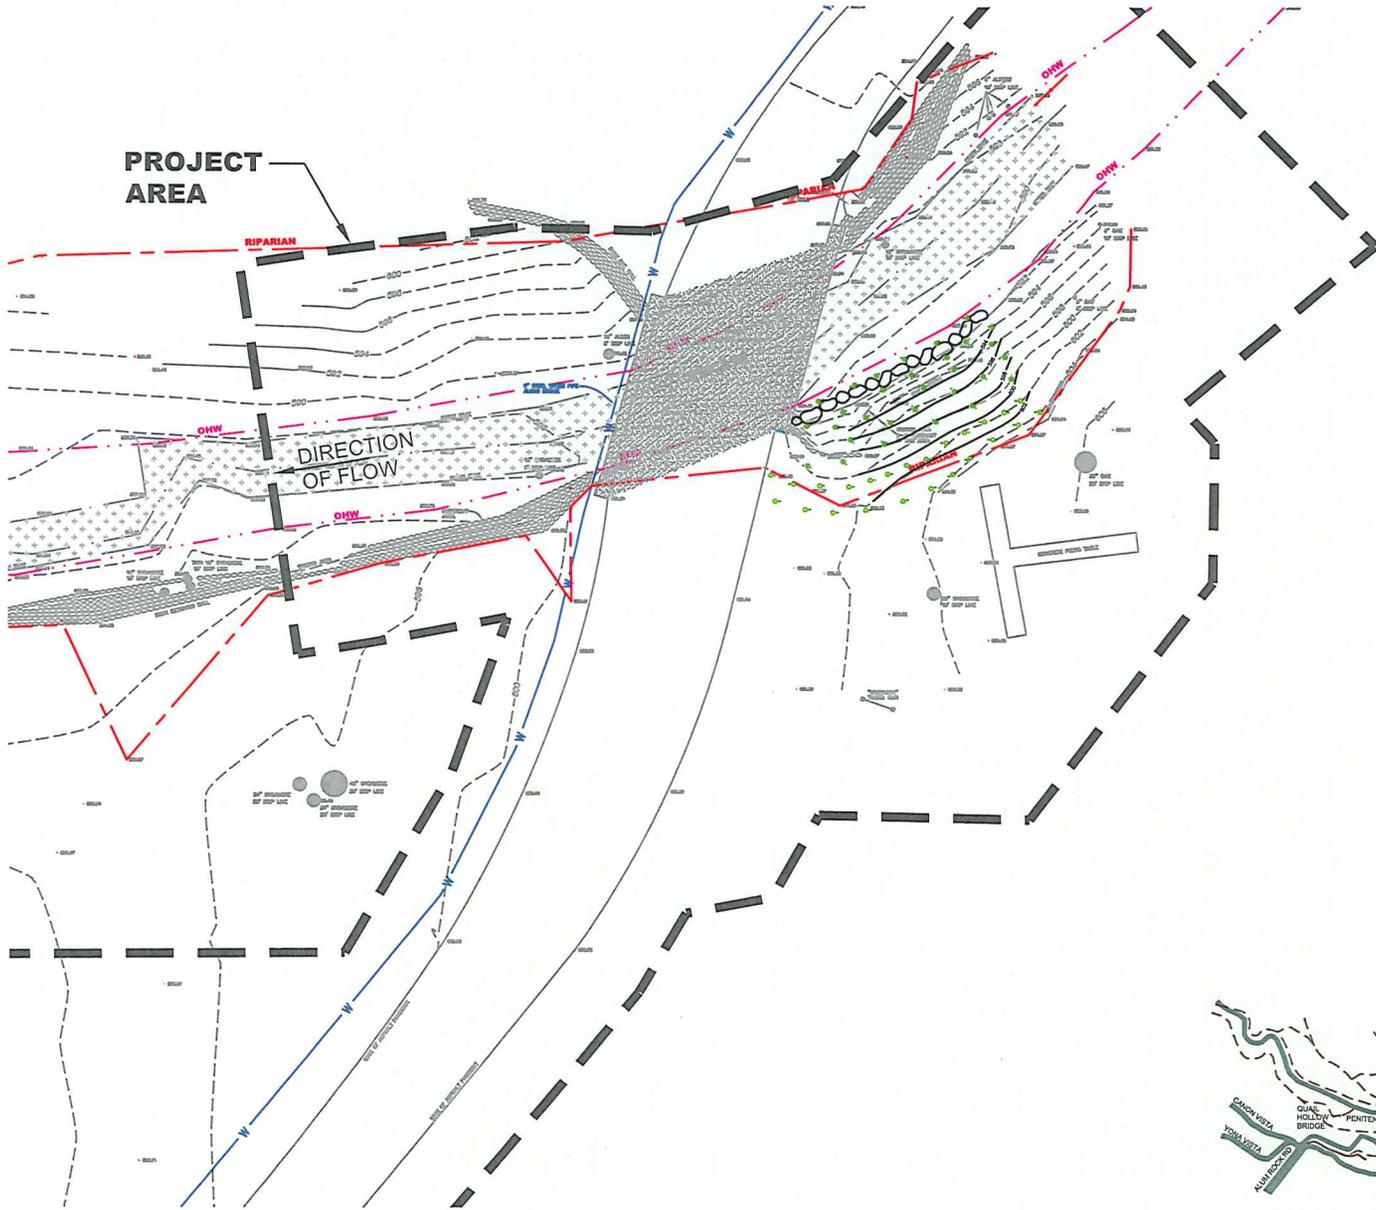
FIGURE 2  
PROJECT 1  
CREEKSIDE BRIDGE REPAIR

**SITE PLAN**  
SCALE: 1"=30'

##### **Project 1. Creekside Bridge Abutment Repair**

Project 1 is located at the upstream section of the Creekside Bridge along the existing left (south) bank. The left bank at this location is the outside bank at the end of a minor bend. This bend is causing erosion to occur at the left (south) abutment just before the entrance of the bridge. The erosion is causing riprap that was placed as artificial fill during the bridge construction to be exposed and migrate downstream. The erosion of the riprap and fill on the left bank is exposing the left abutment and has the potential to undermine the abutment and cause the bridge to fail.

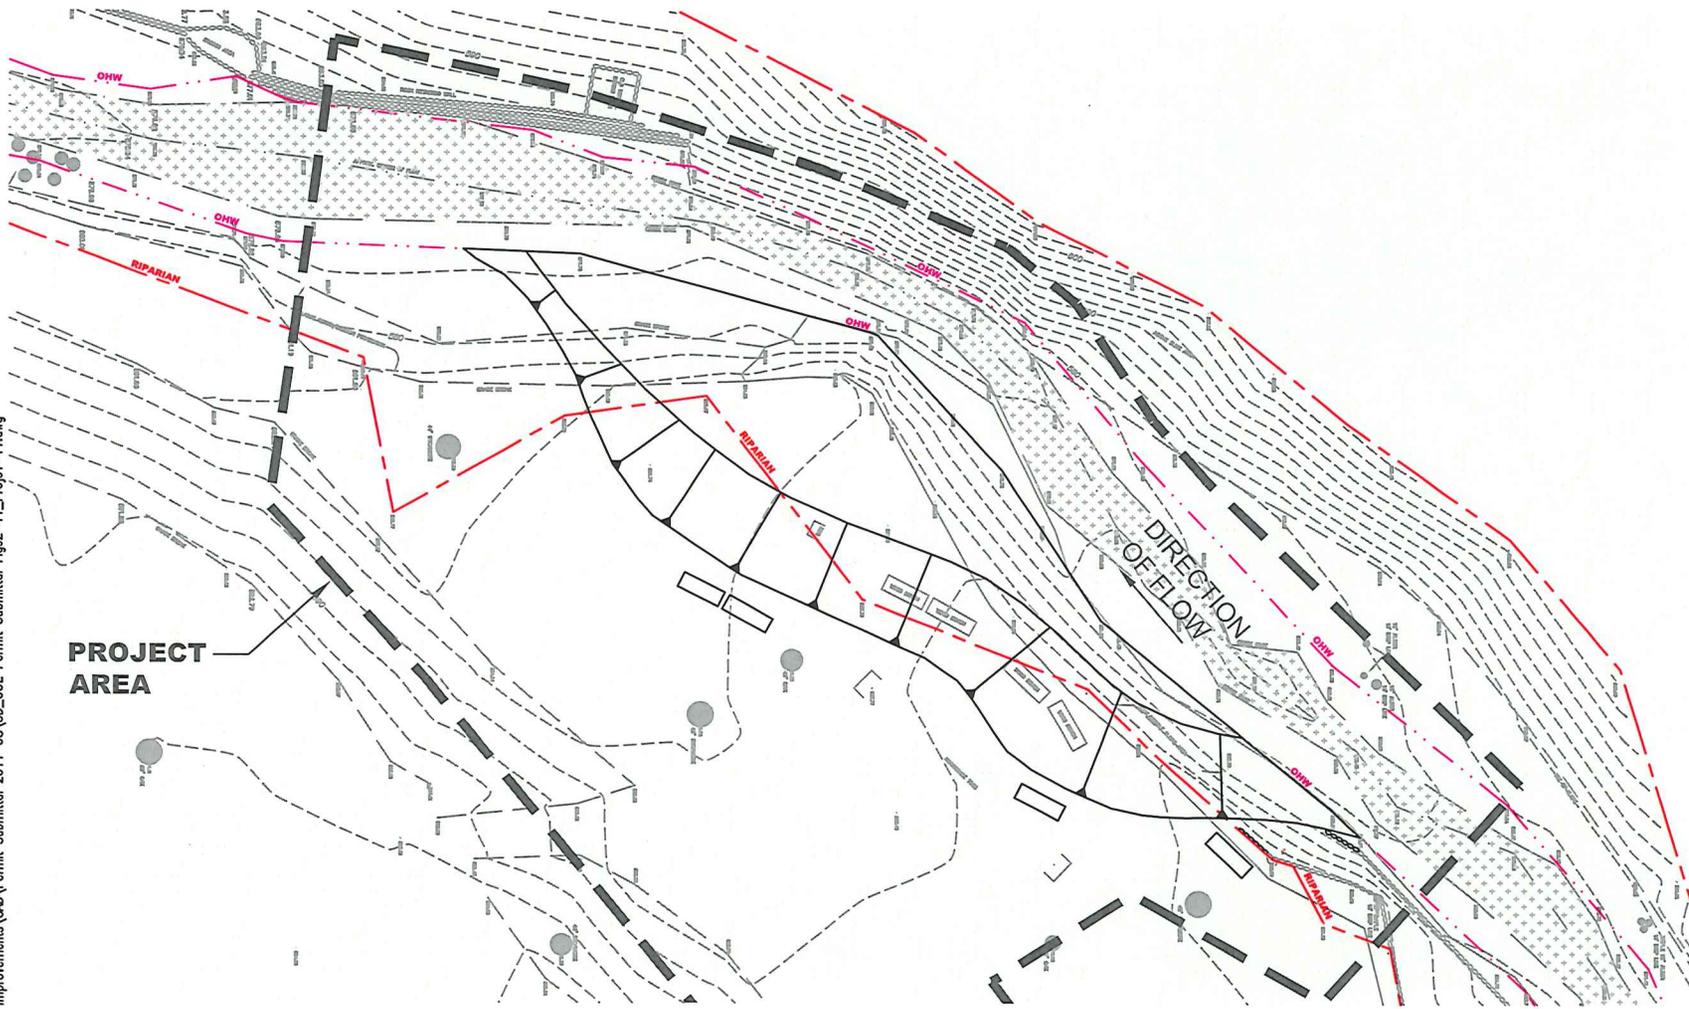
**FIGURE 3  
PROJECT 11  
PROPOSED EROSION REPAIRS**

**SITE PLAN**

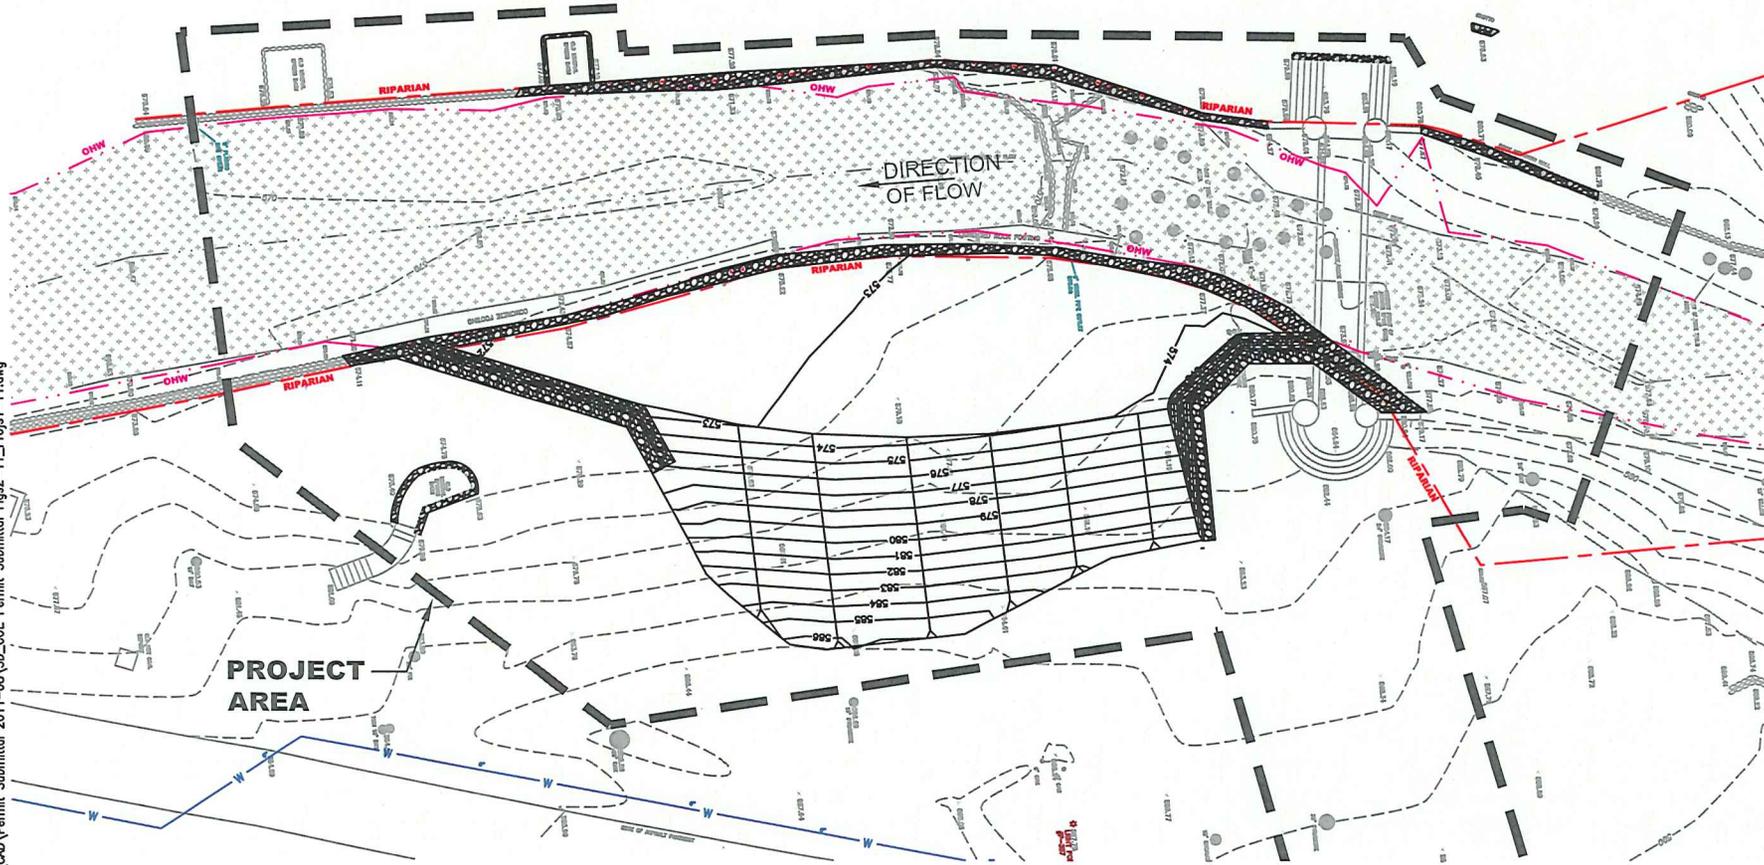
FIGURE 4  
PROJECTS 3 AND 10  
PROPOSED EROSION REPAIRS

### SITE PLAN

##### **Projects 3 and 10: Bridge L Wall Repair and Floodplain Expansion**

This sub-project consists of repair of the rock wall and expansion of floodplain downstream of Bridge L. Immediately downstream of Bridge L, a rock wall on the east bank is undercut for a length of approximately 25 feet. The wall constrains the stream, which is only 25 feet wide at this location, which results in increased channel velocity and scour. The restoration action at site

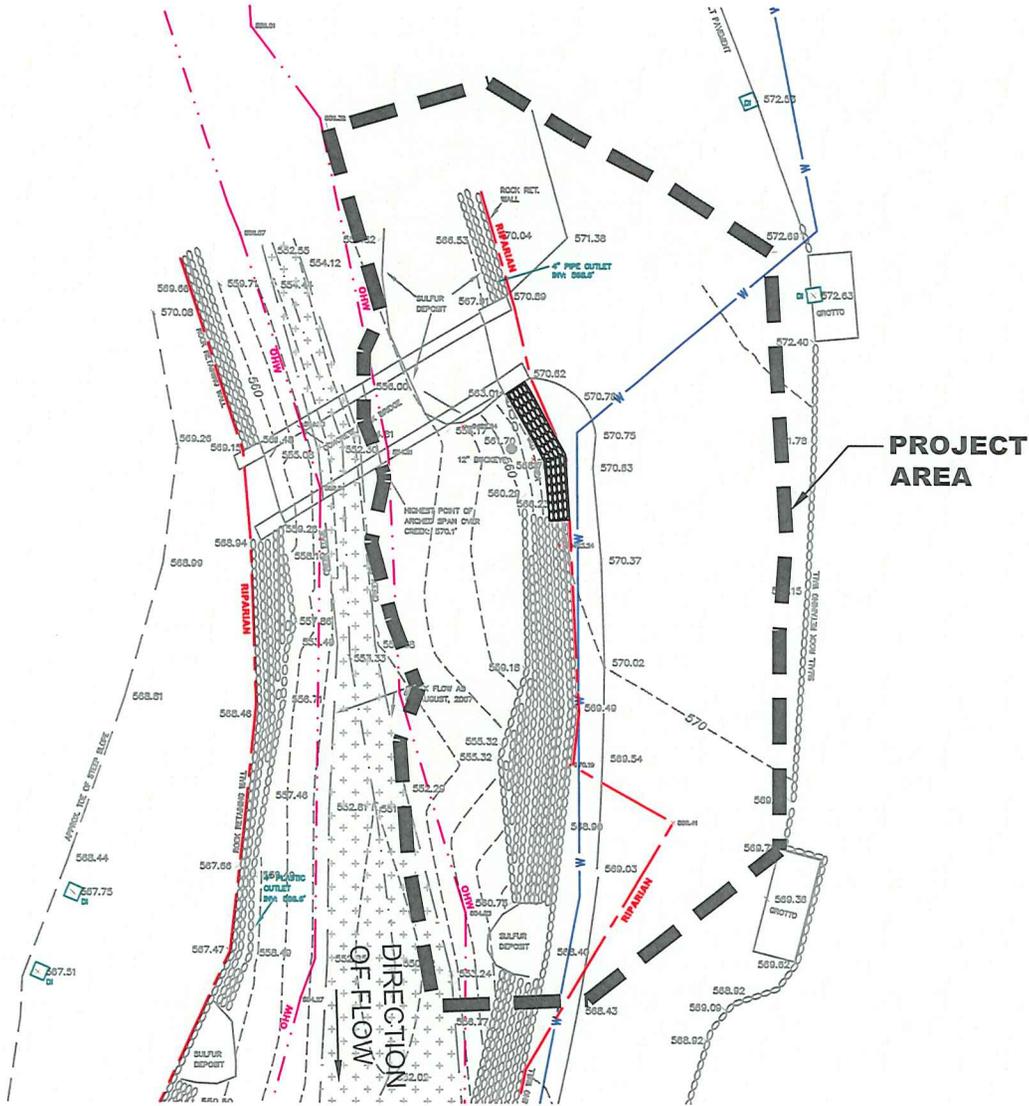
PROPOSED DAMAGED WALL REPAIR

**SITE PLAN**

#### **Project 4: Bridge K Rock Wall Repair**

This sub-project consists of repair of an undercut section of rock wall on the east bank downstream of historic Bridge K. A rock and mortar wall immediately downstream of Bridge K has failed, exposing unstable soil and making additional sections of wall and a nearby asphalt path vulnerable to storm damage. In-kind repair is proposed, using native rocks and mortar and with the addition of weep holes. The project is more than 15 horizontal feet and 7 vertical feet away from the ordinary high water line of Upper Penitencia Creek and is limited to bank repair work. There will be no impacts to waters or wetlands. The repair activities will reduce the future risk of erosion and sedimentation.

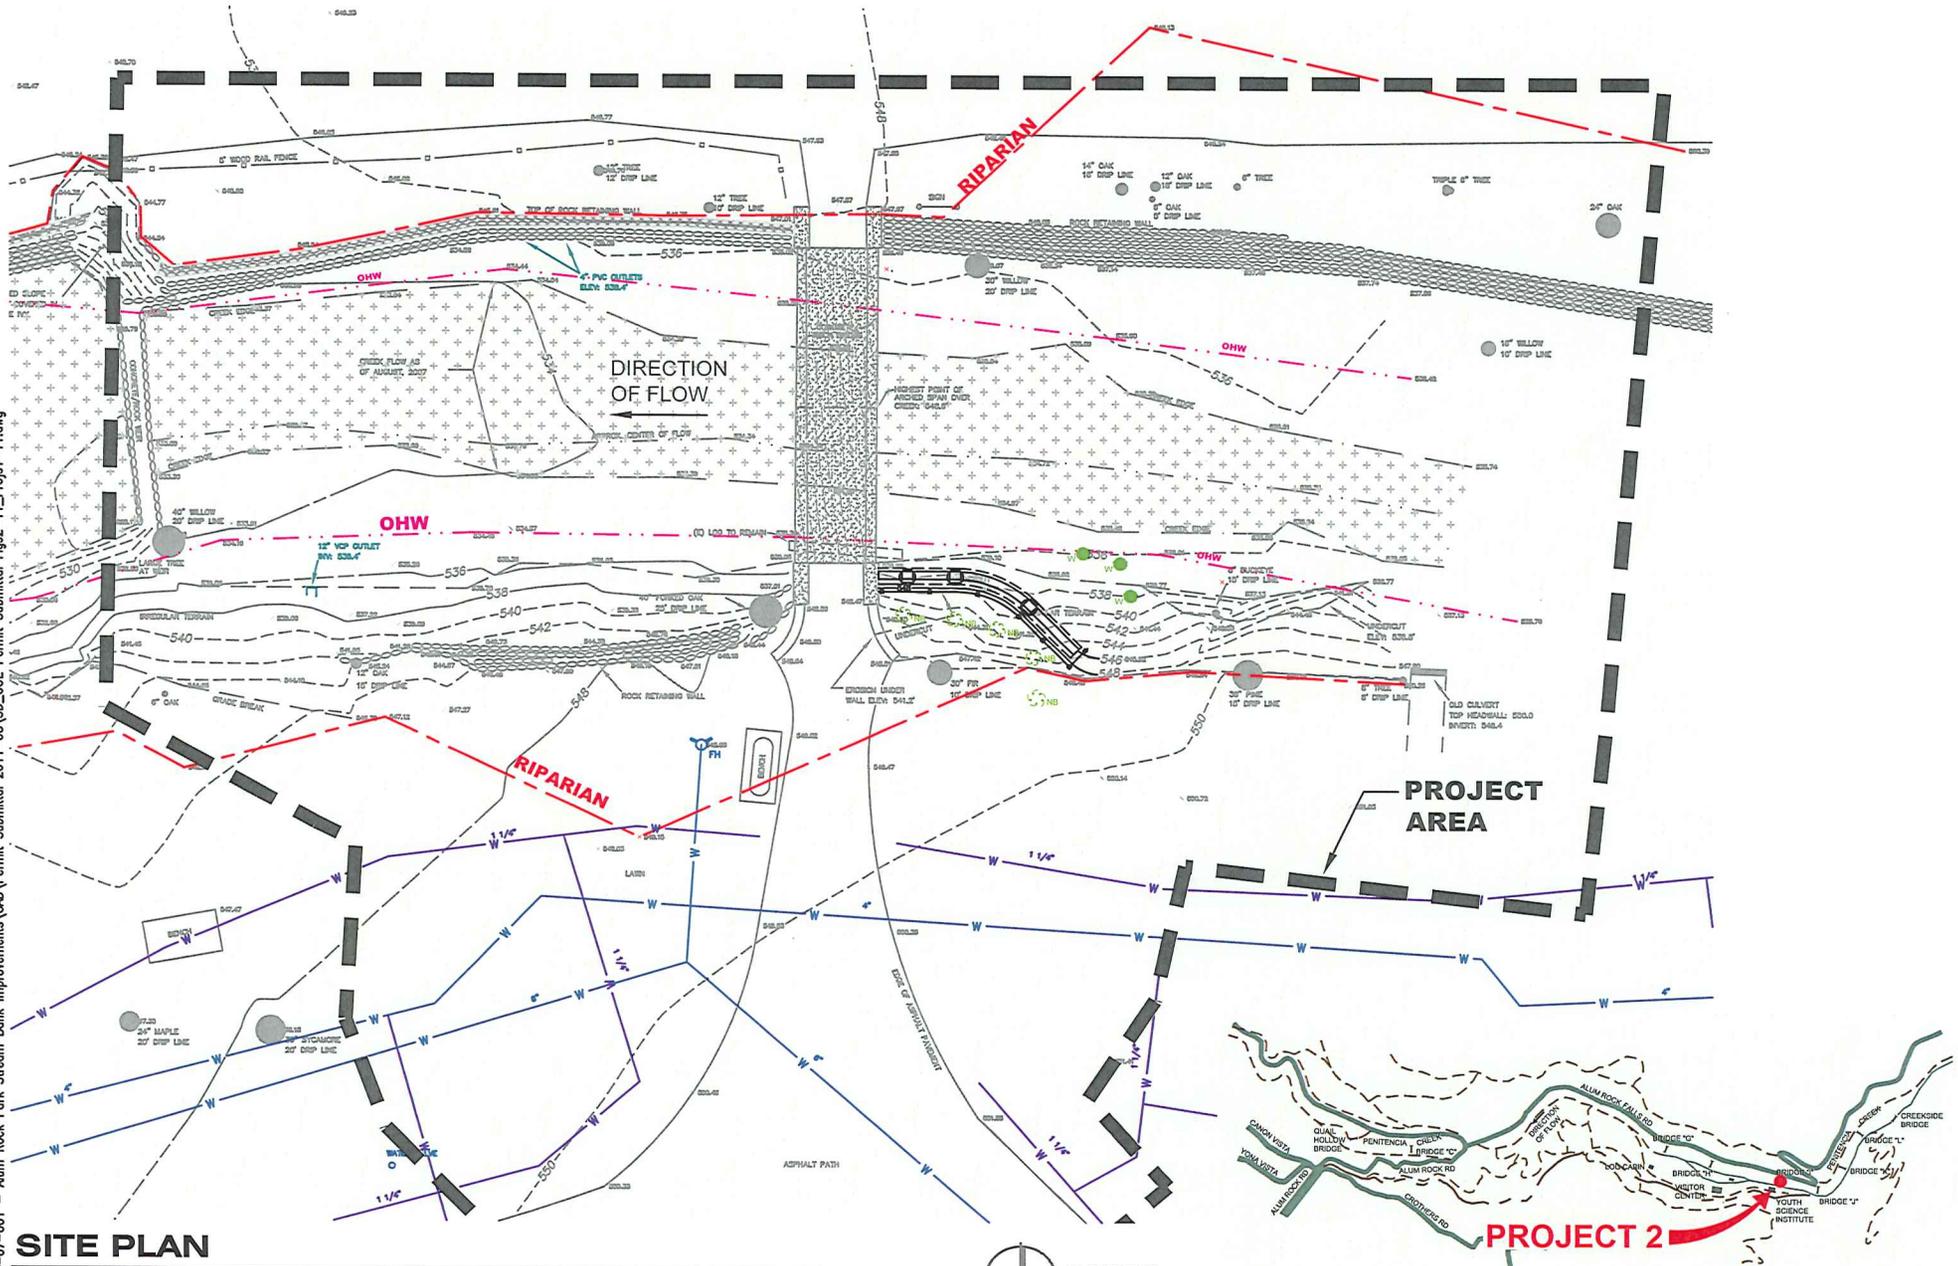
FIGURE 6  
PROJECT 2  
Y.S.I. BRIDGE REPAIRS

### SITE PLAN

#### **Project 2: Youth Sciences Institute Bridge Abutment Repair**

At the Youth Sciences Institute (YSI) Bridge along the left (south) bank, just upstream of the bridge the existing left abutment is constricting the flow of the creek as it passes underneath the bridge. High velocities from turbulence associated with flow constrictions are the likely cause of the erosion located just upstream of the abutment and potential undermining of the abutment. The erosion extends to the top of the bank, where erosion is occurring underneath the wall.

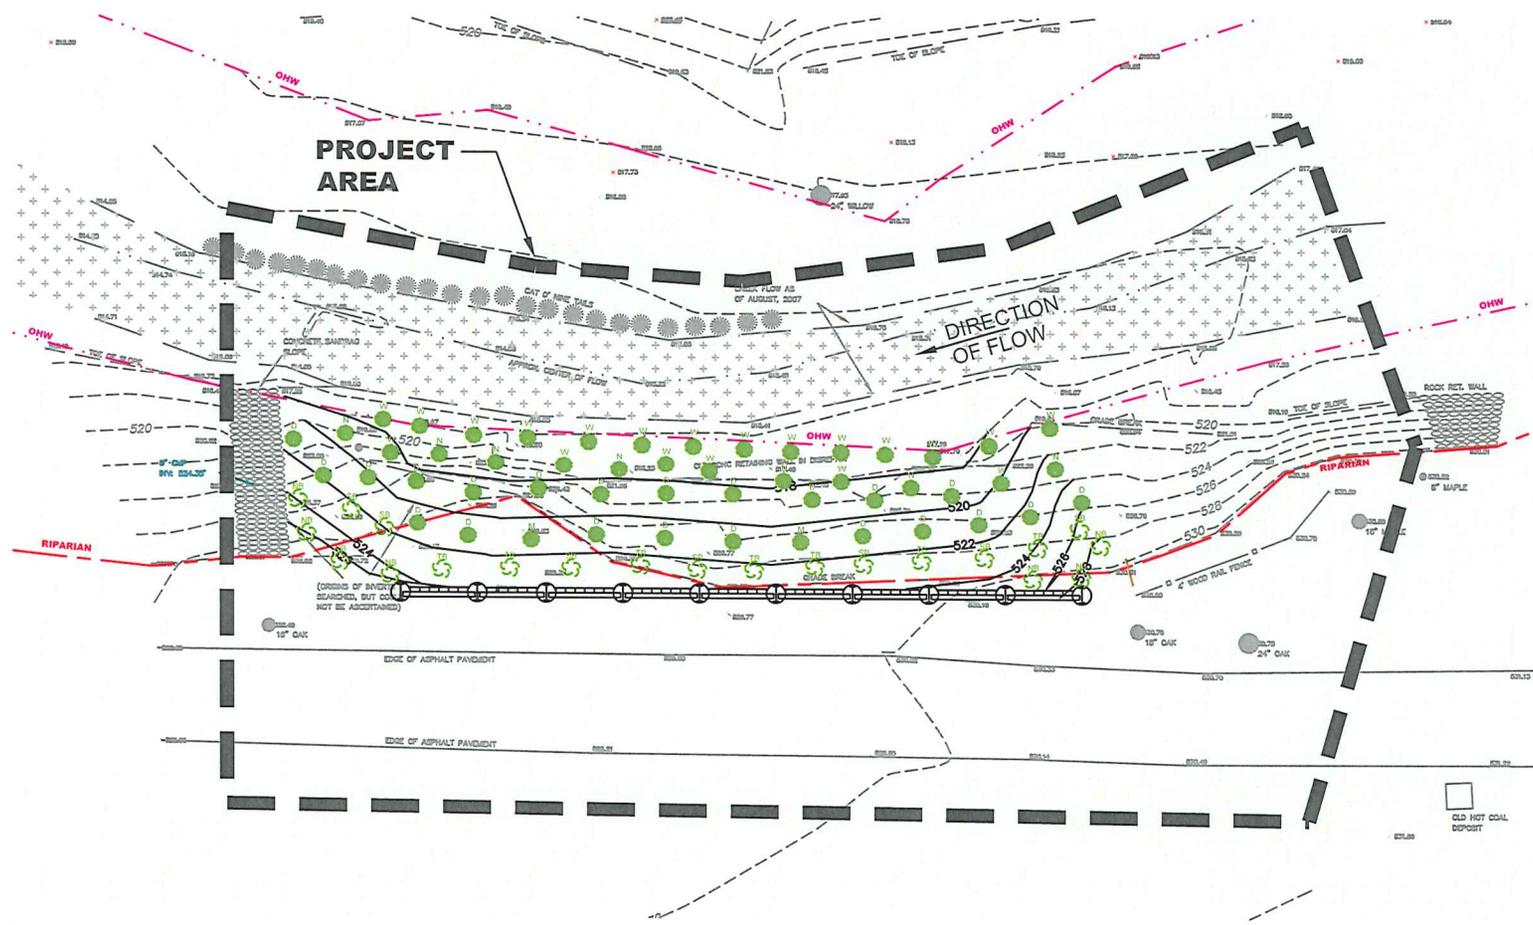
**FIGURE 8  
 PROJECT 6  
 PROPOSED EROSION REPAIRS**

**SITE PLAN**  
 SCALE: 1"=20'

#### **Project 6: Visitor's Center Bank Protection Repair**

This sub-project consists of repair of failed bank protection adjacent to the Visitor's Center. About 175 feet upstream of the Visitor Center Bridge, a previous bank protection project on the south bank has failed, possibly because of runoff from the adjacent parking lot. An approximately 50-foot long by 5-foot high crib wall has broken and no longer retains the slope. About 30 feet upstream a 6 by 15-foot rock and mortar wall has failed and slid into the channel. Downstream of the crib wall, a 7-by-20-foot section of rock and mortar bank facing has been undercut by erosion and has slid down to the edge of the stream. In this area of multiple failures, a 30-to-40 foot long section of the bank protrudes into the channel and is near vertical.

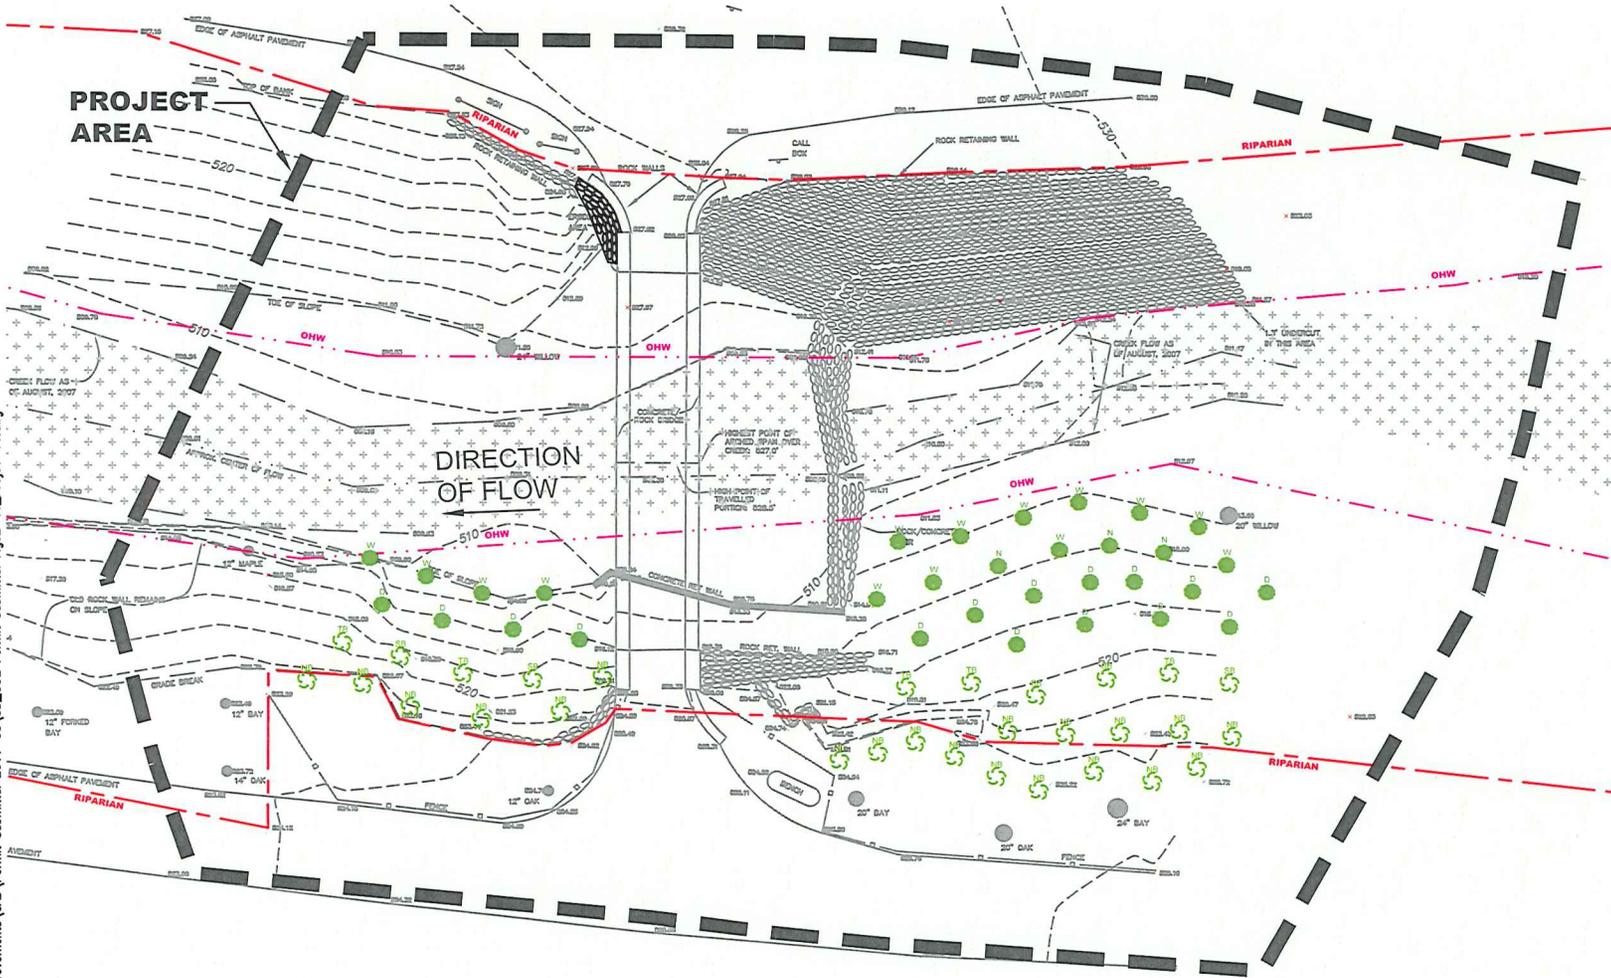
FIGURE 9  
PROJECT 9  
PROPOSED EROSION REPAIR

**SITE PLAN**  
SCALE: 1"=20'

#### **Project 9: Visitor's Center Bridge Abutments Repair and Fish Passage Improvement**

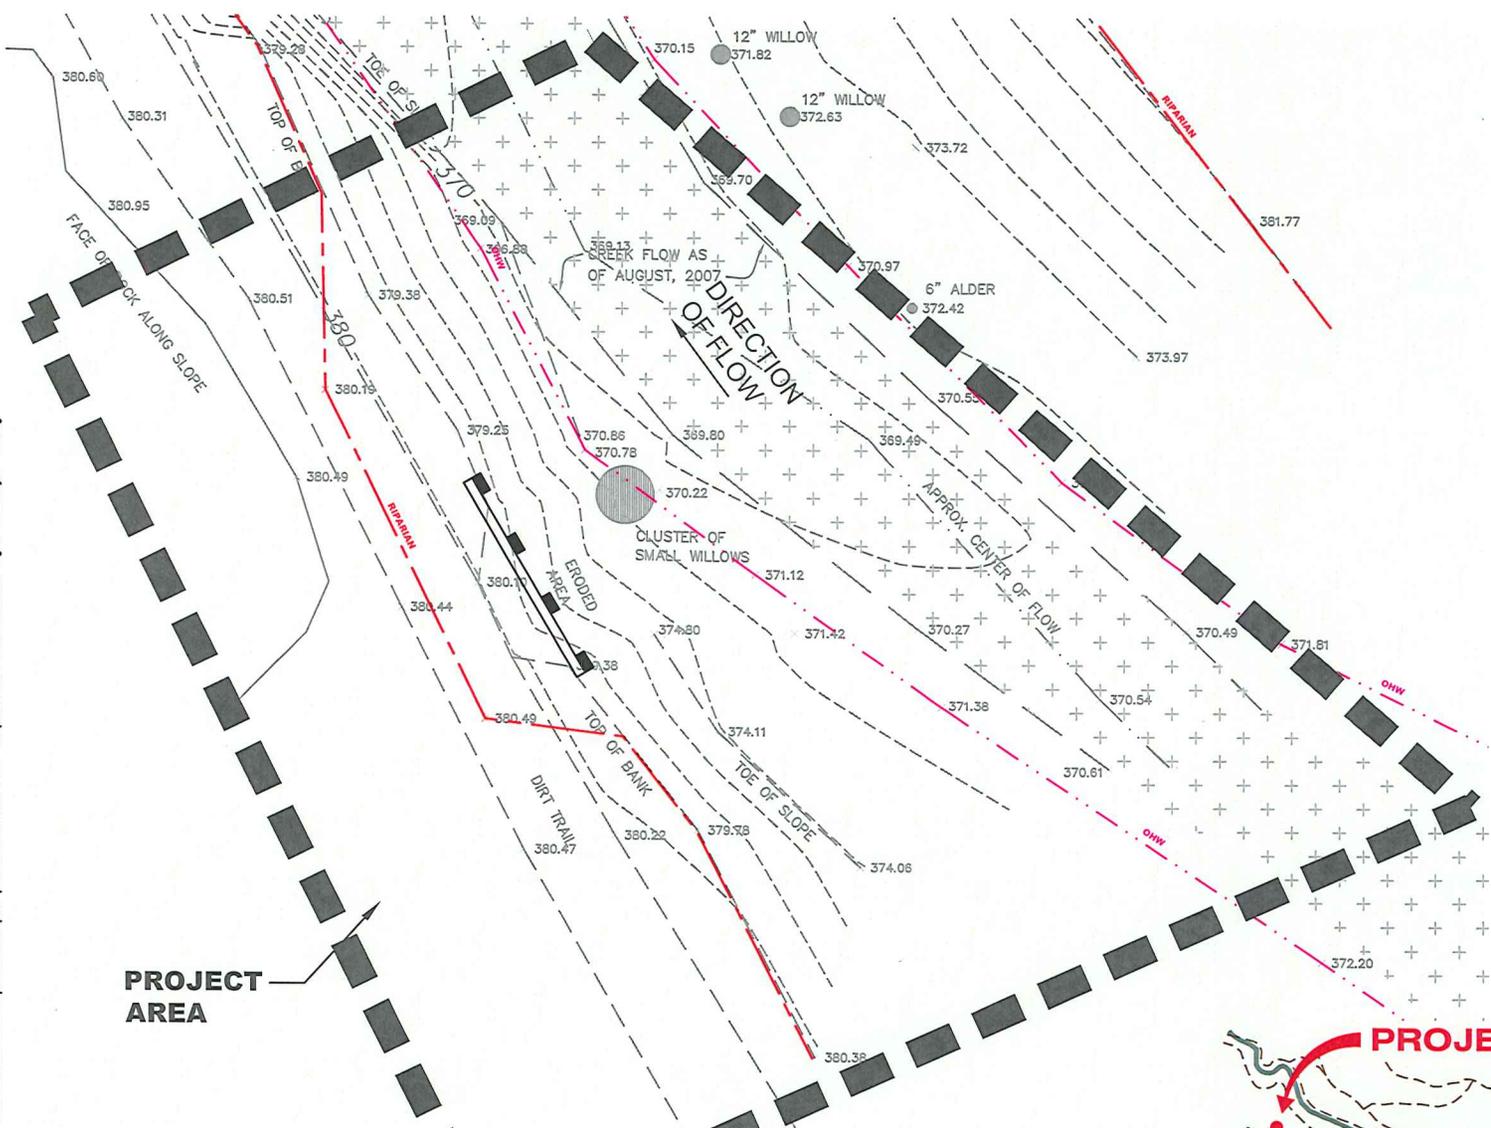
**FIGURE 10  
PROJECT 7  
PROPOSED EROSION REPAIR**

**SITE PLAN**  
SCALE: 1"=10'

**Project 7: Bank Repair Downstream of Quail Hollow**

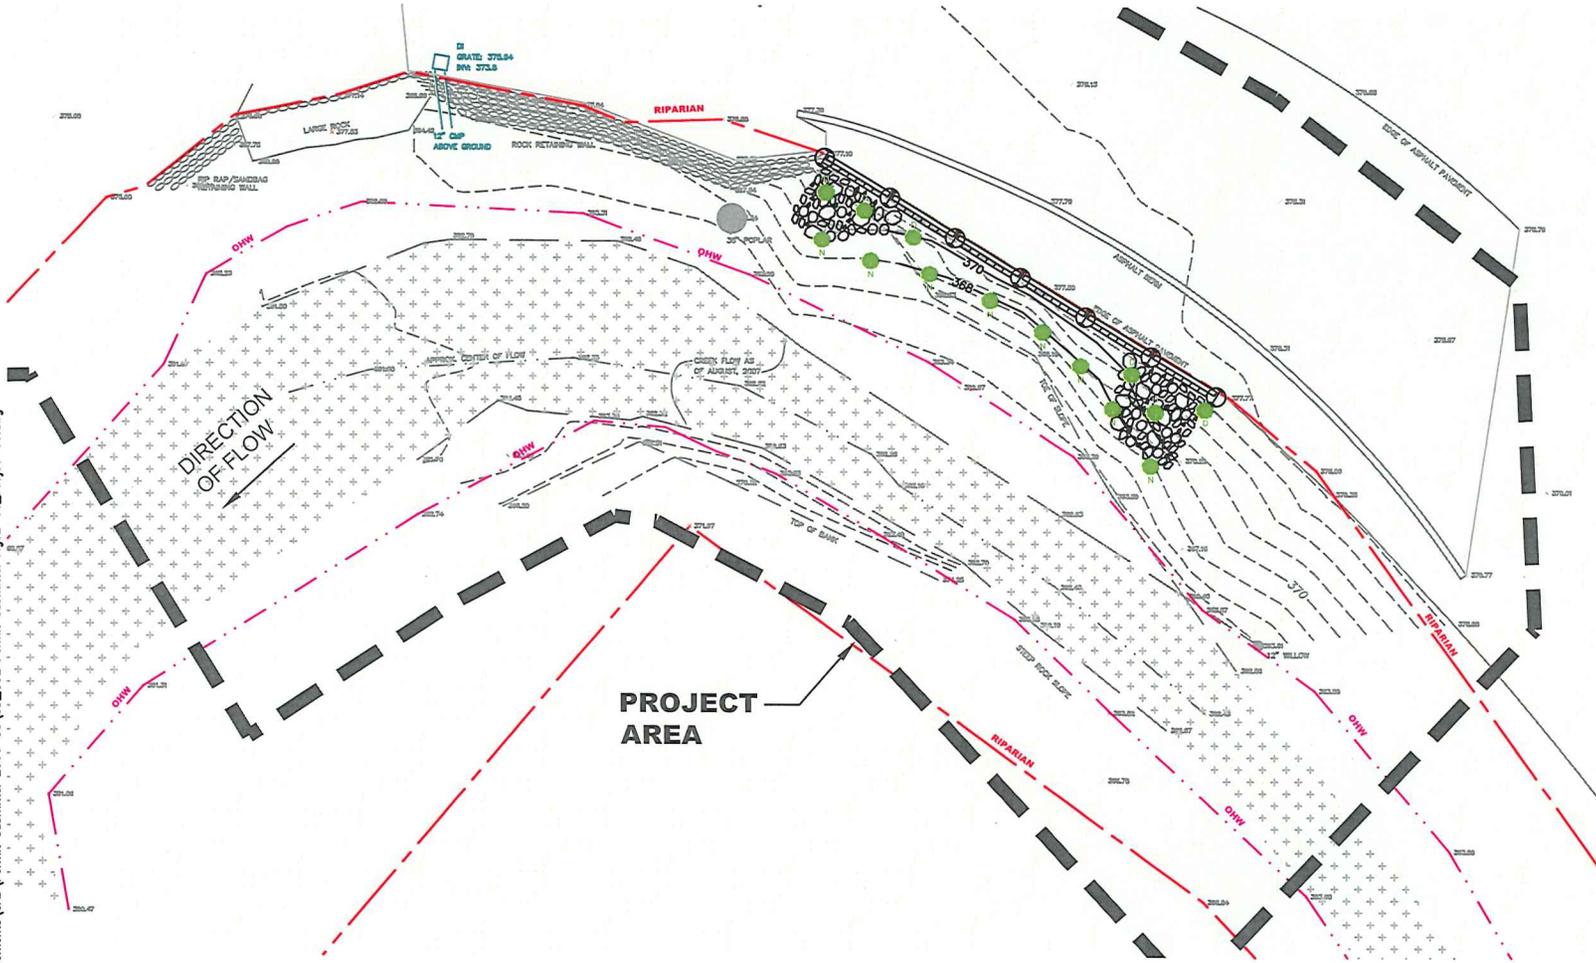
### FIGURE 11 PROJECT 8 PROPOSED EROSION REPAIR

### SITE PLAN

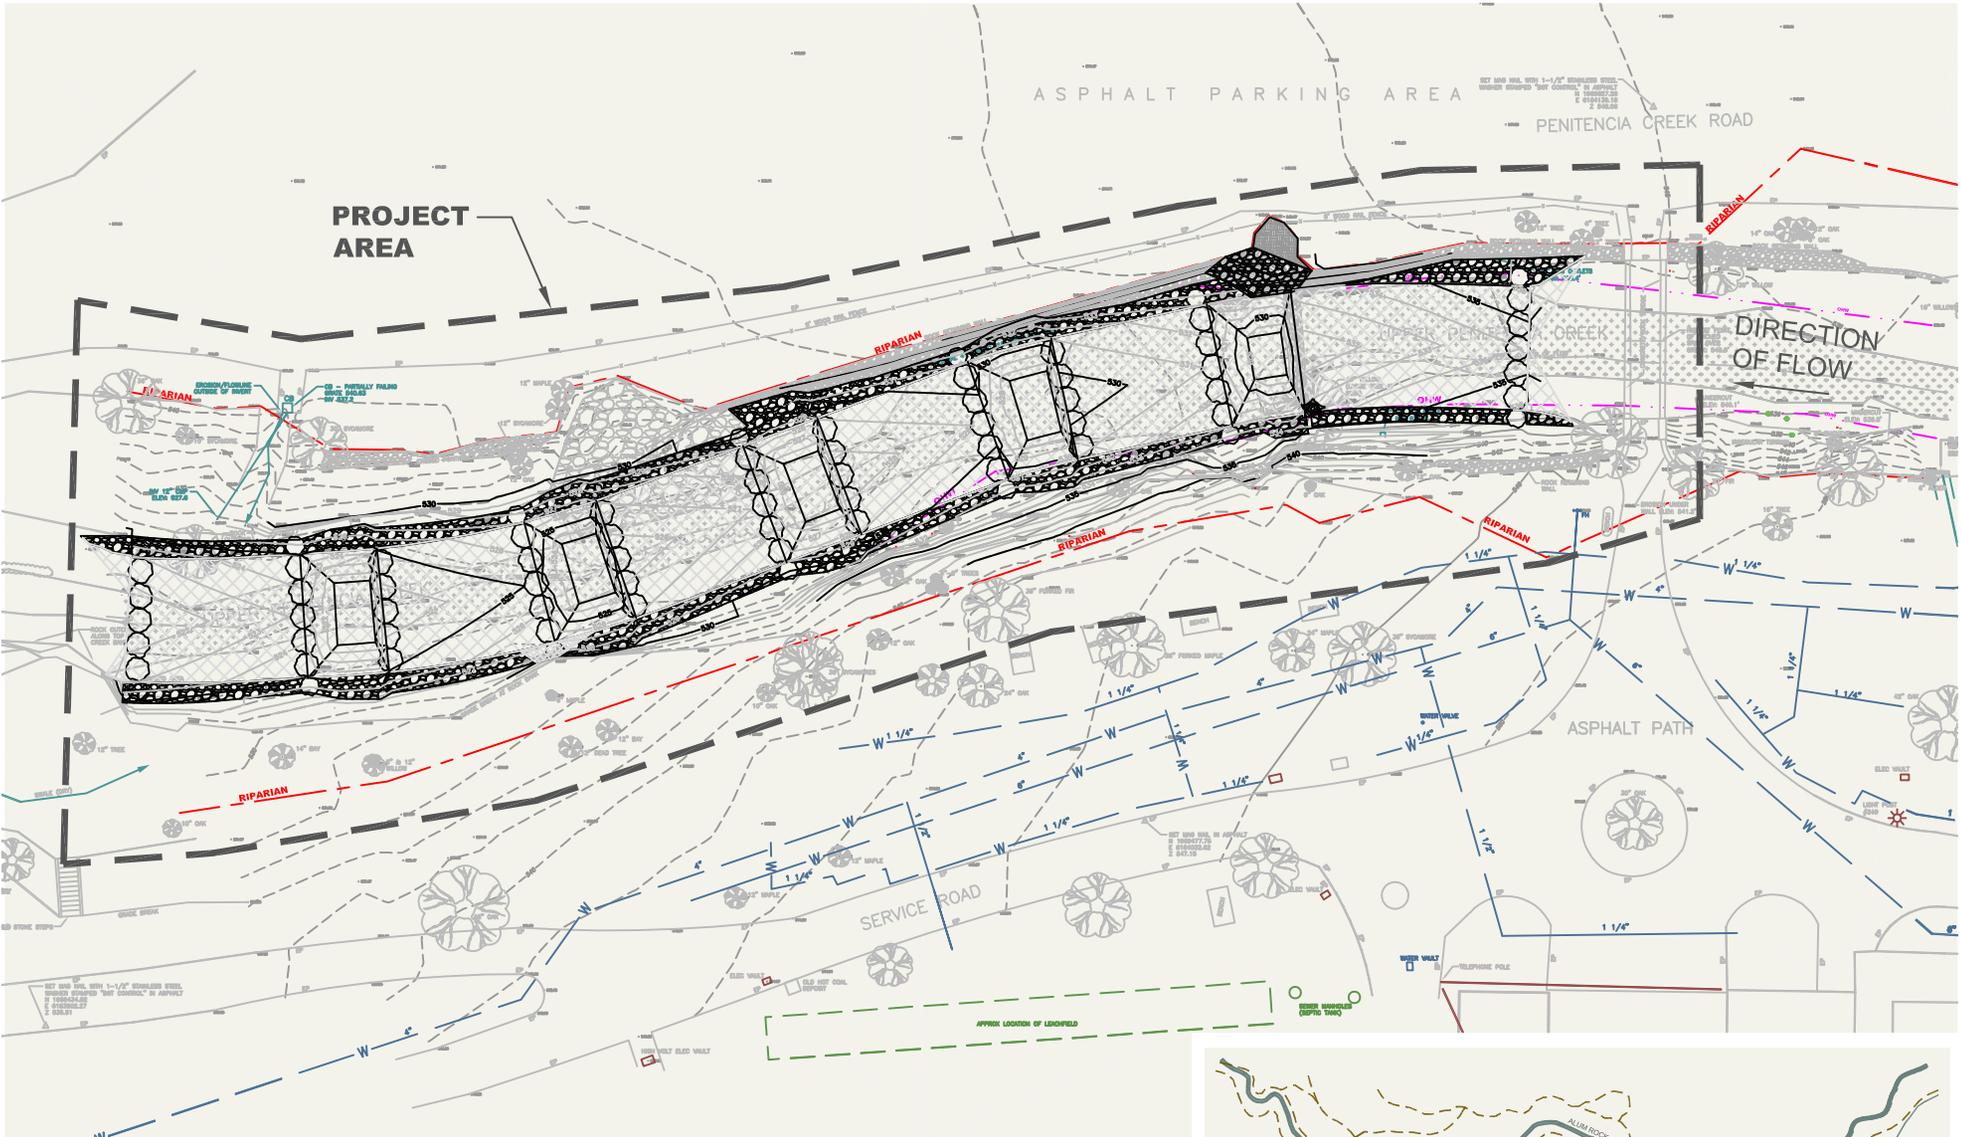
FIGURE 12  
PROJECT 13  
CEMAR FISH PASSAGE IMPROVEMENT

### SITE PLAN

completed for the Center for Ecosystem Management and Restoration (CEMAR). An undercut weir serving as a grade control structure 75 feet downstream of the YSI bridge has caused a scour pool and a 4.5-foot vertical drop from the crest of the weir to the normal pool surface, creating a salmonid migration barrier. Simple weir removal could allow upstream channel degradation and threaten the structural integrity of the bridge. This project proposes to leave the weir in place and to create a stable roughened channel suitable for fish passage. The new roughened channel will extend for 225 linear feet, with a chute and pool design to allow fish resting places. As a result of the channel design, the OHWM will be elevated through the restored channel reach. There will be no net change in channel cross section, area of jurisdictional waters, or wetted area other than a slightly increased elevation of both channel bed and the OHWM. There will be a significant improvement in fish migration capability, and there will also be a net gain in aquatic habitat quality.
