# **Habitat Mitigation and Monitoring Plan Alum Rock Park Bank Repair and Stream Restoration Projects**

**July 2011**

Appendix A – Figures  
Appendix B – Project Plans  
Appendix C – Project Photographs  
Appendix D – OHMM Delineation Report

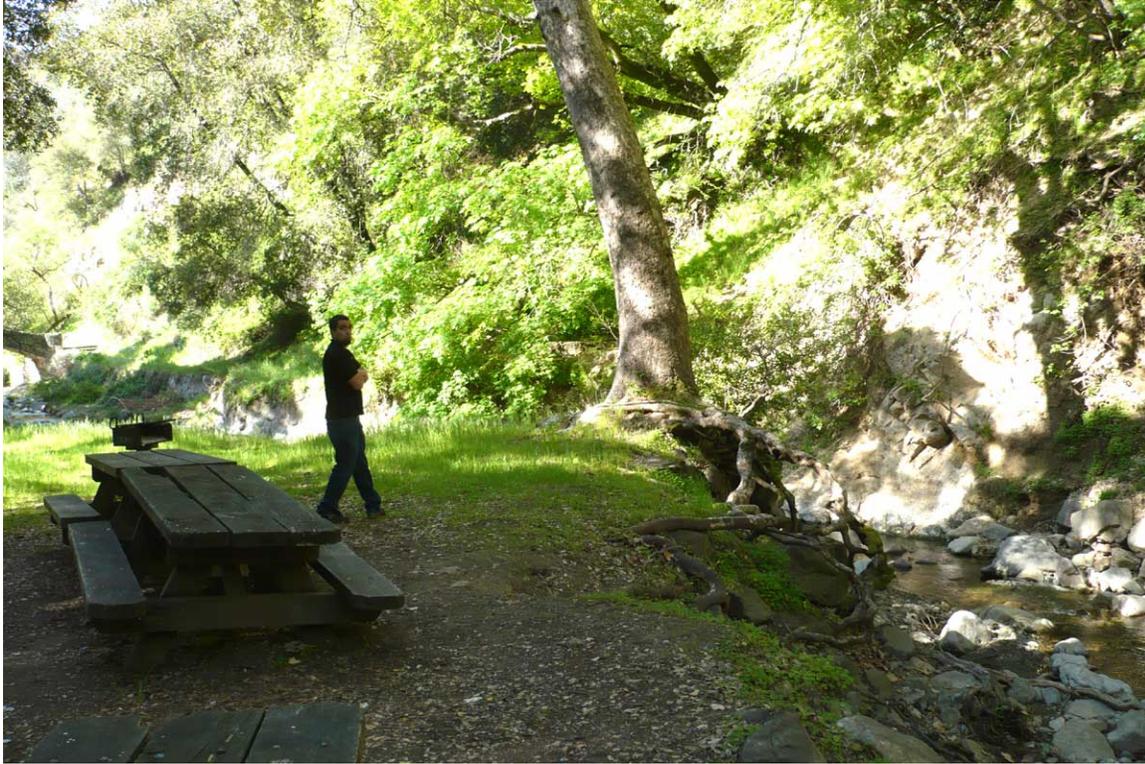
Project 11: Mature Sycamore Tree and Picnic Area

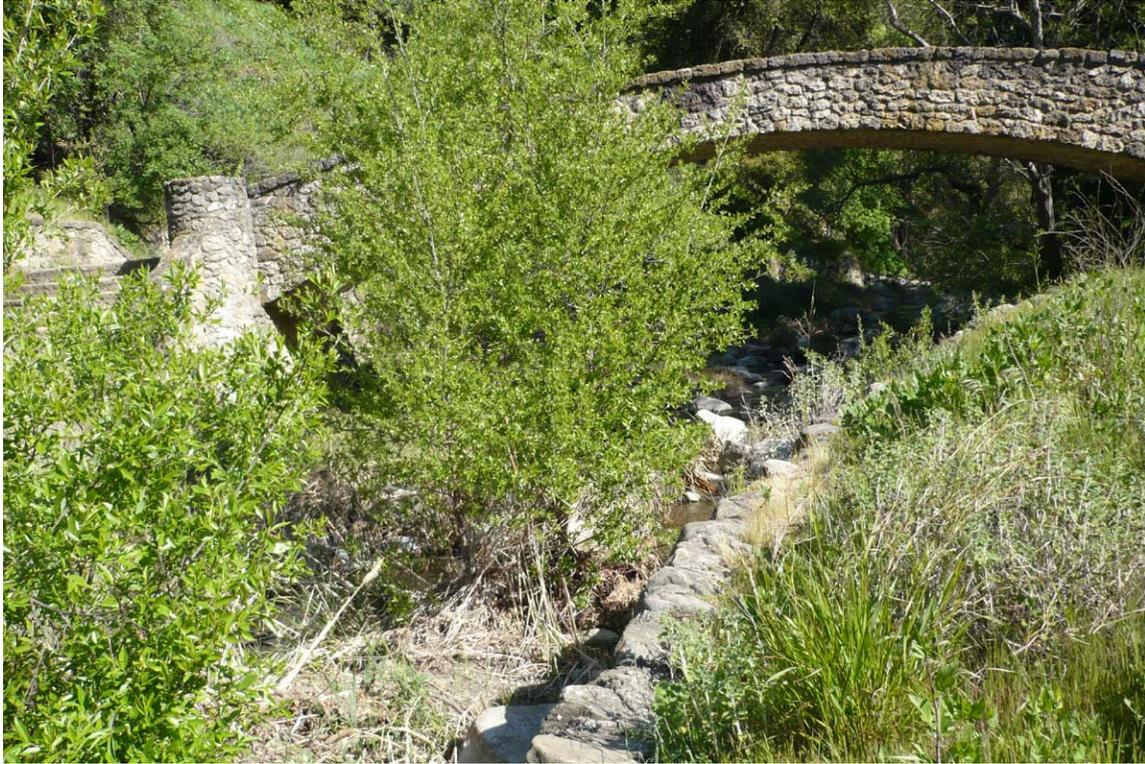
Project 3 and 10: Rock Wall Looking Upstream

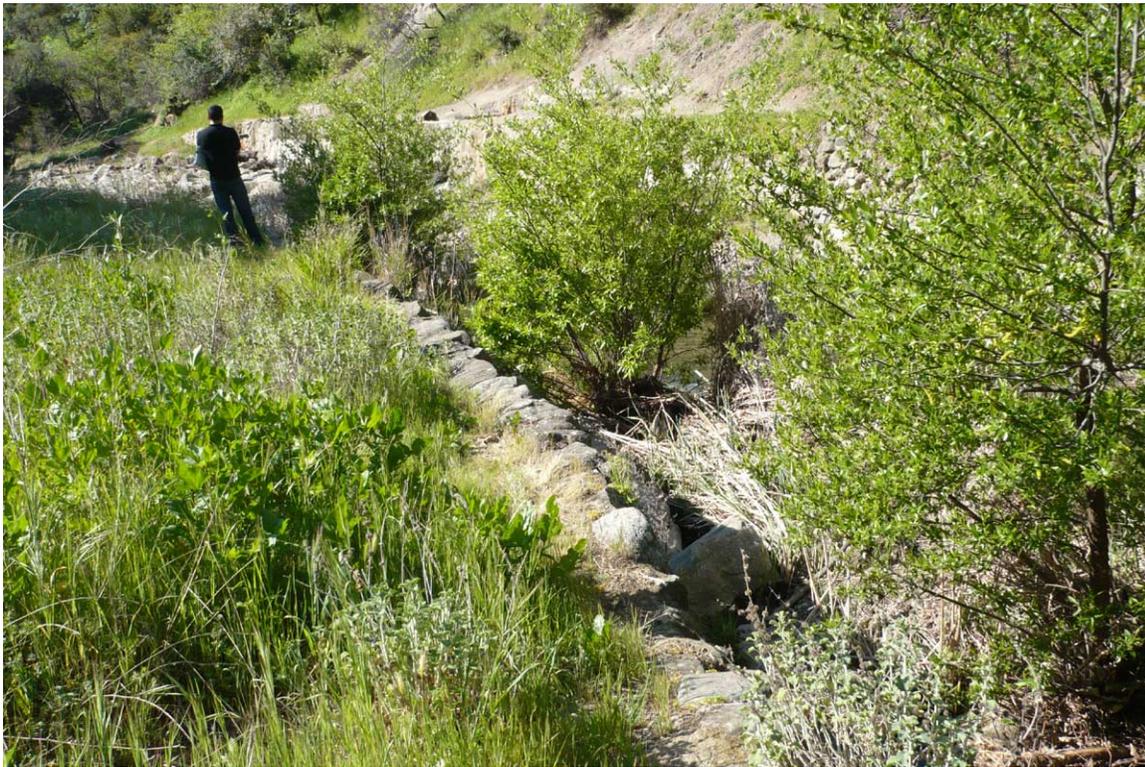
Project 3 and 10: Rock Wall Looking Downstream

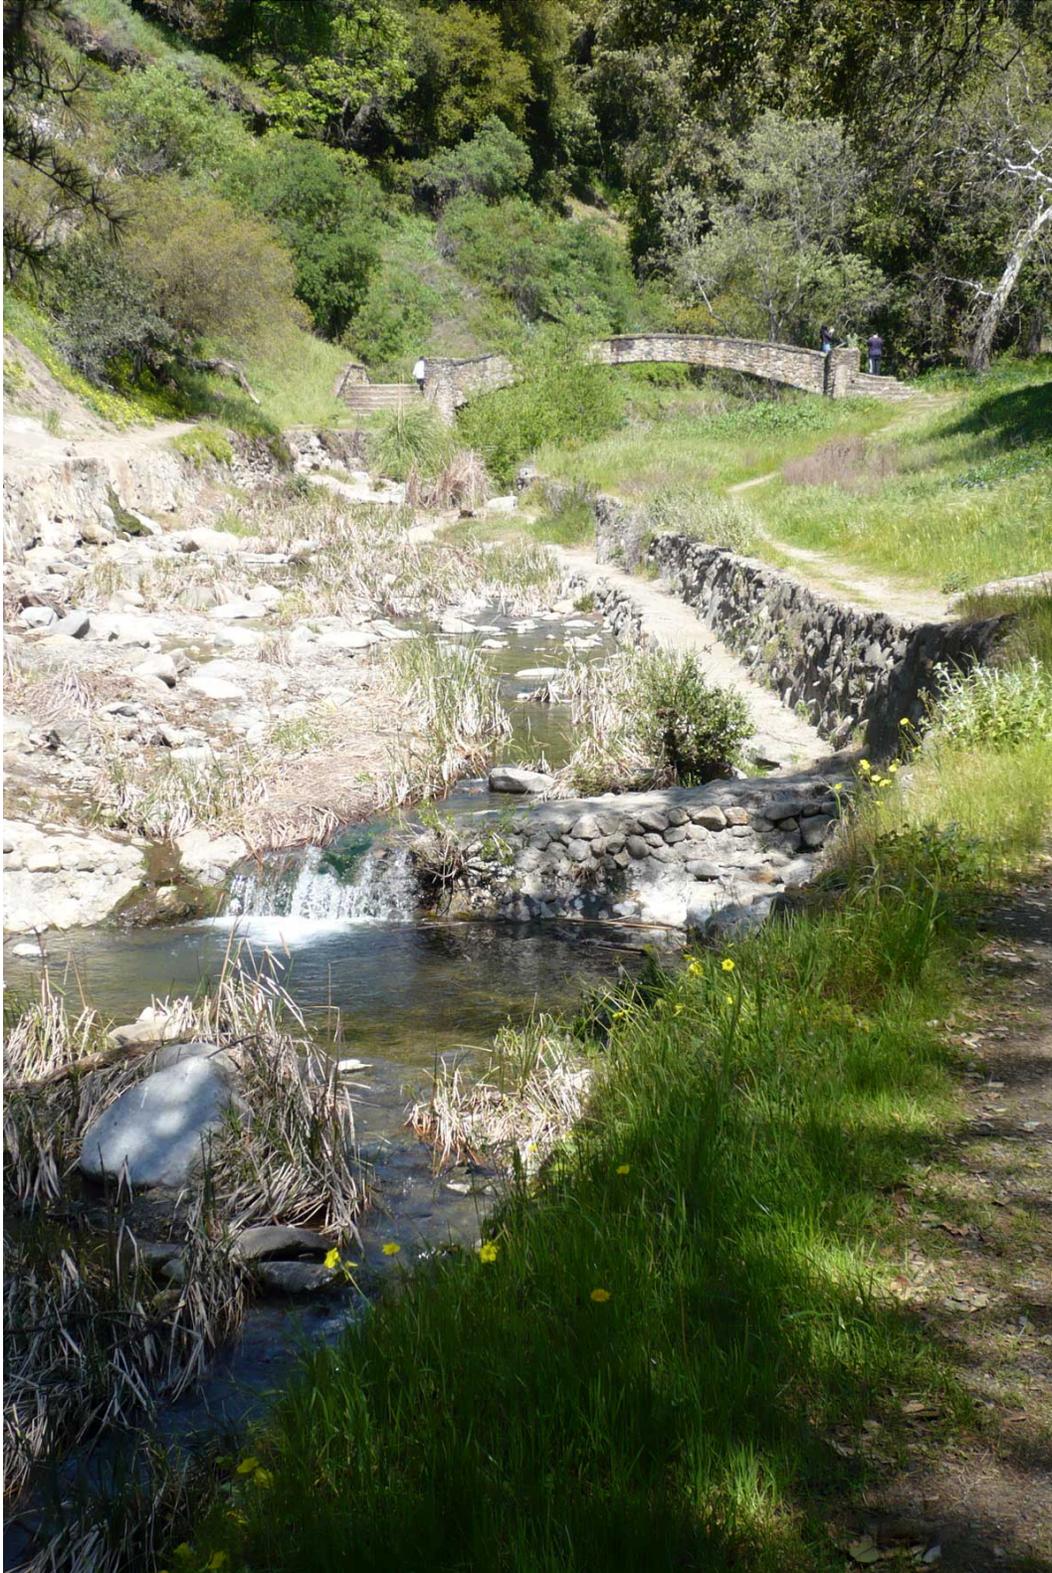
Project 3 and 10: Overview of Floodplain Re-establishment Area

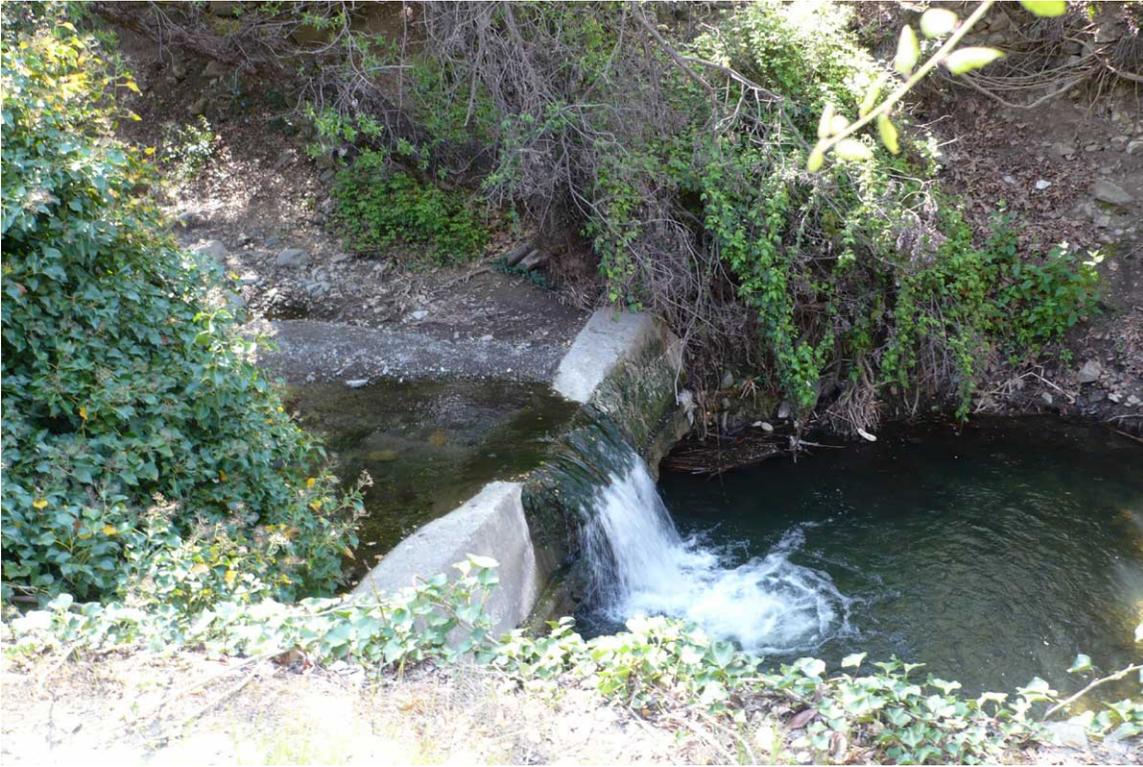
Project 5 and 13/CEMAR: Weir Area, Plunge Pool

completed for the Center for Ecosystem Management and Restoration (CEMAR). An undercut weir serving as a grade control structure 75 feet downstream of the YSI bridge has caused a scour pool and a 4.5-foot vertical drop from the crest of the weir to the normal pool surface, creating a salmonid migration barrier. Simple weir removal could allow upstream channel degradation and threaten the structural integrity of the bridge. This project proposes to leave the weir in place and to create a stable roughened channel suitable for fish passage. The new roughened channel will extend for 225 linear feet, with a chute and pool design to allow fish resting places. As a result of the channel design, the OHWM will be elevated through the restored channel reach. There will be no net change in channel cross section, area of jurisdictional waters, or wetted area other than a slightly increased elevation of both channel bed and the OHWM. There will be a significant improvement in fish migration capability, and there will also be a net gain in aquatic habitat quality.

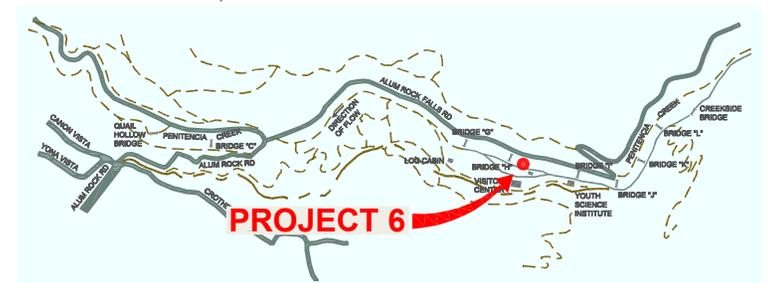
**SITE PLAN**

SCALE: 1"=20'

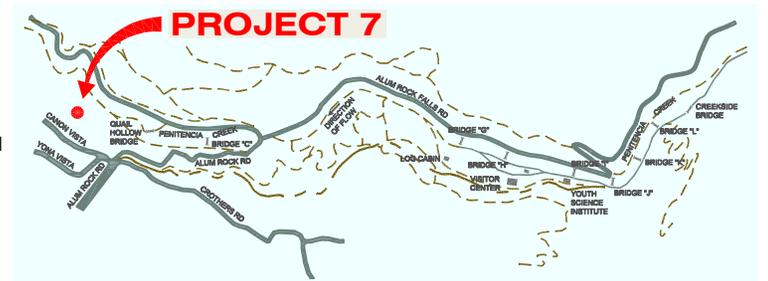
**SITE PLAN**

SCALE: 1"=10'
